Texas Clean Rivers Program

San Antonio River Basin 2018 Summary Report

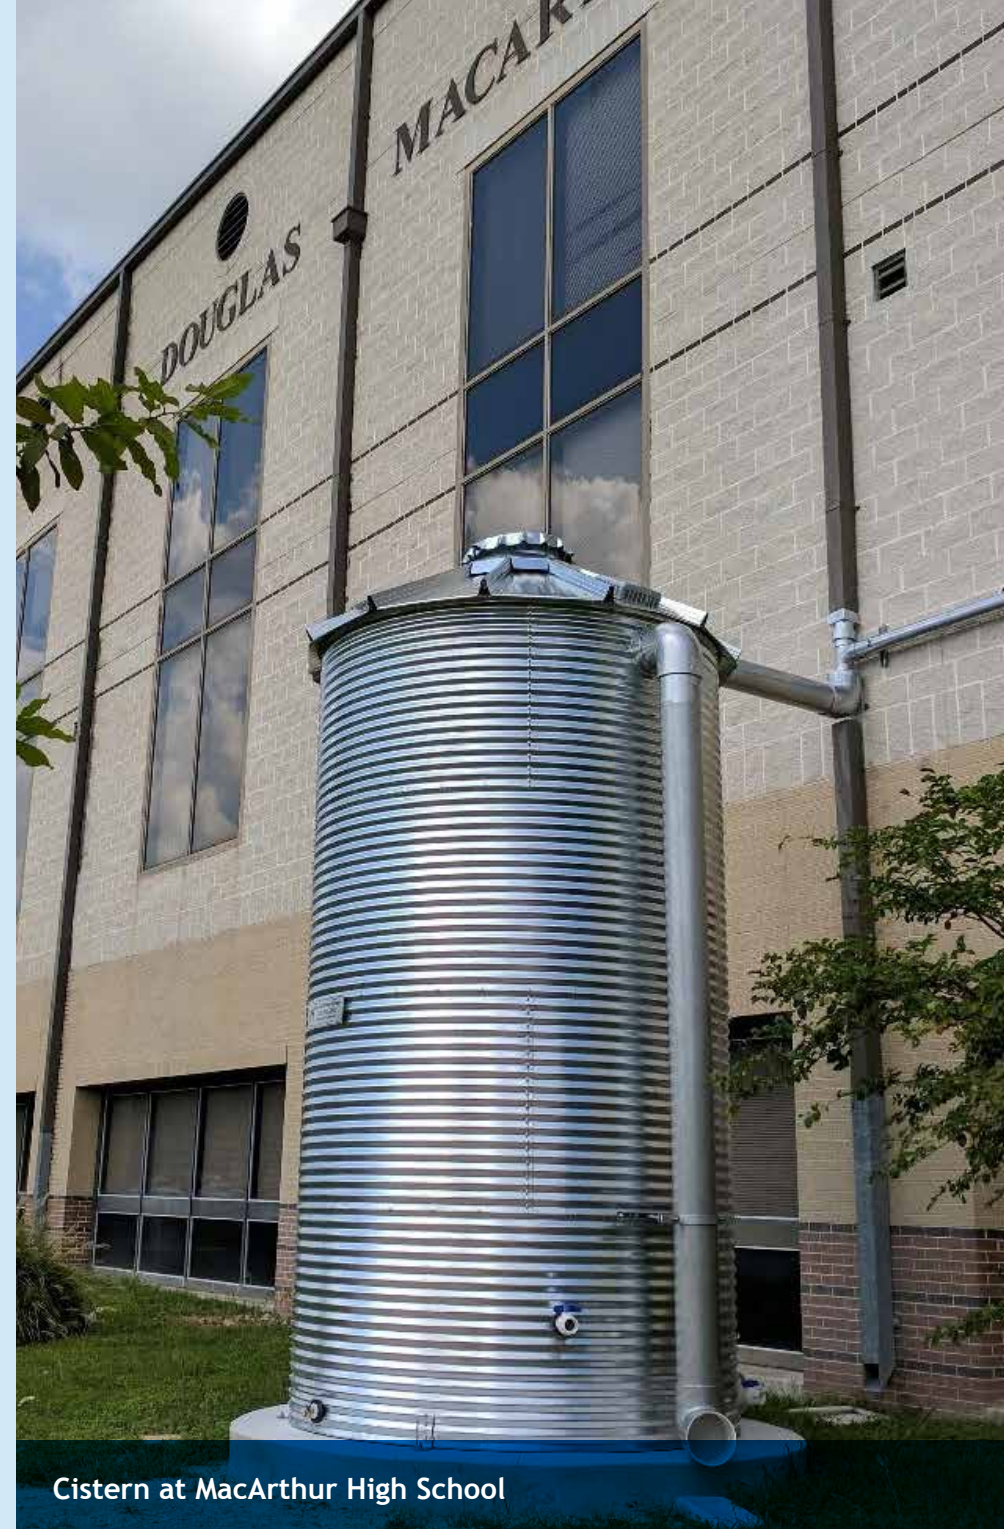
Cistern at MacArthur High School

As SARA is committed to innovative, collaborative, adaptive and strategic actions that result in watershed solutions, SARA is leading activities within the San Antonio River Basin to promote sustainable land use. SARA's multipronged approach will work to preserve natural watershed functions that manage the quality and quantity of stormwater runoff through a balance of economic, environmental, and quality of life considerations. Several efforts and programs included in SARA's multipronged approach include: SARA's long-term network of automated instream stormwater monitoring stations, Low Impact Development (LID) Best Management Practice (BMP) Verification Project, SARA's Watershed Wise Grant Program, SARA's Watershed Wise Rebate Program and the SARA and Bexar County developed LID Training Courses for the construction, inspection and maintenance of LIDs permanent stormwater BMPs. Additional information can be found in SARA's LID Technical Guidance Manual located at <https://www.sara-tx.org/wp-content/uploads/2015/05/Full-LID-Manual.pdf>

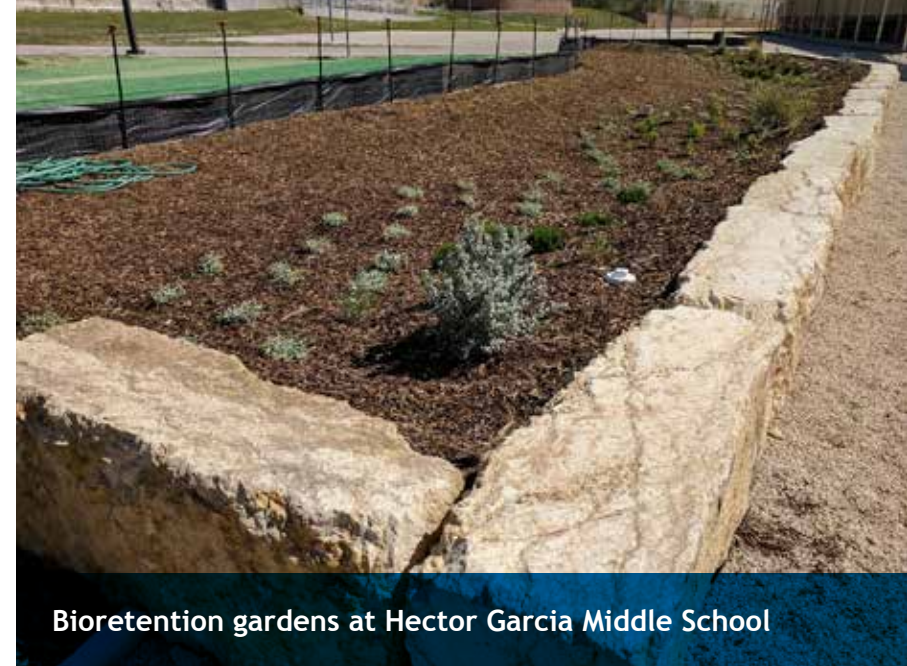
Bioretention gardens at Hector Garcia Middle School

SARA Watershed Wise Grant provides funds to construct LID and BMPs at K-12 public schools within Bexar, Wilson, Karnes, and Goliad counties. This project began in 2015 and is projected to be completed in 2019. The purpose of this project is to educate the public about stormwater runoff and the effects on nonpoint source pollution, flooding, and erosion, while also demonstrating that these issues can be alleviated by green infrastructure. Depending on the year, anywhere from two to four grants, up to \$22,000 per grant, are awarded to local schools. These projects are used by SARA educators to provide in-class presentations and activities on the importance of green infrastructure. To date, approximately \$225,000 have been awarded to nine schools.

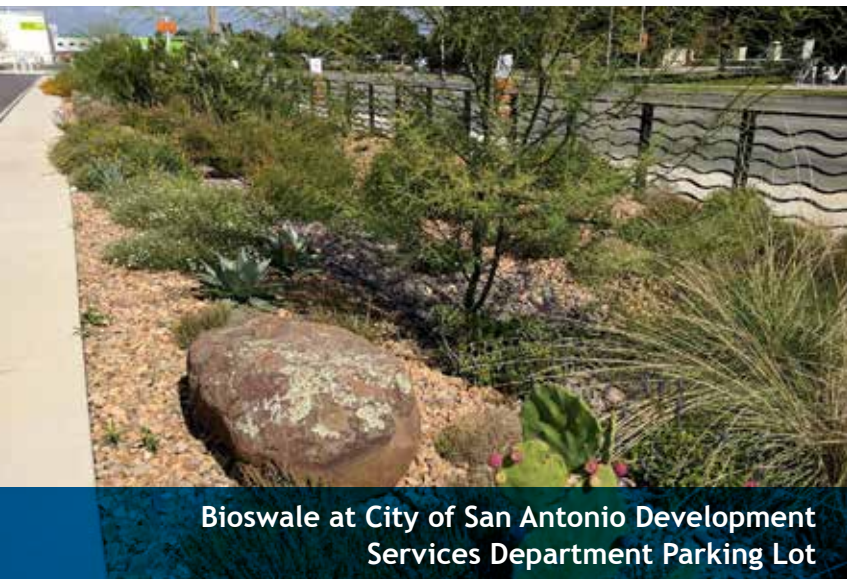
Bioswale at City of San Antonio Development Services Department Parking Lot

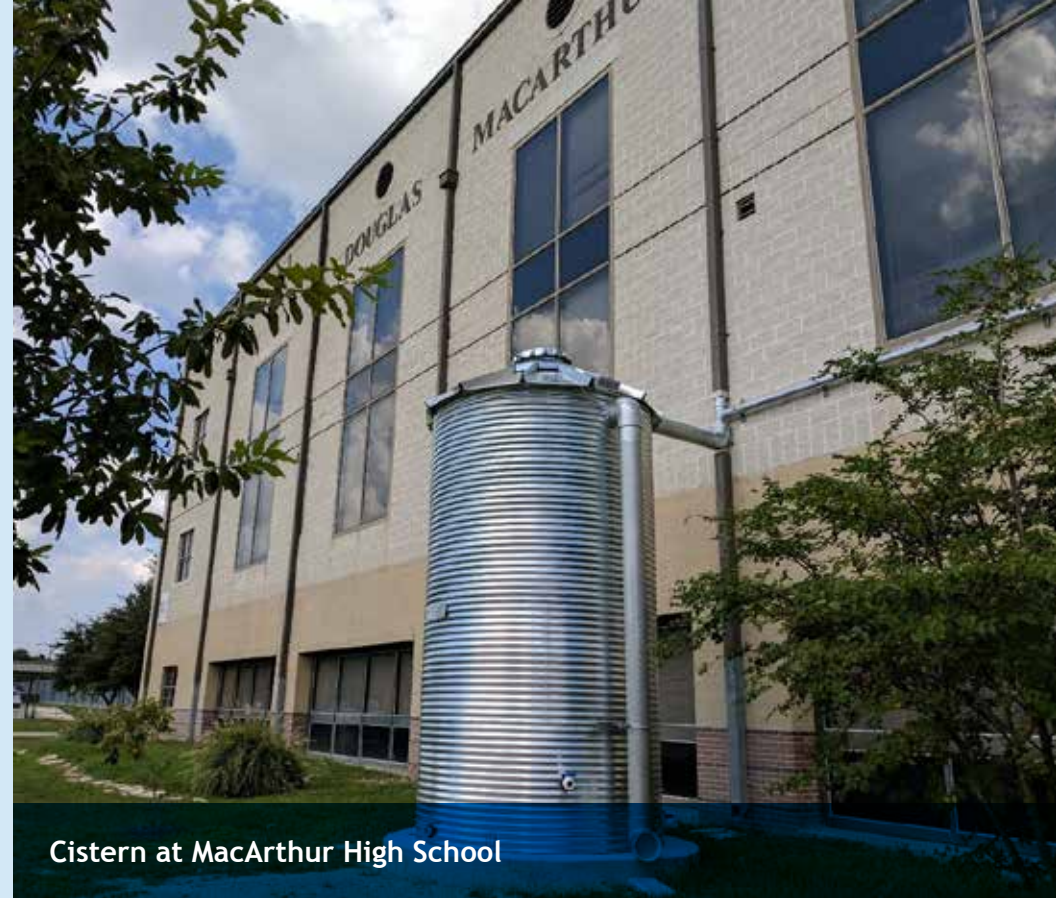
Cistern at MacArthur High School

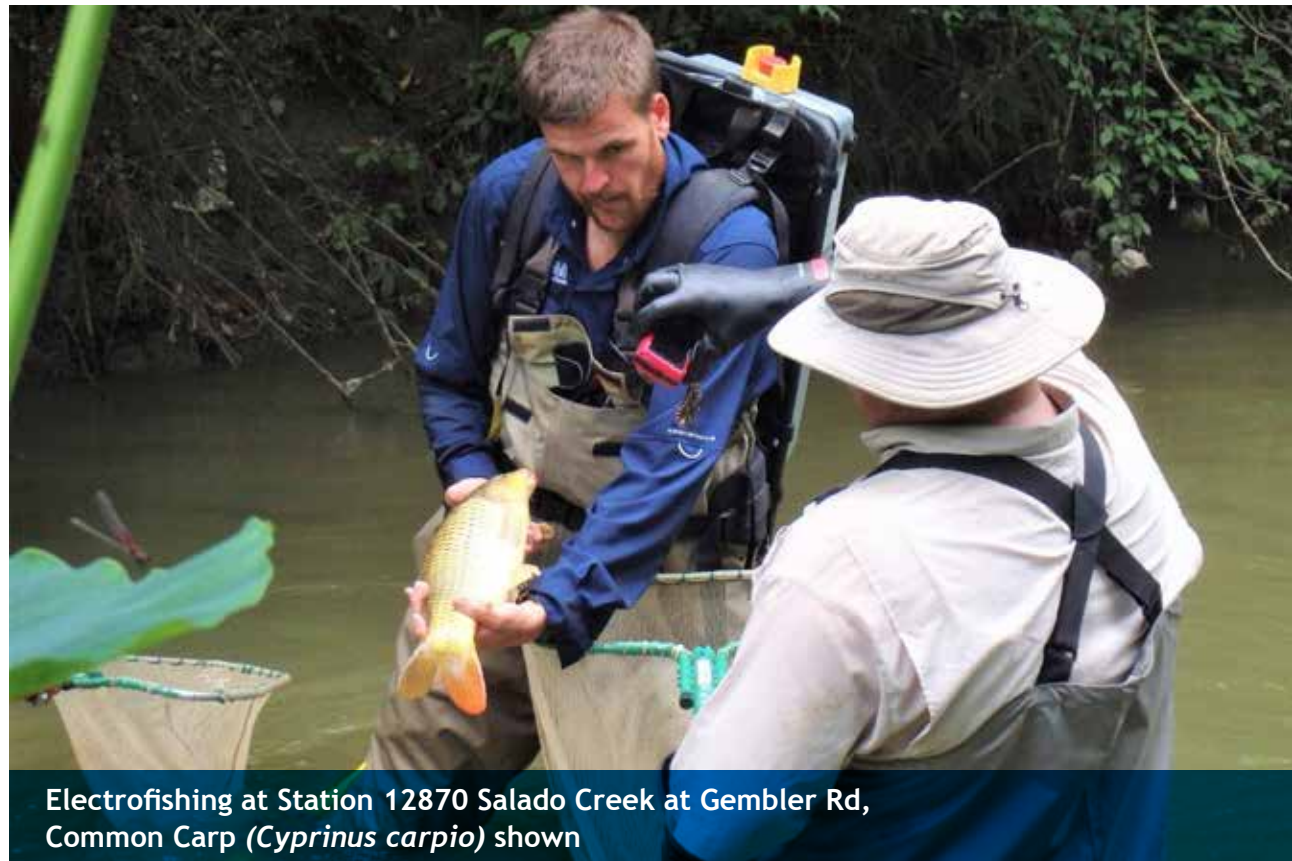
Electrofishing at Station 12870 Salado Creek at Gembler Rd, Common Carp (*Cyprinus carpio*) shown

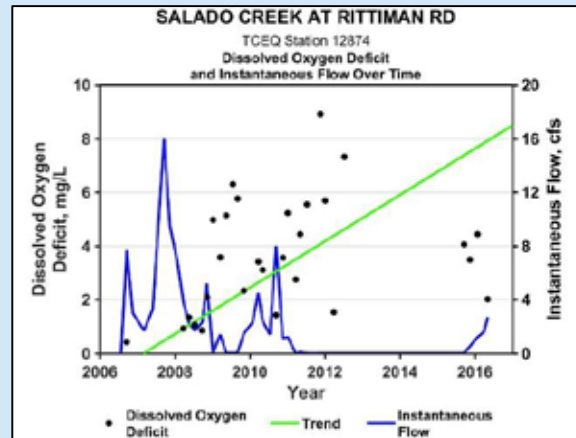
Fig. SC 9: 12874 Salado Creek at Rittiman, DO Deficit Over Time

Station 12874 Salado Creek at Rittiman was analyzed for trends to represent assessment unit 1910_03. Statistically significant increases trends over time were found for *E. coli* levels (Figure SC 8) and dissolved oxygen deficit (Figure SC 9). Flow, temperature, pH, total phosphorous (Figure SC 10), and chlorophyll-*a* all decreased over time. This station was the site of a major construction project, which, combined with the 2011 drought, resulted in very low flows at the station, and a complete lack of data from July 2012 until September 2015. While there is a concern for nitrate levels in this assessment unit, there was not a significant trend over time. Due to the large gap in data collection, it is difficult to confidently discern the driving factors behind the significant trends seen at this station.
