Nature-Based (NB) Project Opportunity Pipeline for SARA Self-Investment

EAC
9/16/2022

Nature-Based Infrastructure

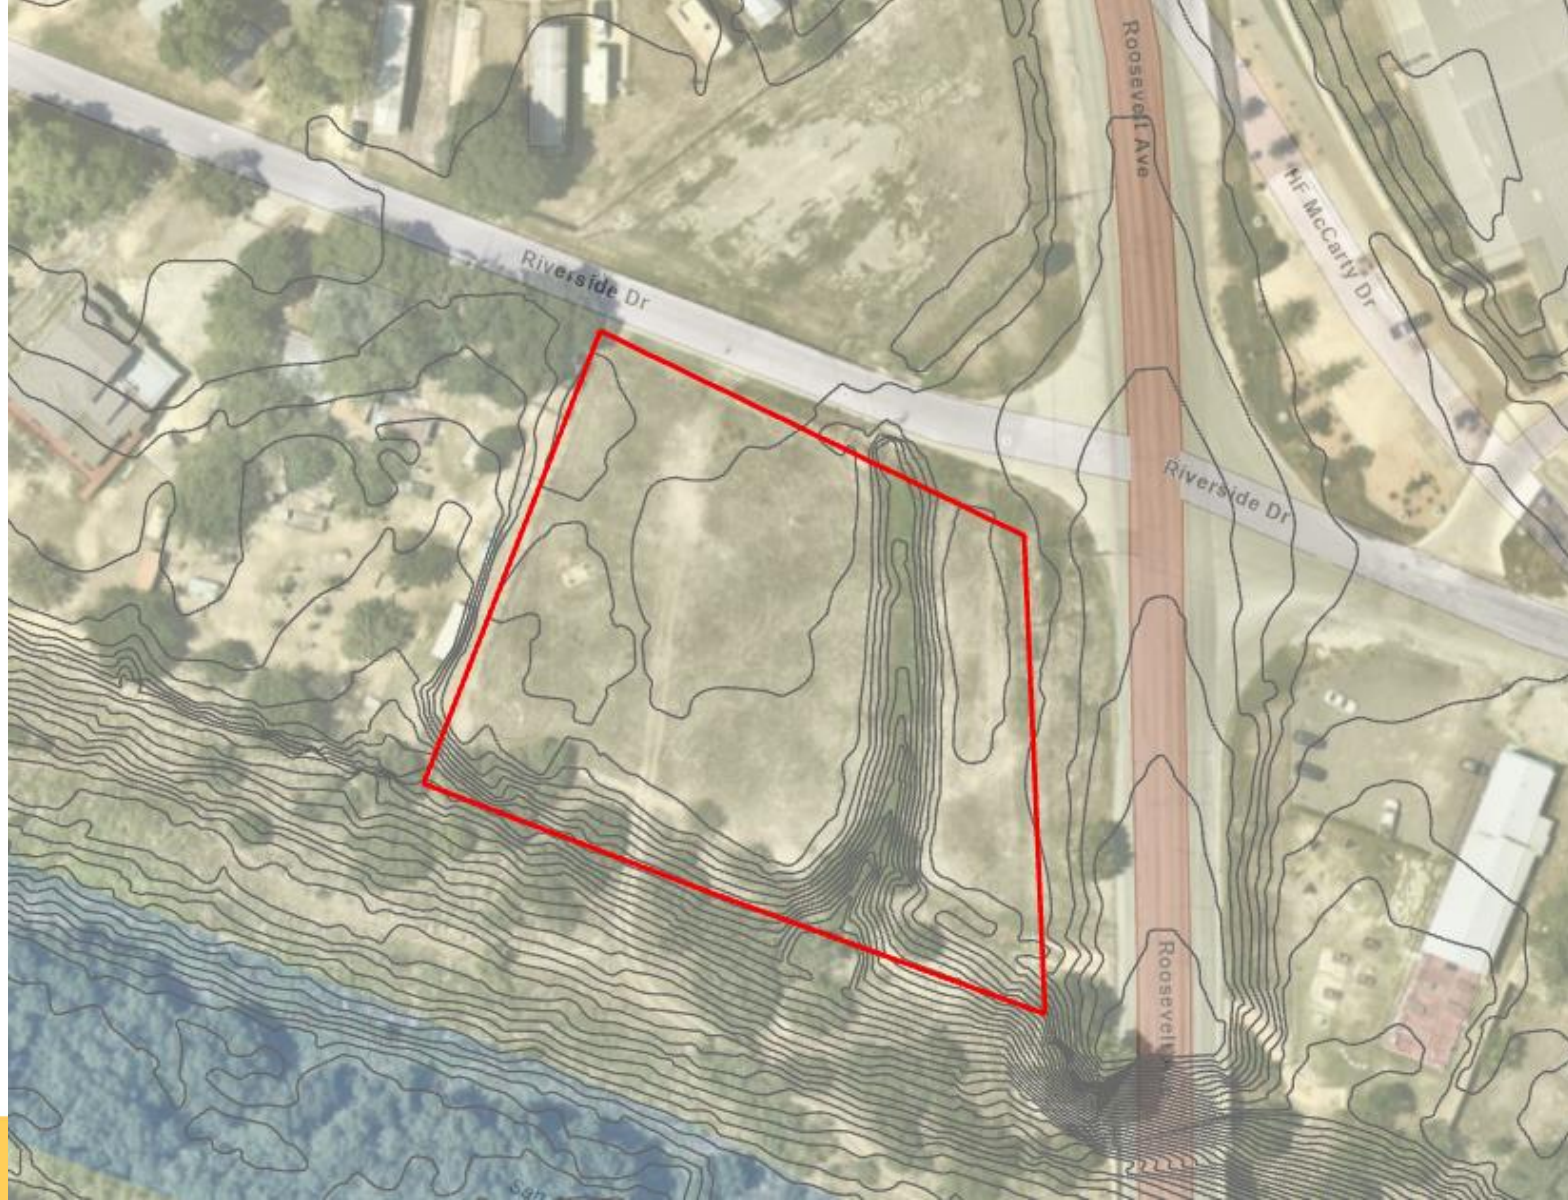
LID DRAINAGE AREA MAP

- EXTERNAL DRAINAGE AREA BOUNDARIES DELINEATED TO ROOSEVELT AVE. BASED OFF 2017 LIDAR 1' CONTOURS.
- BIOSWALE FOOTPRINTS SHOWN REFLECTS BOTTOM STONE LAYER LIMITS OR LAYER BENEATH SOIL MEDIA.
- BIOSWALE ARE DESIGNED TO ALLOW PONDING FOR UP TO 6-INCHES.

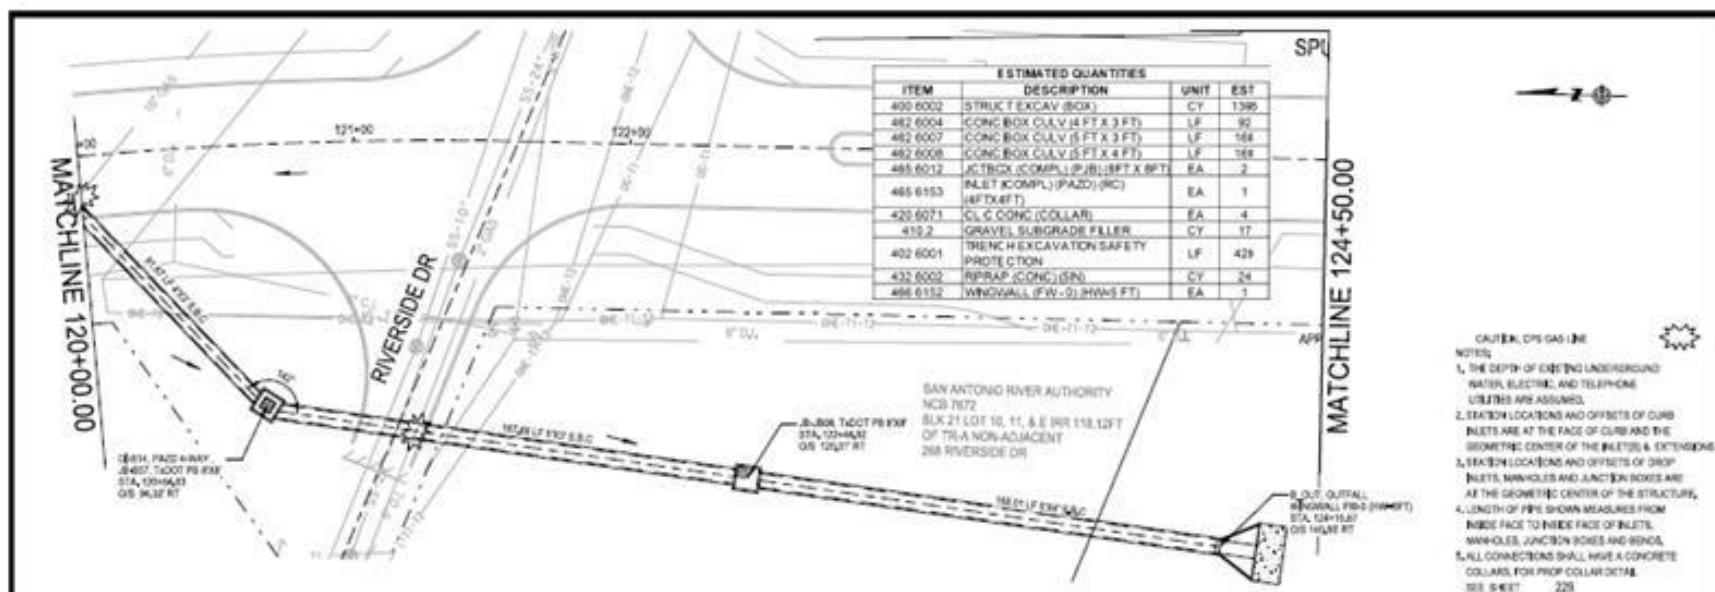
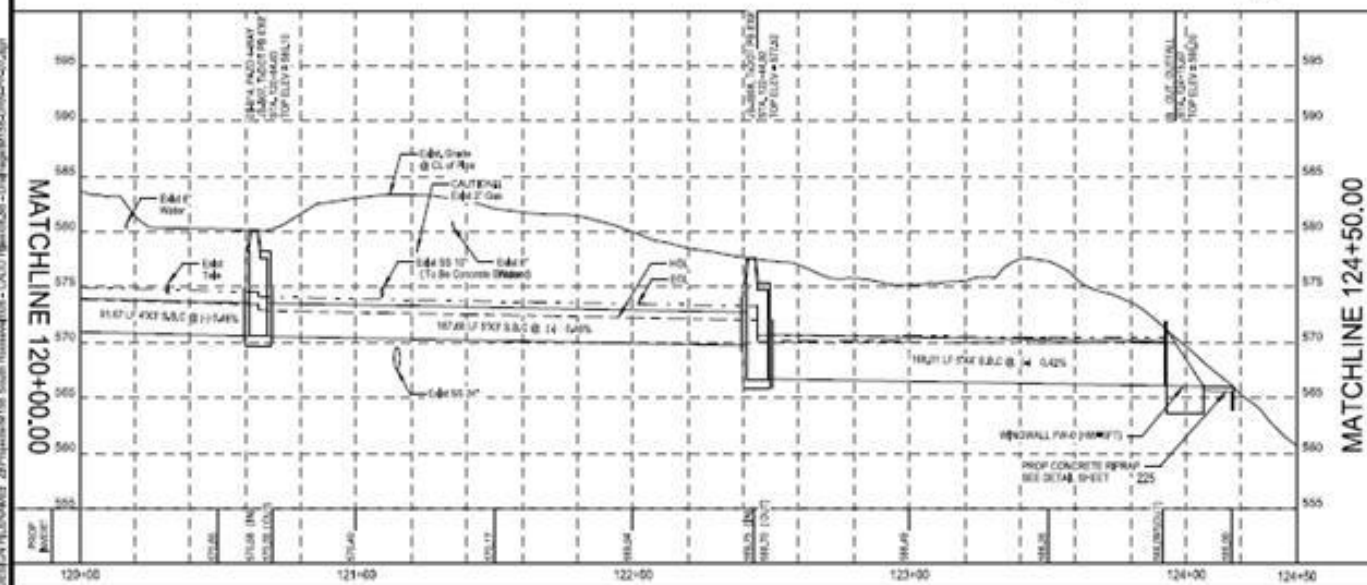
PLAN AND PROFILE

STORM SYSTEM "B"

STA. 120+00.00 TO STA. 124+50.00

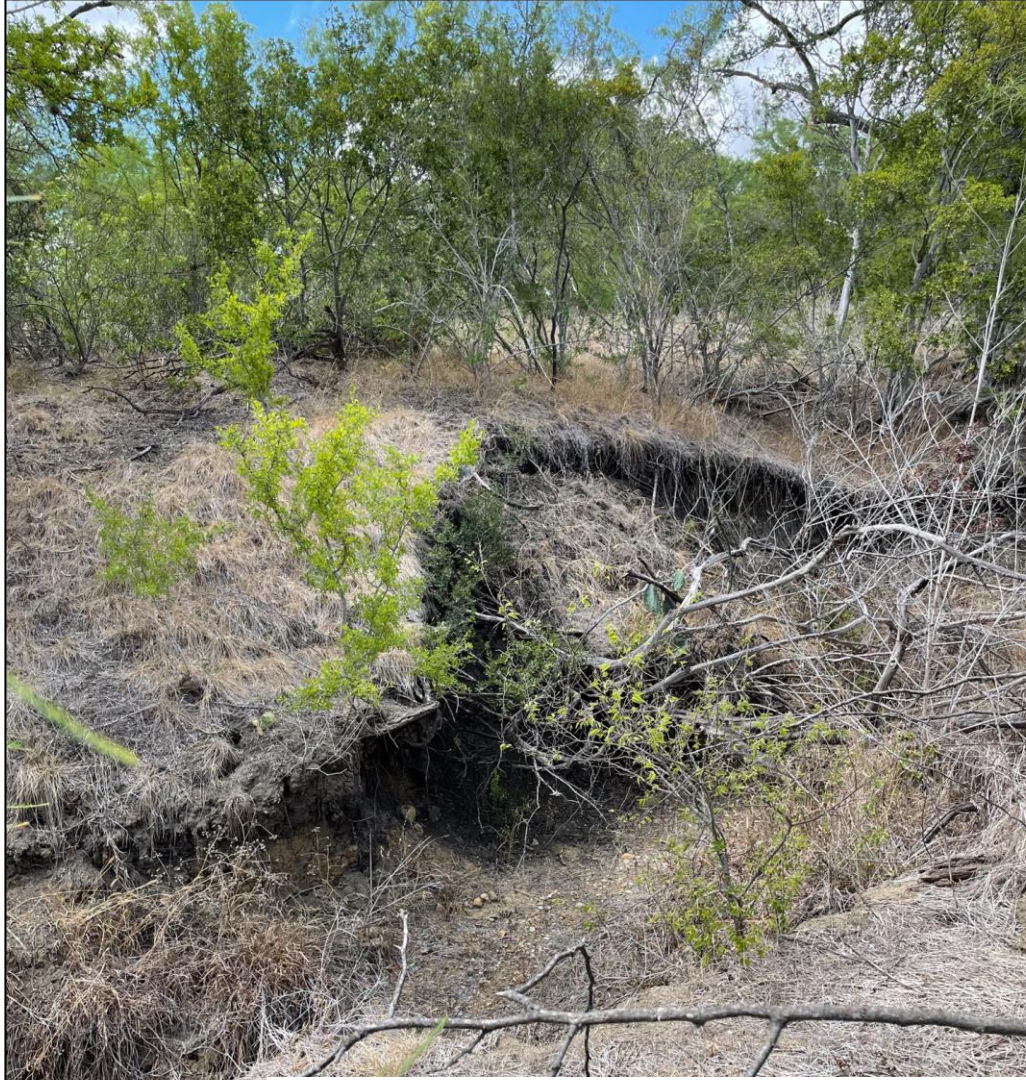
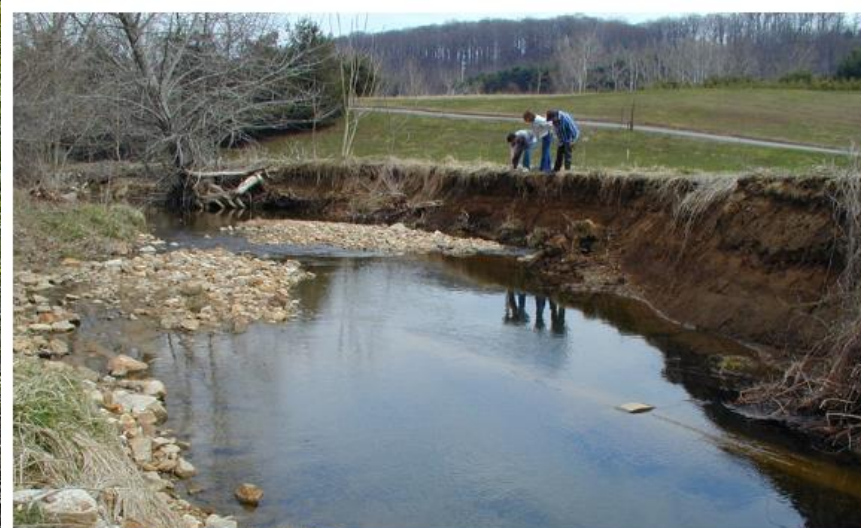
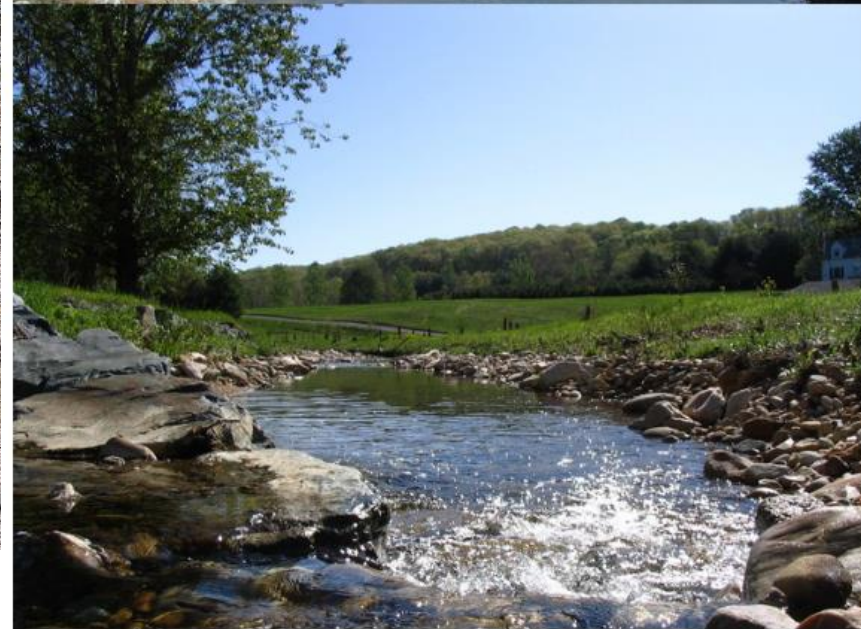
Minebank Run in Baltimore, Maryland. Before (top) and after (bottom) stream restoration .
