San Antonio River 2023 Basin Summary Report

PREPARED BY THE SAN ANTONIO RIVER AUTHORITY

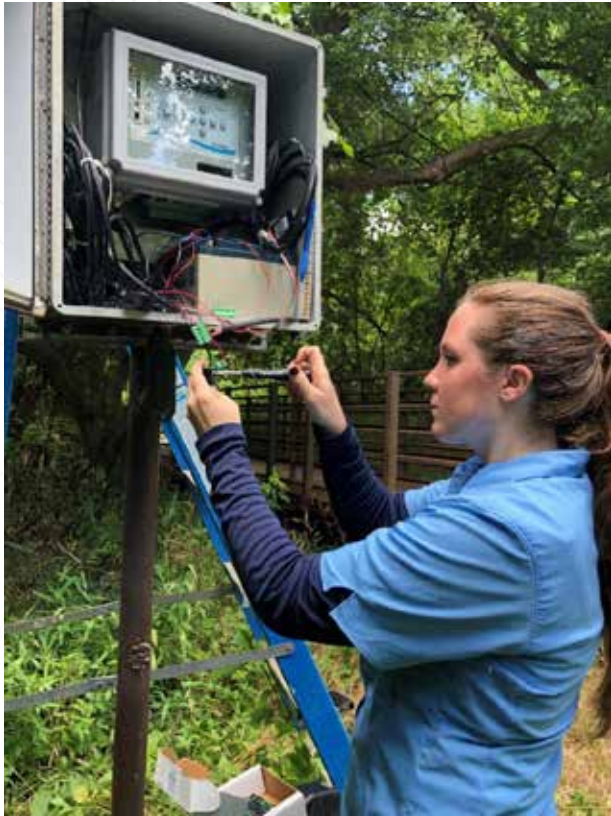
Staff performing maintenance on a continuous monitoring site, San Antonio River at San Juan Remnant.

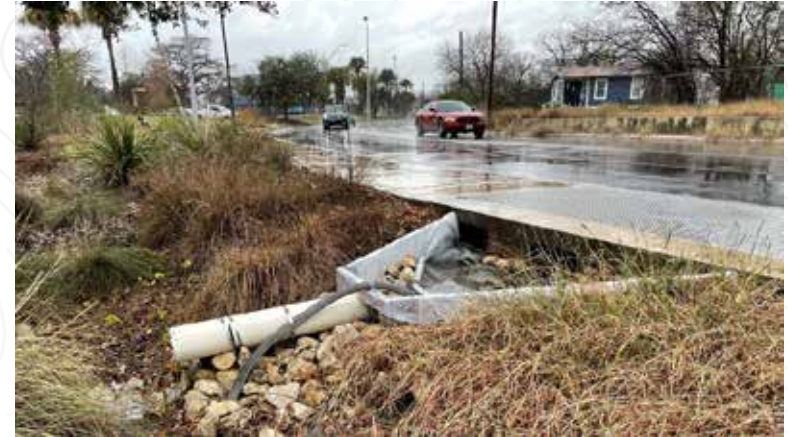
Structure designed to capture stormwater runoff from the street before it enters into the bioretention structure at Elmendorf Lake. Samples were collected prior to entering the BMP and after the BMP.

Staff have been conducting low impact development (LID) stormwater sampling at various locations, aiming to collect at least five viable storm events from each station. Stormwater sampling is underway at a San Antonio River Authority office, evaluating a High-Flow Media which was installed in December 2020, and at Elmendorf Lake Park, installed in February 2019. Heightened levels of bacteria in the west side creeks instigated the need for an integrated Implementation Plan (I-Plan) to decrease bacteria levels, which led to the stormwater sampling in Elmendorf Lake Park. Two past LID BMP sampling locations were on Ray Ellison Boulevard on the southwest side of San Antonio and on Hausman Road near University of Texas at San Antonio (UTSA). As of 2019, sampling is complete at both of these stations after five events were successfully collected. Two more sample events are needed from each of the two active BMP stations, Elmendorf Lake Park and High Flow Media.

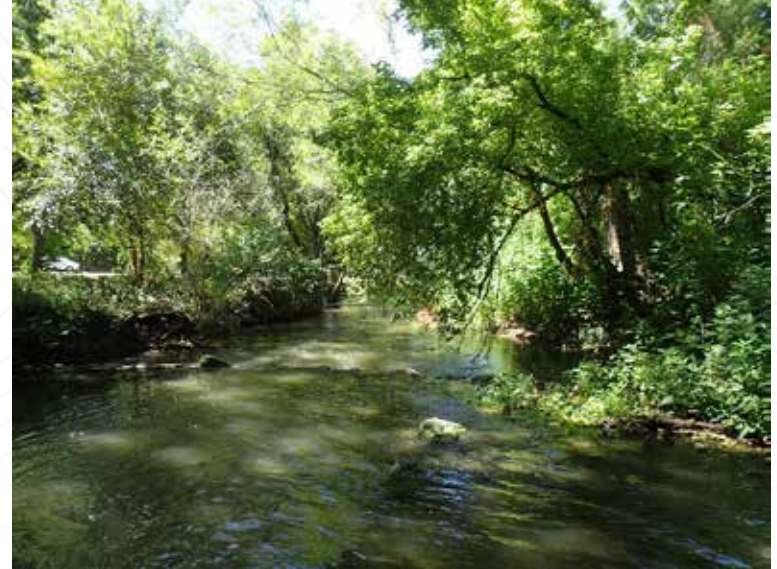
Downstream view of TCEQ station 12909 during a habitat survey on August 18, 2022.

The Upper San Antonio River at these stations is characterized by overall moderate instream cover, pool size, flow and bank stability, channel sinuosity, and riparian buffer vegetation corridors. Higher quality features in this reach include stable bottom substrates and common riffle habitats. The average width of the riparian buffer across the five sites is about twelve meters wide and is dominated mainly by trees and grasses. Higher scores in these metrics indicates better instream and riparian habitat for aquatic organisms to inhabit, increasing species diversity and ecological integrity. The percent tree canopy coverage across the two sites is about 63%, providing ample shading to the river. Developed canopy and understory are present, however, an established mid-story is lacking. A more developed mid-story would allow for higher species abundance and diversity, leading to higher ecological function in the riparian zone.

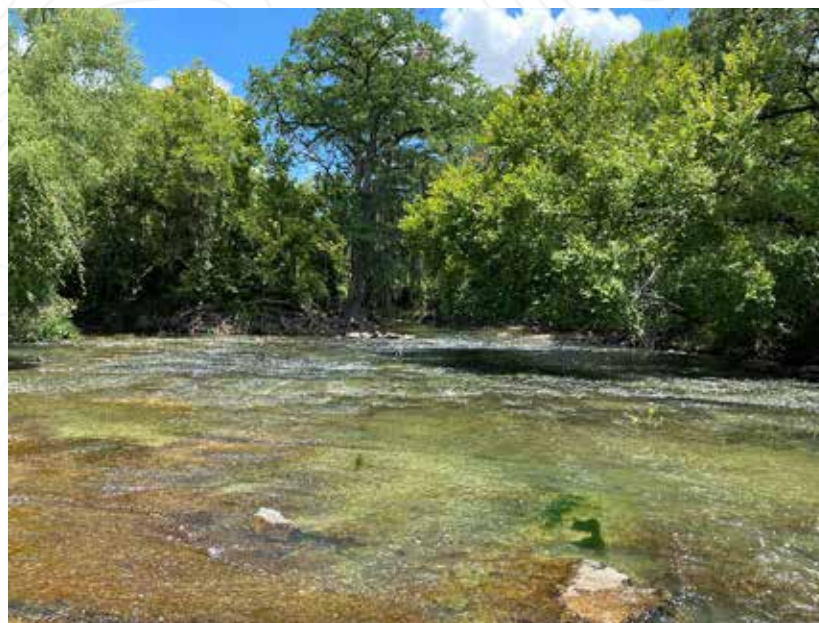
Downstream view of TCEQ station 16580 during a habitat survey on July 7, 2023.

The Lower San Antonio River at these stations is characterized as moderate quality due to rare instream cover, moderately unstable bottom substrate, moderate number of riffle habitats, a lack of pooled habitats, moderately stable flows and banks, moderate channel sinuosity, and wide riparian buffer vegetation corridors. The average width of the riparian buffer across the two sites is about sixteen meters wide and is dominated mainly by trees and grasses. The percent tree canopy coverage across the two sites is about 63%, providing ample shading to the river. Developed canopy and understory are present, however, and established mid-story is lacking. A more developed mid-story would allow for higher species abundance and diversity, leading to higher ecological function in the riparian zone. Segment 1901_02, assessed at station 12792, is considered to have impaired habitat in water. Station 16580 trends higher in habitat quality relative to station 12792 due mainly to higher quality of instream cover, bottom substrate stability, and number of riffles present. Higher scores in these habitat metrics would indicate better instream and riparian habitat for aquatic organisms to inhabit, increasing species diversity and ecological integrity.

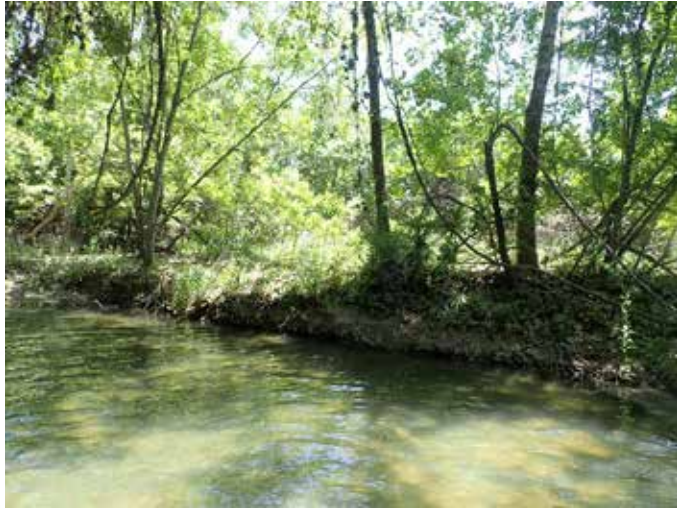
Left bank of station 20821 Upper Cibolo Creek at the downstream end of City of Boerne Northrup Park during a habitat assessment on May 4, 2020.

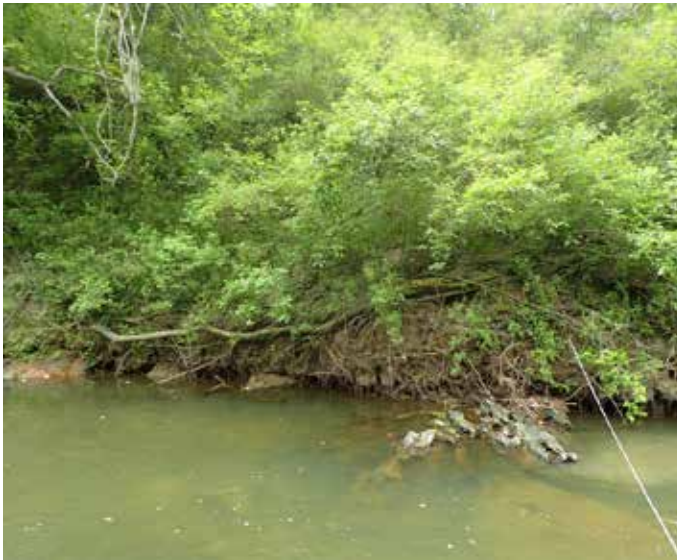
Lower Cibolo Creek approximately 2.25 km upstream of FM 537 southwest of Stockdale during a habitat survey on May 28, 2019.

Assessment of habitat in the Lower Cibolo Creek Watershed from 2019-2022 included TCEQ stations 12802 Cibolo Creek at FM 541 West of Kosciusko, 14197 Cibolo Creek at Sculls Crossing, and 21755 Cibolo Creek approximately 2.25 km upstream of FM 537 southwest of Stockdale. According to San Antonio River Authority (River Authority) data, current habitat in the Lower Cibolo Creek Watershed is described

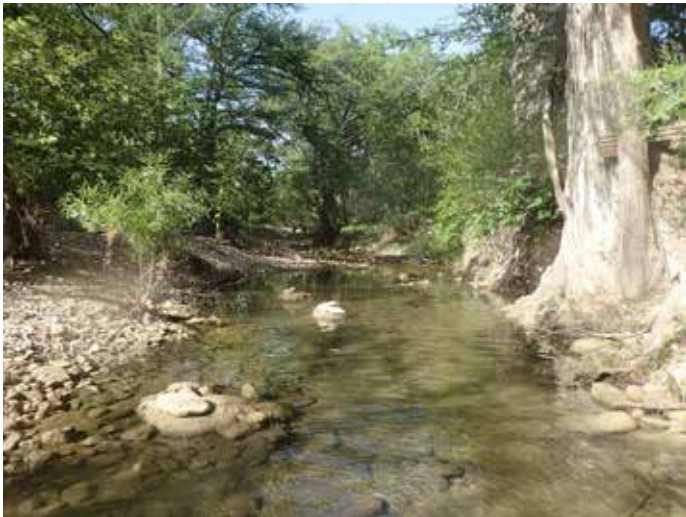
Upstream view of TCEQ station 21631 Medina River at the north side of Mayan Ranch, west of City of Bandera and 2.16 kilometers upstream of the Schmidtke Road crossing during a habitat assessment on June 13, 2022.

Assessment of habitat in the Medina River above Medina Lake Watershed from 2019-2022 was completed at TCEQ station 21631 (Medina River at the north side of Mayan Ranch, west of City of Bandera and 2.16 kilometers upstream of the Schmidtke Road crossing). According to San Antonio River Authority (River Authority) data, current habitat in the Medina River above Medina Lake Watershed is described as intermediate quality according to the HQI.

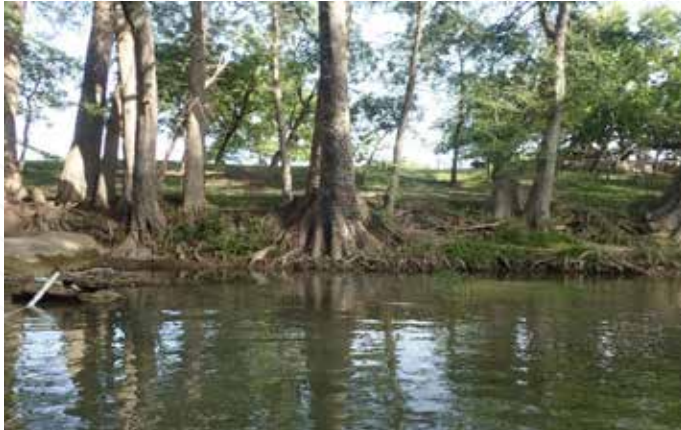
The left bank TCEQ station 21631 Medina River at the north side of Mayan Ranch, west of City of Bandera and 2.16 kilometers upstream of the Schmidtke Road crossing during a habitat assessment on June 13, 2022.

The Medina River at station 21631 is characterized by overall moderate quality features, including instream cover, bottom substrate stability, number of riffle habitats, small pools, flow and bank stability, channel sinuosity, and riparian buffer vegetation corridors. Higher scores in these metrics indicate better instream and riparian habitat for aquatic organisms to inhabit, increasing species diversity and ecological integrity. The average width of the riparian buffer across the site is about ten meters wide and is dominated mainly by trees and grasses. The percent tree canopy coverage across the site is about 87%, providing ample shading to the river. Developed canopy and understory are present, however, and established midstory is lacking. A more

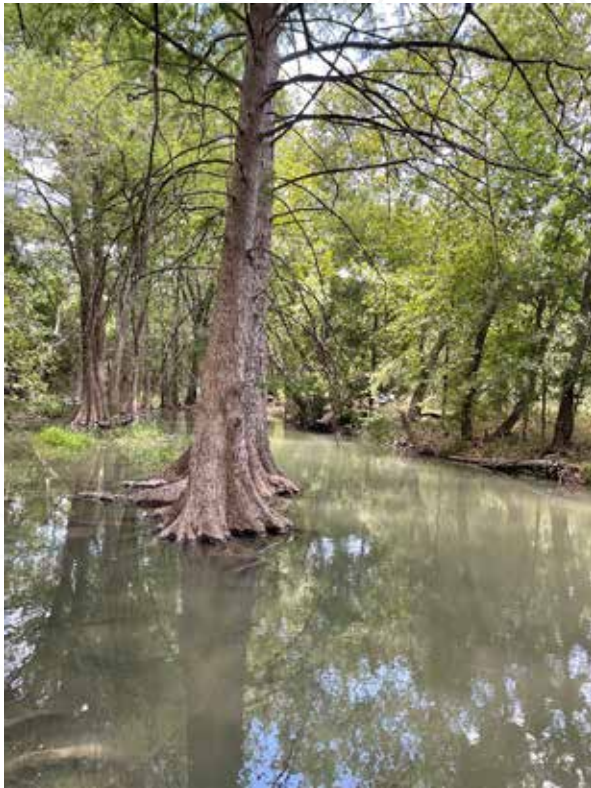
Downstream view of TCEQ station 14200 Medina River at CR 484 during a habitat assessment on July 7, 2022.

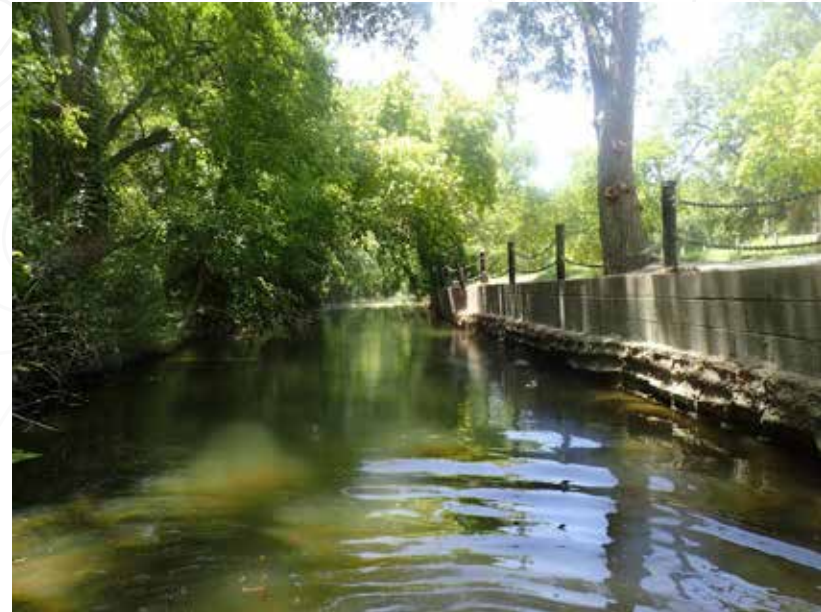
Downstream view of Salado Creek at station 12870 during the habitat assessment done on August 11, 2022. The right side of the creek is shown with concrete separating the creek from the adjacent campground.

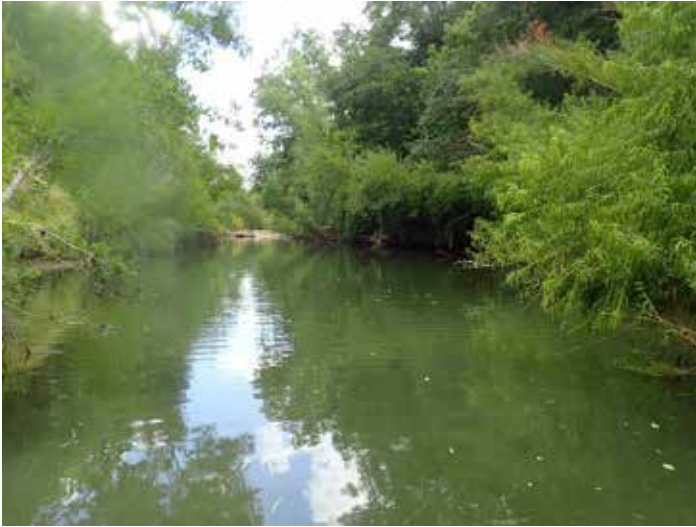
TCEQ station 14198 during a habitat assessment on August 9, 2022.

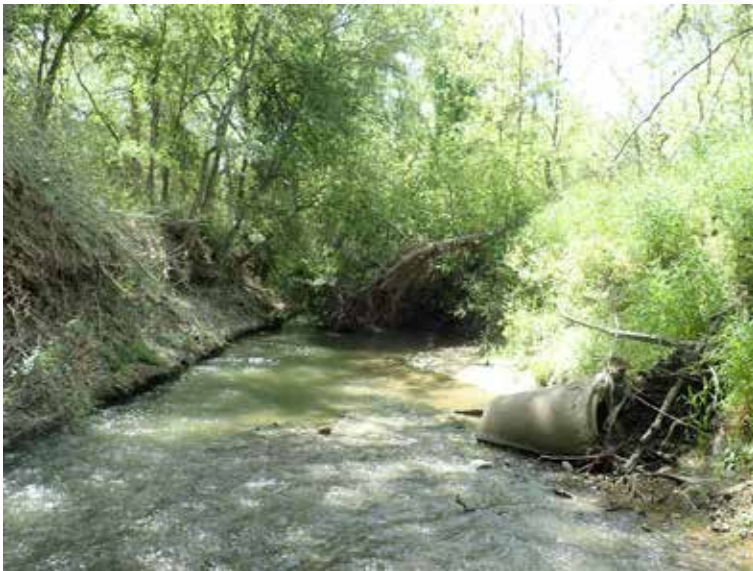
Downstream view of TCEQ station 12916 Medio Creek at Hidden Valley Campground during a habitat assessment on April 7, 2022.

Habitat assessments are done during biological sampling events to holistically evaluate the health of a water body. Habitat quality can tell us how aquatic communities can be supported. The Habitat Quality Index (HQI) is a quantitative measurement used to assess aquatic habitat quality, as described in the Surface Water Quality Monitoring (SWQM) Procedures Manual. This is done by quantitatively and qualitatively assessing various features of the stream reach, including available instream cover, number of riffles, and the structure of riparian vegetation, among other things. These features have an intrinsic value for characteristics like bank stability, buffering capacity, and refugia for aquatic organisms. Based on the metrics measured, habitat quality is scored and then categorized as either limited, intermediate, high, or exceptional.
