MASTER PLAN :: TRUEHEART RANCH NATURE PARK

August 9, 2022

Terra Design Group, Inc.
2015 N.E. Loop 410
San Antonio, Texas 78217
210.220.1400

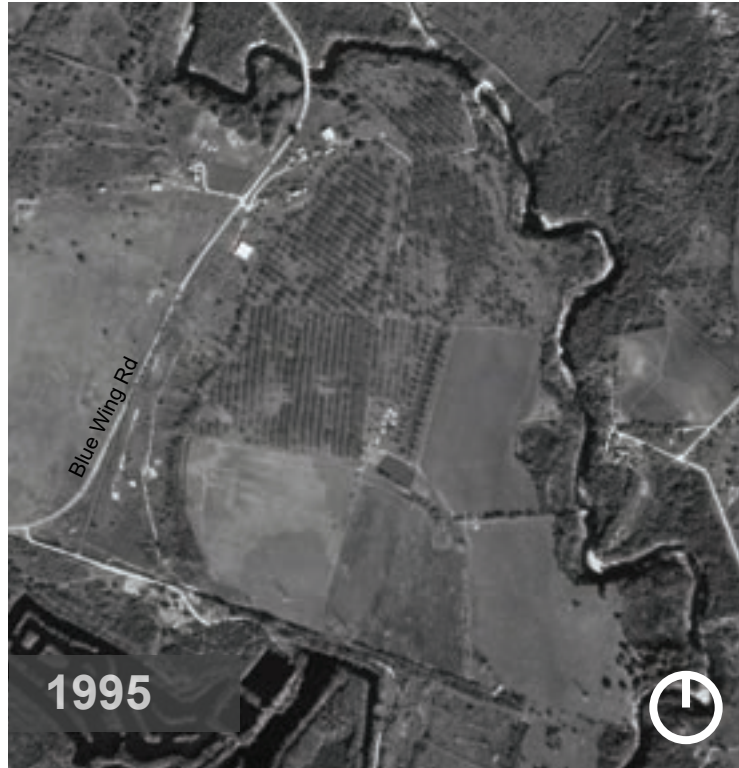
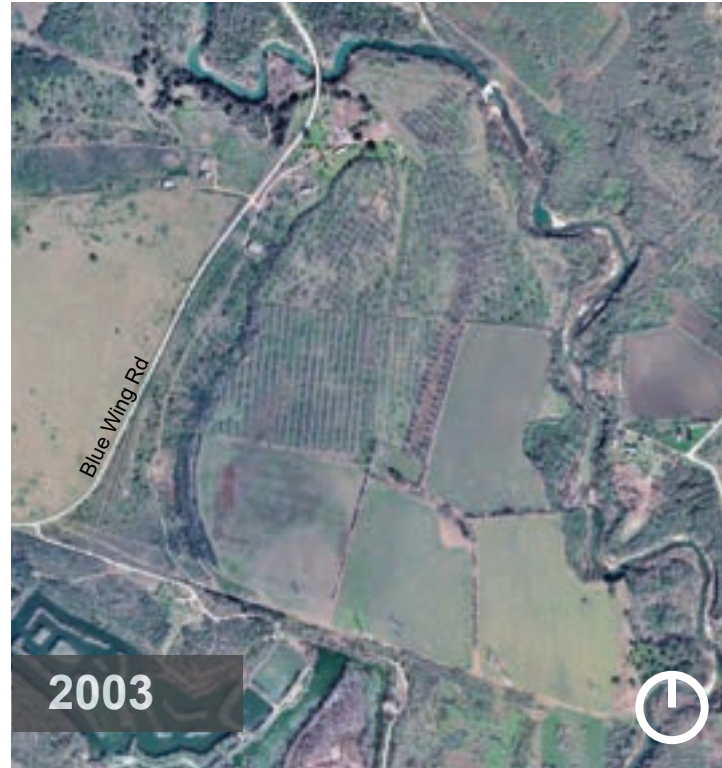
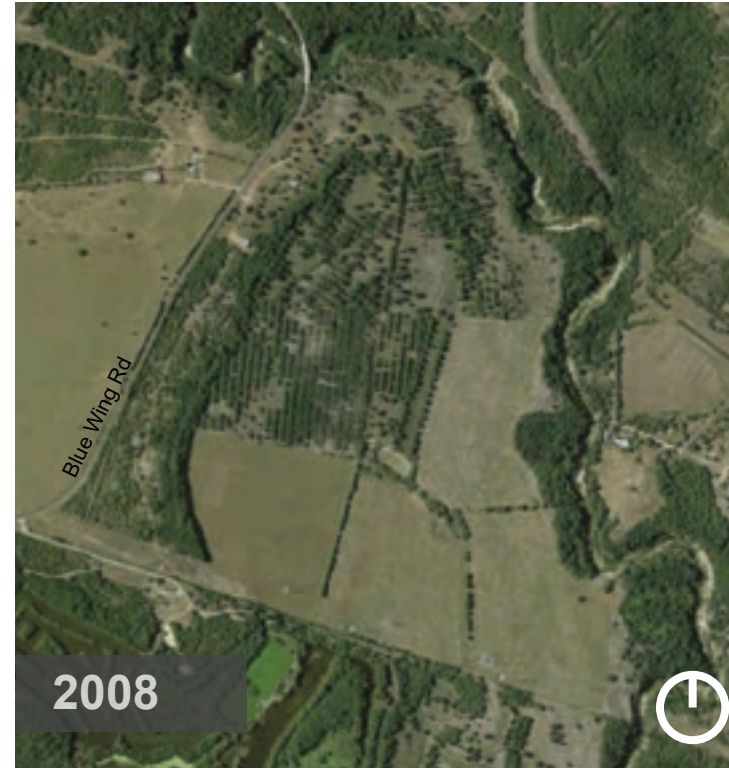
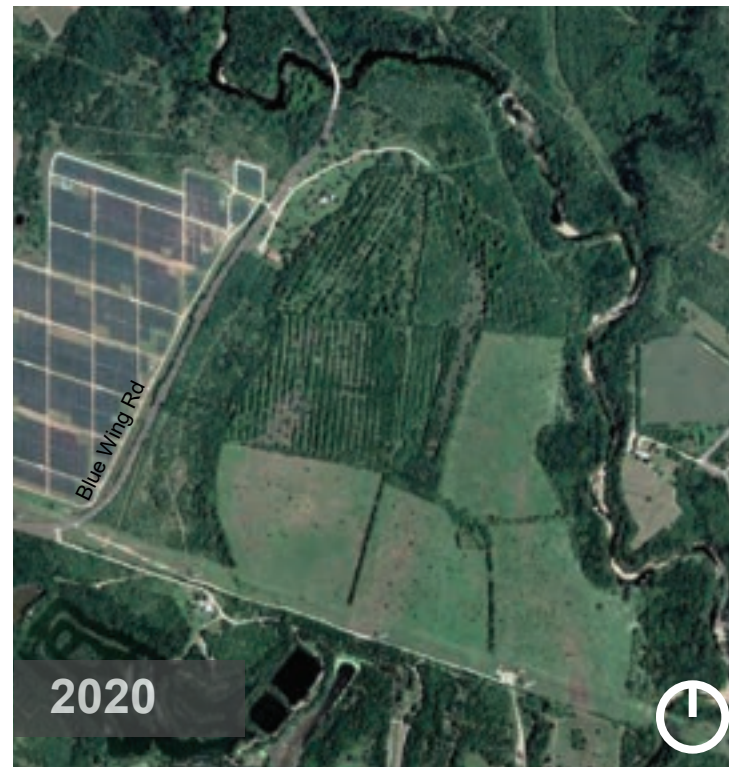
The Trueheart Ranch Property has seen rapid transformation of agricultural over the past 27 years. The elapsed aerial views illustrates the dynamic and changing nature of the ranch.

1995 - The ranch was divided into three major uses: hay production, cattle production, and pecan orchards. Acequias were still being utilized to move irrigation water throughout the ranch and modern pumping systems to deliver the water to the crops. The original 10,000 square foot main barn, residence, and outbuildings are all still in place.

2003 - Hay production expands with center pivot irrigation, cattle grazing is reduced to one pasture, and pecan orchards began to decline due to age of trees. Acequias are still being utilized to move irrigation water throughout the site. The 10,000 square foot main barn is replaced by a 6,000 square foot structure. Preservation work begins on the main residence and adjacent outbuildings.

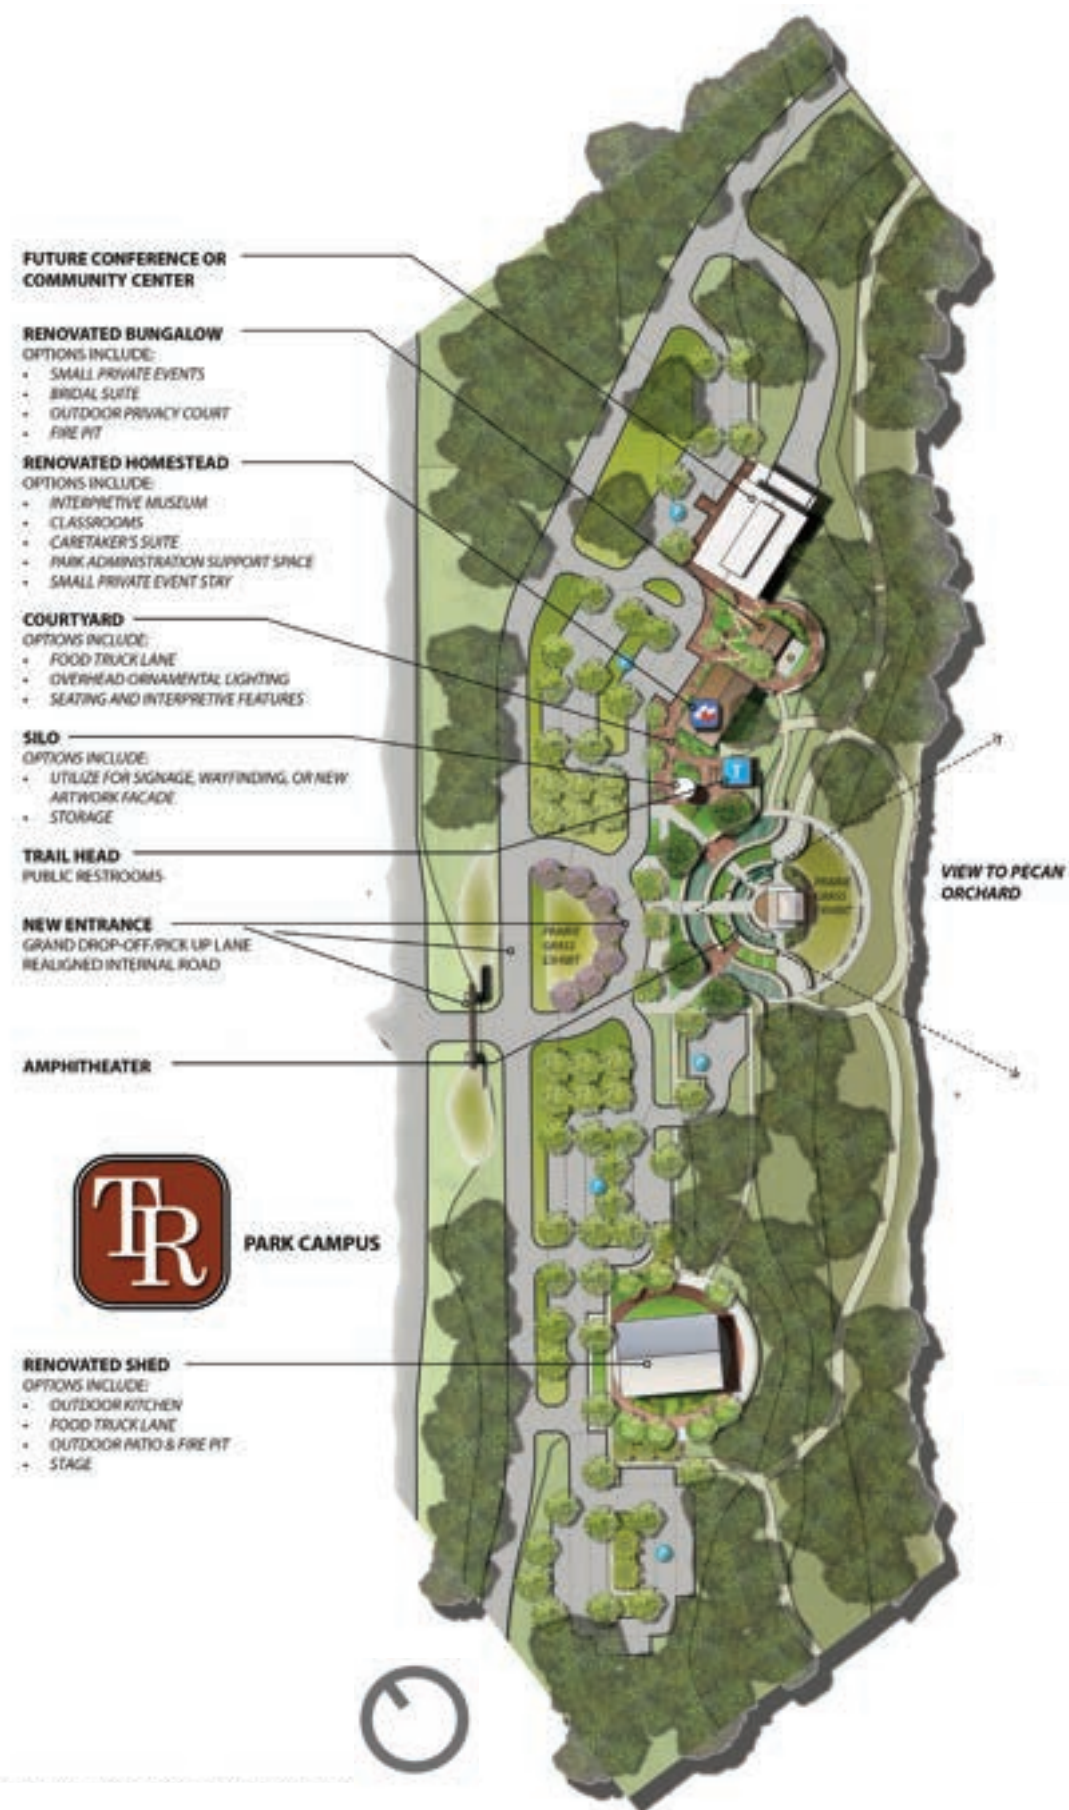
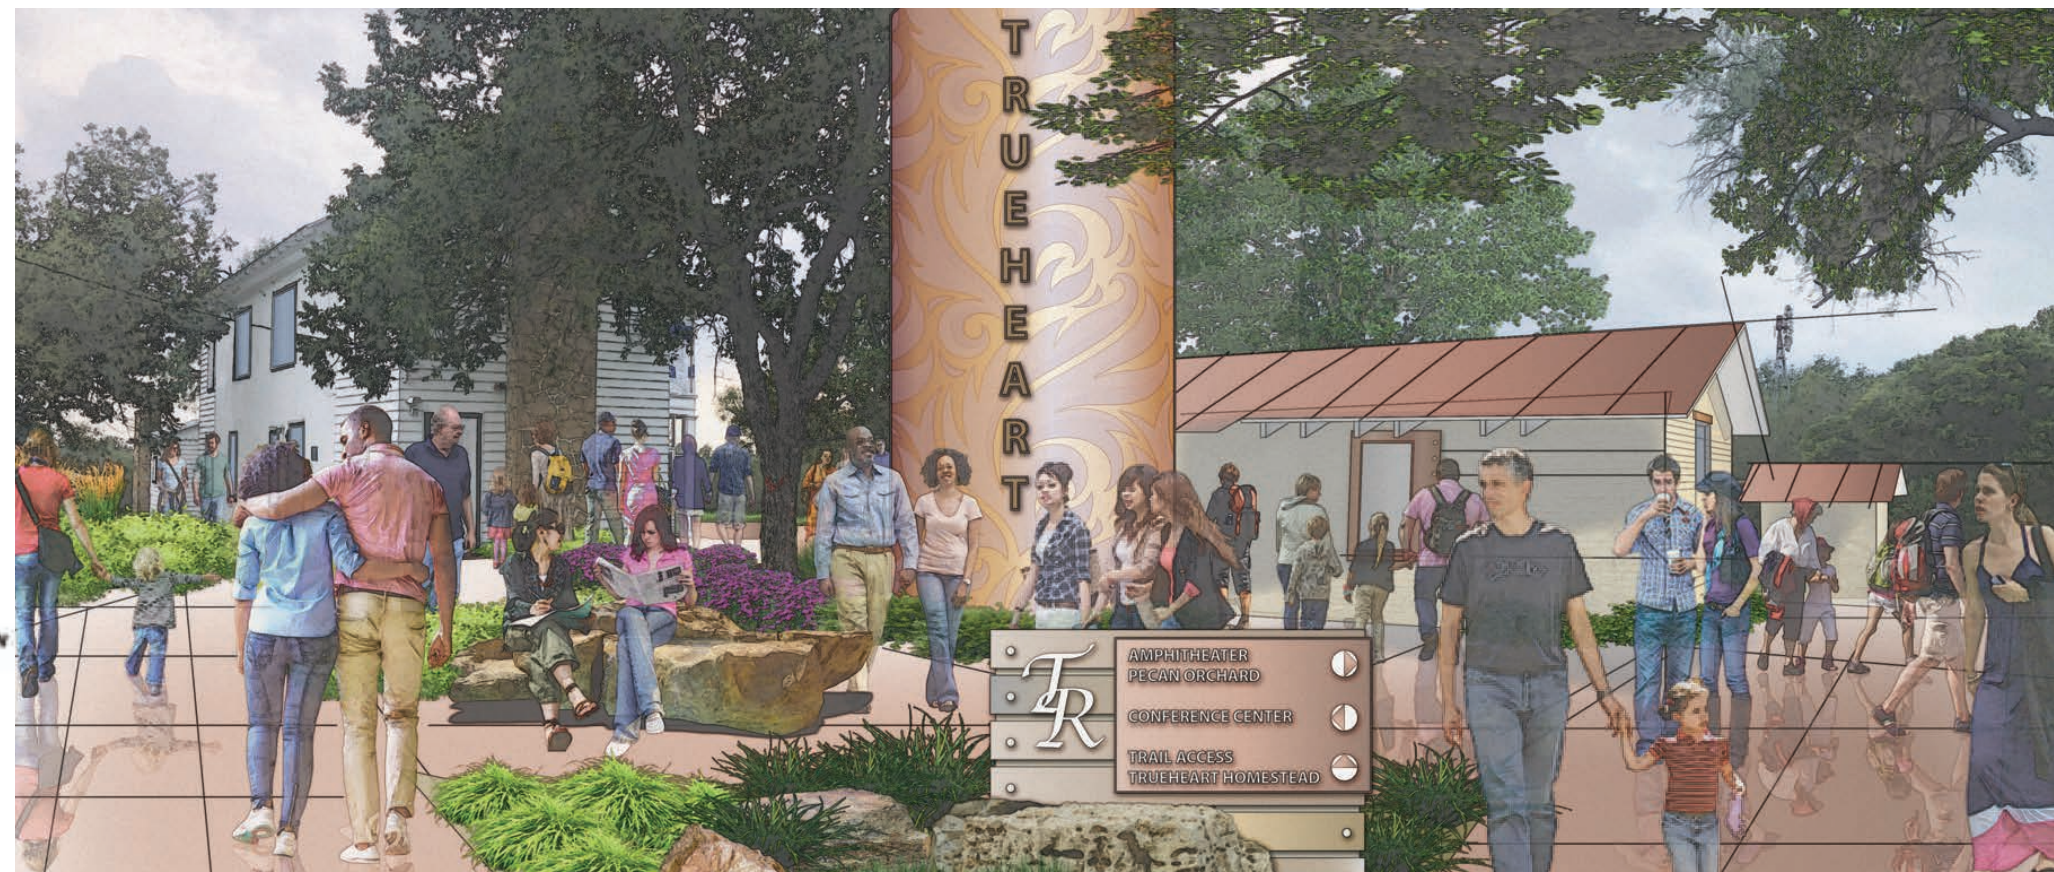
PARK CAMPUS

The park campus is the result of the site controlling facilities location via high 100-year flood plain elevations and the location of historic structures that could be utilized within the Park Campus development. The Park Campus has enough area out of the flood plain to develop new facilities such as repurposing the existing hay barn into a beautiful event pavilion with a full outdoor kitchen and seating patio. The restoration of the historic residence can be transformed into an information center and museum.

Other possibilities in the plan include an amphitheater with seating for 500 people and an indoor events center to be utilize for community gatherings, cooperate retreats, weddings, anniversaries, and many other local events. Supporting these functions is parking for 350 vehicles designed with porous paving and rain gardens to collect and filter stormwater before it exits the site.

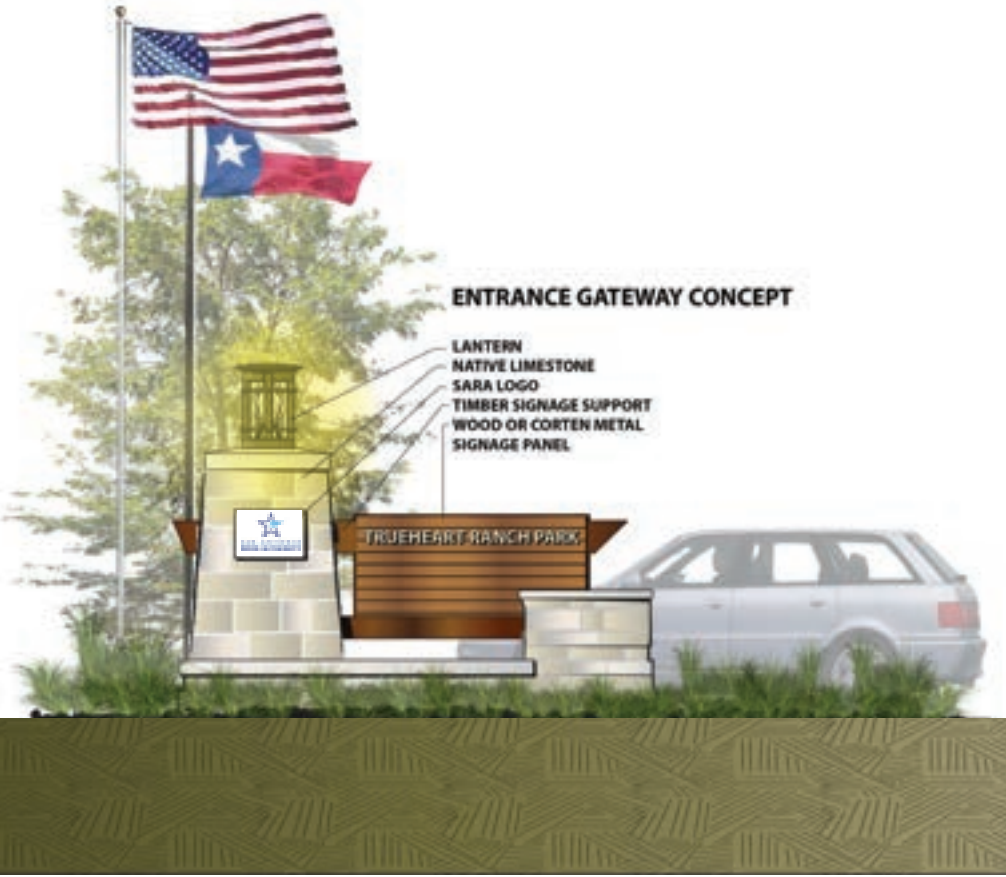
GATEWAYS

The gateway to Trueheart Ranch Nature Park sets the tone for the entire park. The main entrance to the park would be tall enough to accommodate motor homes and travel trailers. The entrance also establishes that this park is a destination with multiple recreational activities for people of all abilities.

Materials would include local limestone, sealed Corten steel fittings and fixtures, and Ipe wood. This combination of materials was selected for their extreme durability, long life, and very low maintenance. These materials require no painting and age in a manner that increases their beauty every year. The master plan illustrates how these materials can be used for all structures within the nature park.

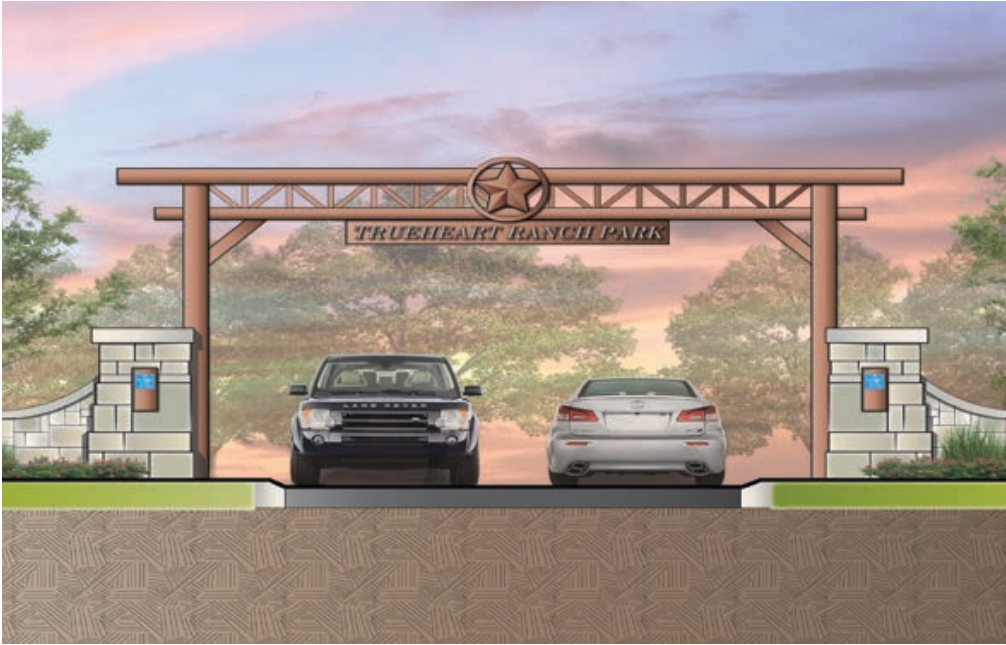
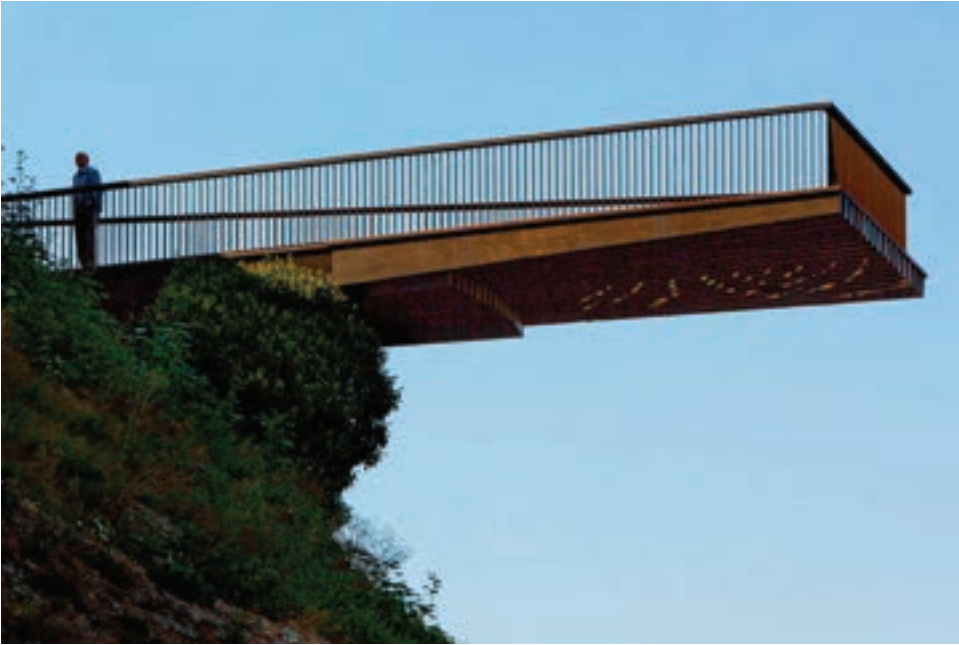
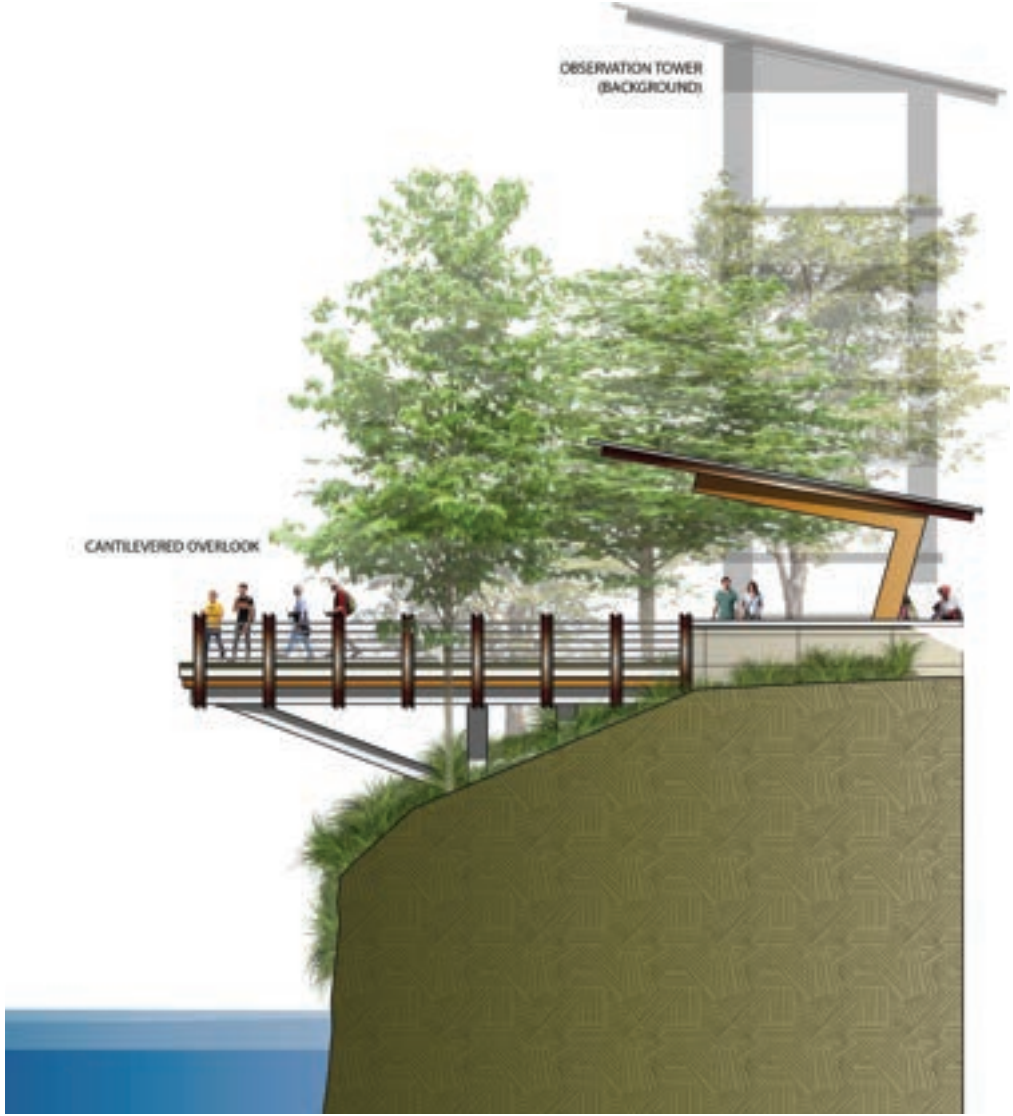
OVERLOOKS AND VIEWING TOWERS

It is human nature to enjoy the view of your surroundings from a higher point. Overlooks are a special kind of rest area tied to a unique natural feature that provides an exciting observation experience. This difficult to reach point of the proposed cantilevered overlook will reward visitor with a 360-degree view to the entire park adding greatly to the nature park experience while suspended over San Antonio River. With no visible means of support, the park visitor will be embraced by nature and feel they are floating over the river. The overlook will also include interpretive signage describing the area's flora and fauna that may be observed from that point.

Viewing towers allow visitors to view their surroundings and take in the beauty of the riparian corridor and river. The tower also adds an impressive landmark, unique to the park, creating a beacon to help guide visitors.

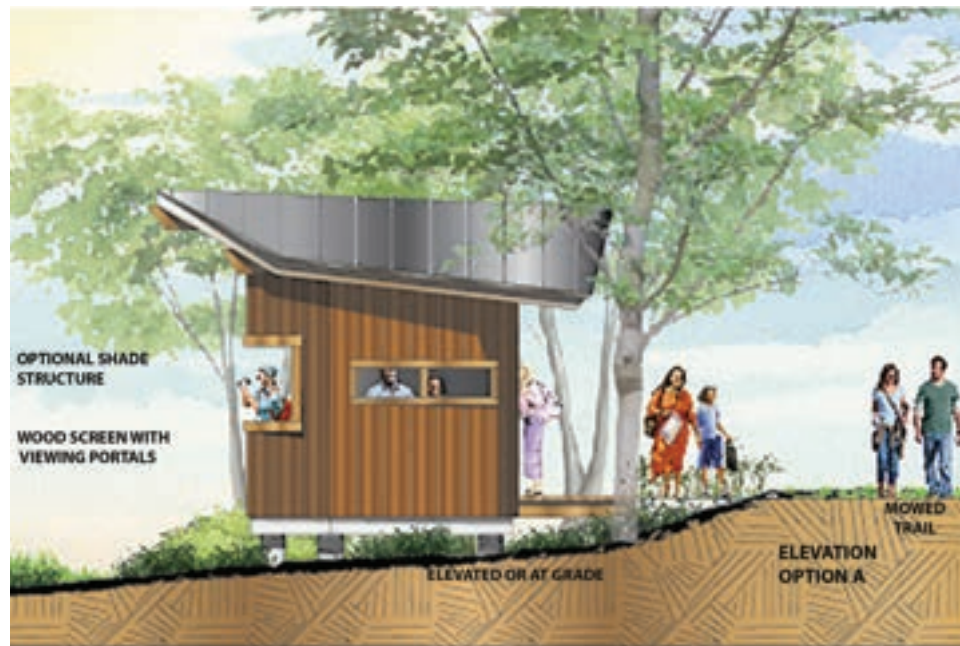
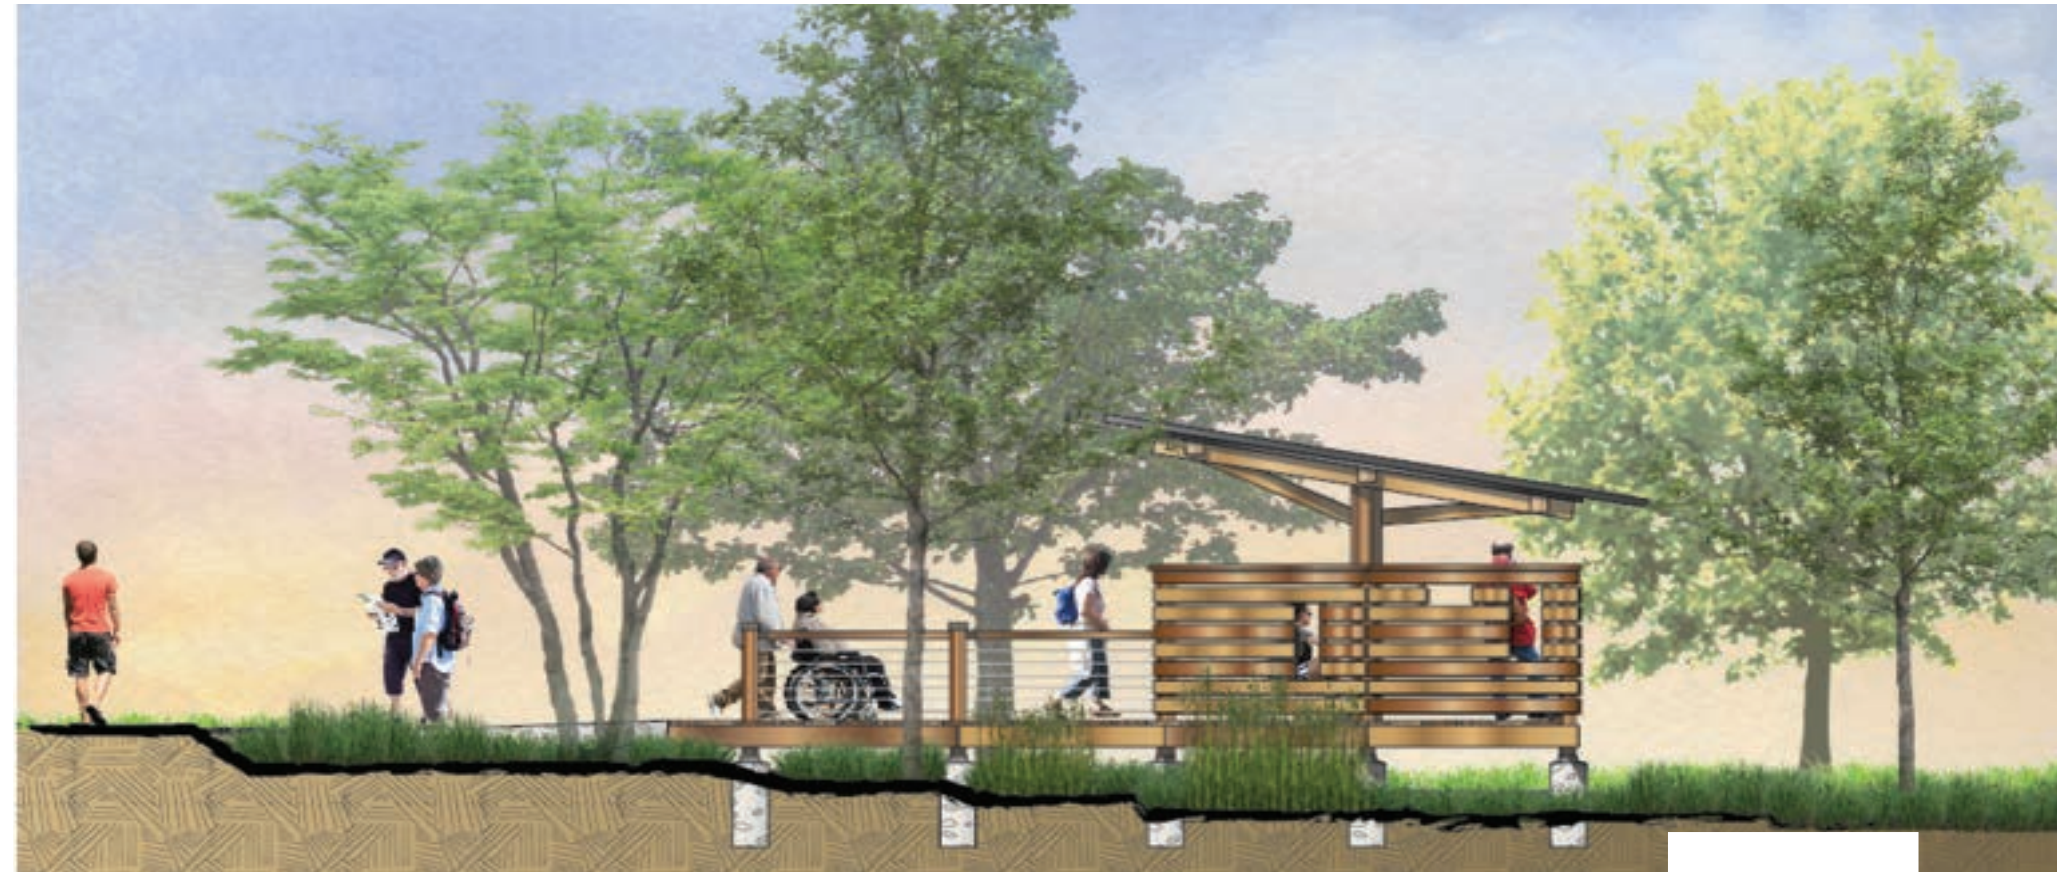
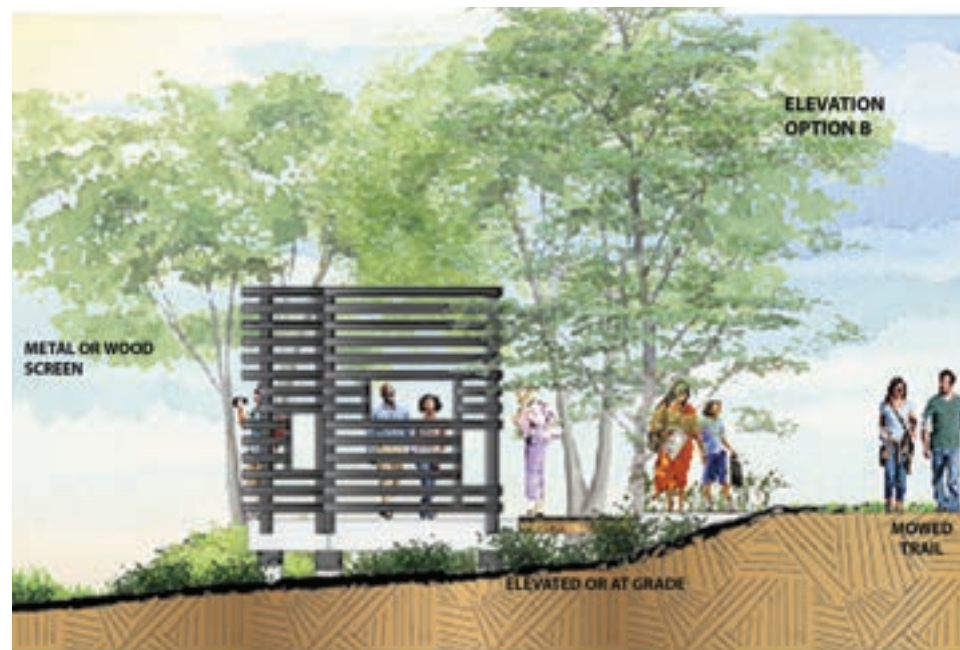
WILDLIFE VIEWING BLINDS

Numerous wildlife viewing blinds are located along the many trails within the park. Blinds bring birds and other wildlife up close that is accessible to all visitors, giving them an appreciation for the animals and their habitat. The blinds are carefully designed with natural materials to help blend into the site. Each blind includes shaded areas for standing and sitting while still being able to view the surrounding wildlife. The blinds will use solar power to operate rain catchment systems to fill watering stations automatically.

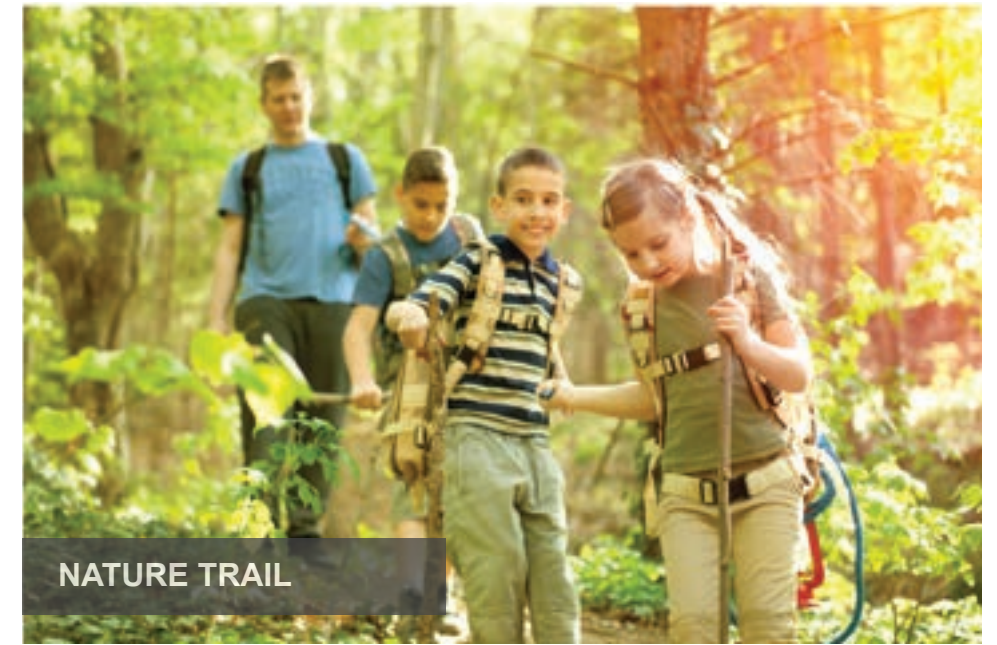
NATURE TRAIL

- Multi-Purpose Trail - Reinforced concrete min. 5" depth, 8'-0" to 10'-0" wide with five-foot-wide native grass shoulders each side.
- Interpretive Trail – Mowed Grass Trails, 8'-0" to 10'-0" wide.
- Acequia Trail - Compacted base min. 6" depth, 8'-0" to 10'-wide with five-foot-wide native grass shoulders each side.
- Equestrian Trail - Mowed Grass Trails, 8'-0" to 10'-0" wide.

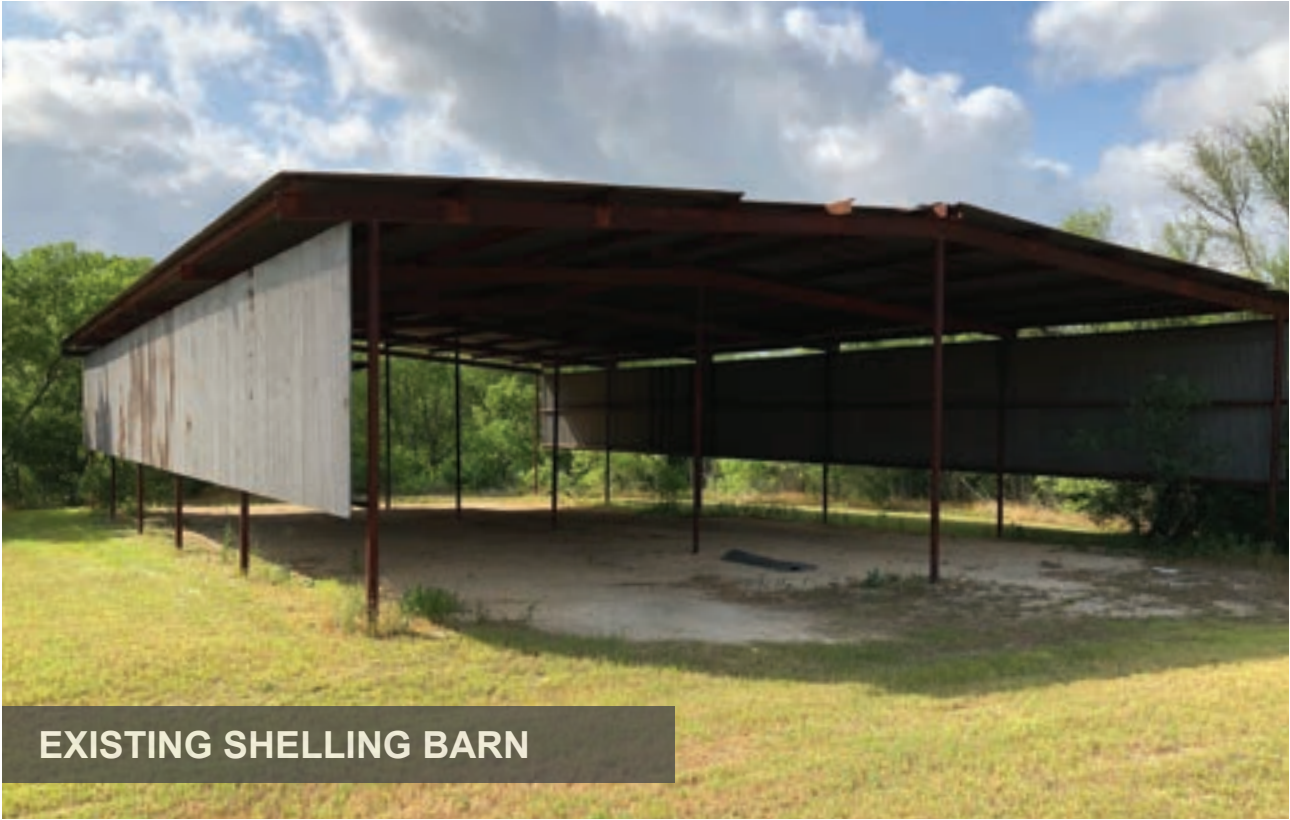
EXISTING SHELLING BARN

Re-designed and re-purposed as a meeting and entertainment venue, the 6,800 square foot classic Texas pole barn would harness the local climate and maximize cross ventilation, daylight, and capture solar energy with a photovoltaic roof system. Minimalistic materials are recommended that can withstand the particularly hot dry climate, of south Texas, achieve long-term durability, and to minimize the need for maintenance. The existing primary columns and roof structure will be reinforced, repaired, and left to weather naturally. An outdoor kitchen designed to accommodate catering needs will be included at the south end of the building complete with buffet style serving bars. The patios surrounding the shelling barn will be well lighted and landscaped with a variety of native plants and shade trees that utilize water captured and stored underground cisterns.

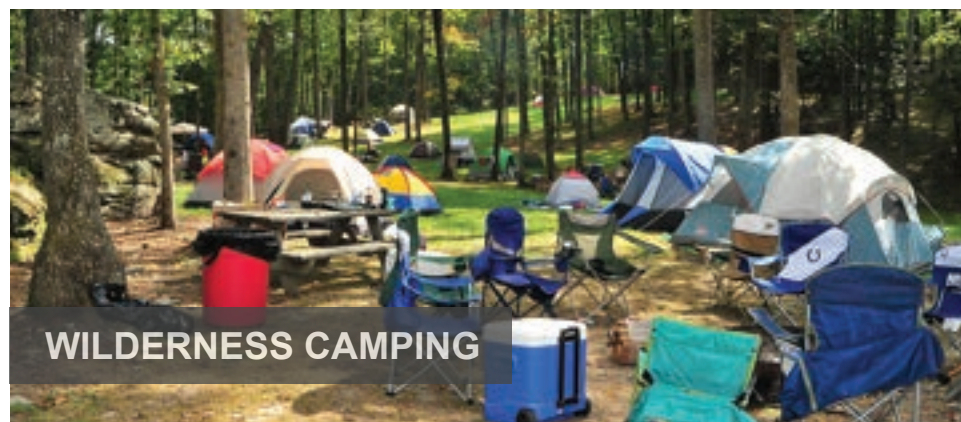
WILDERNESS CAMPING

The most basic and popular type of camping is of course wilderness tent camping. Campsite layouts should fit the site, be located in a shaded area, and provide positive drainage away from each tent site. Facilities at each camp site should include litter/recycle containers, potable water, a concrete pad for vehicle parking and tent, fire ring, and picnic table. For every 15 camp sites a pavilion should be provided for group events and as an emergency refuge.

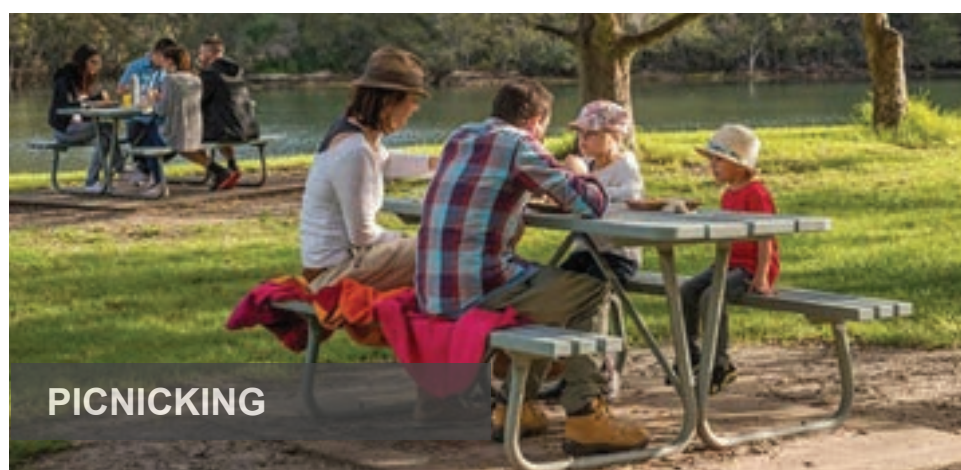
PICNICKING

Picnic tables in groups of 5 to 10 with potable water and restrooms within a 10 minute walking distance. Picnic tables would be located on a concrete pad with a barbecue grill and litter/recycle containers. Tables would be located in shaded areas and near parking. Groupings of picnic tables should be located under a pavilion to provide sun and rain protection and encourage rental opportunities.

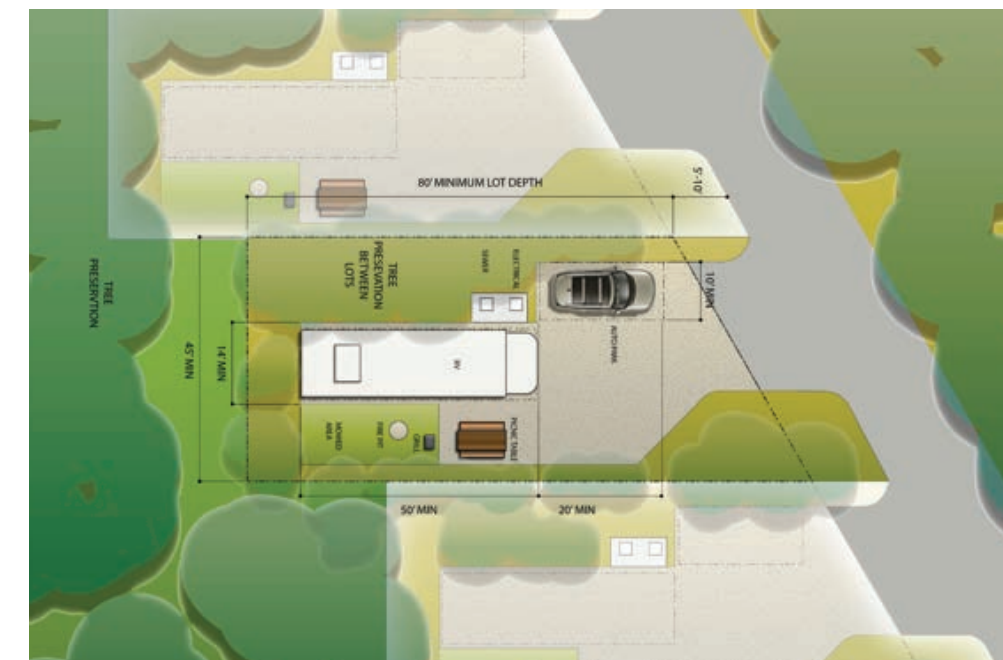
RV CAMPING

Camping is booming in popularity and there is a good reason: RV camping means that you can bring all the comforts of home with you to the campground. Everything a park visitor could need can be always onboard with you. The campsites for modern RVs should accommodate a 75 vehicle and parking for at least one car or truck that might be in tow. Standard amenities should include connections to sewer, water, internet services, barbecue grill, and a centrally located dump station to empty your black and gray water tanks. Optional amenities would include restrooms, showers, and a laundry.

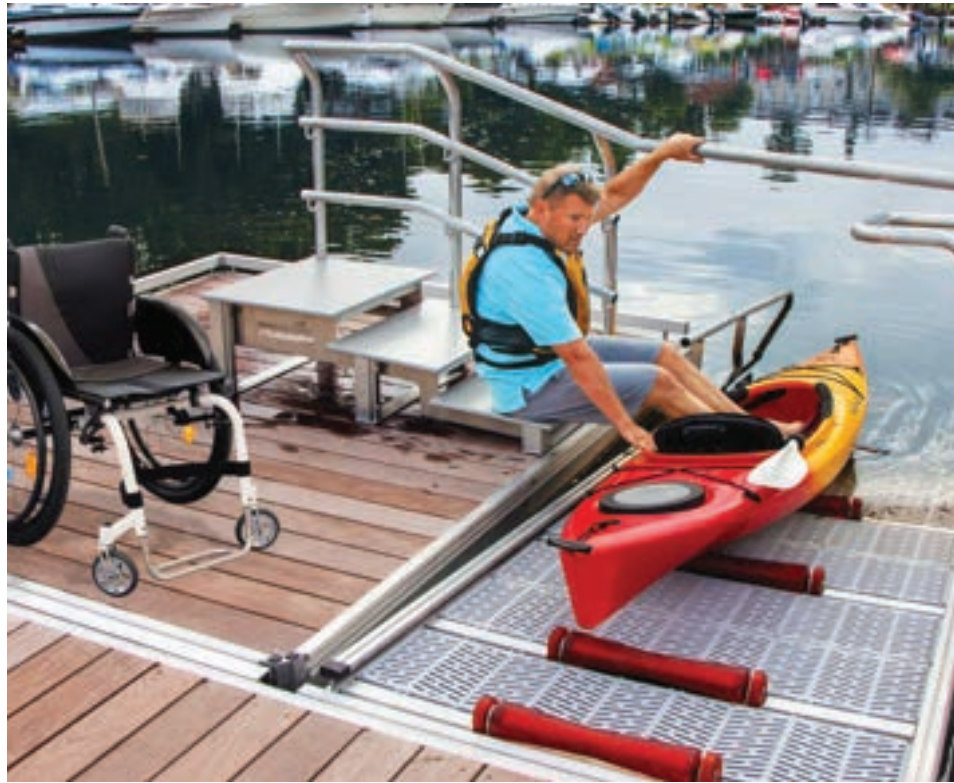
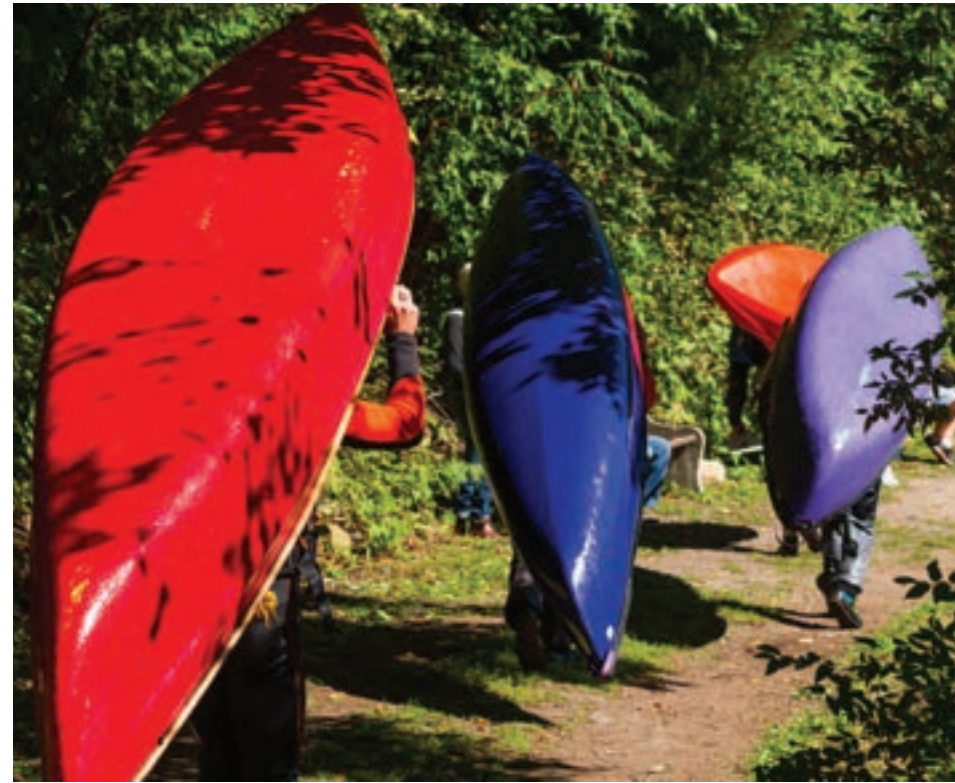
DAM PORTAGE AND BOAT LAUNCH

Launch and retrieval points are located along the San Antonio River at the north and south end of the park. These features follow a design developed during stakeholder meetings with kayak and canoe user groups. The preferred location for the launch and retrieval points is on the bank, inside of a curve, along the river. This configuration also makes launch and retrieval much easier and accessible. The launch and retrieval points will be compliant with Americans with Disabilities Act (ADA), ensuring all visitors can utilize these facilities without assistance.

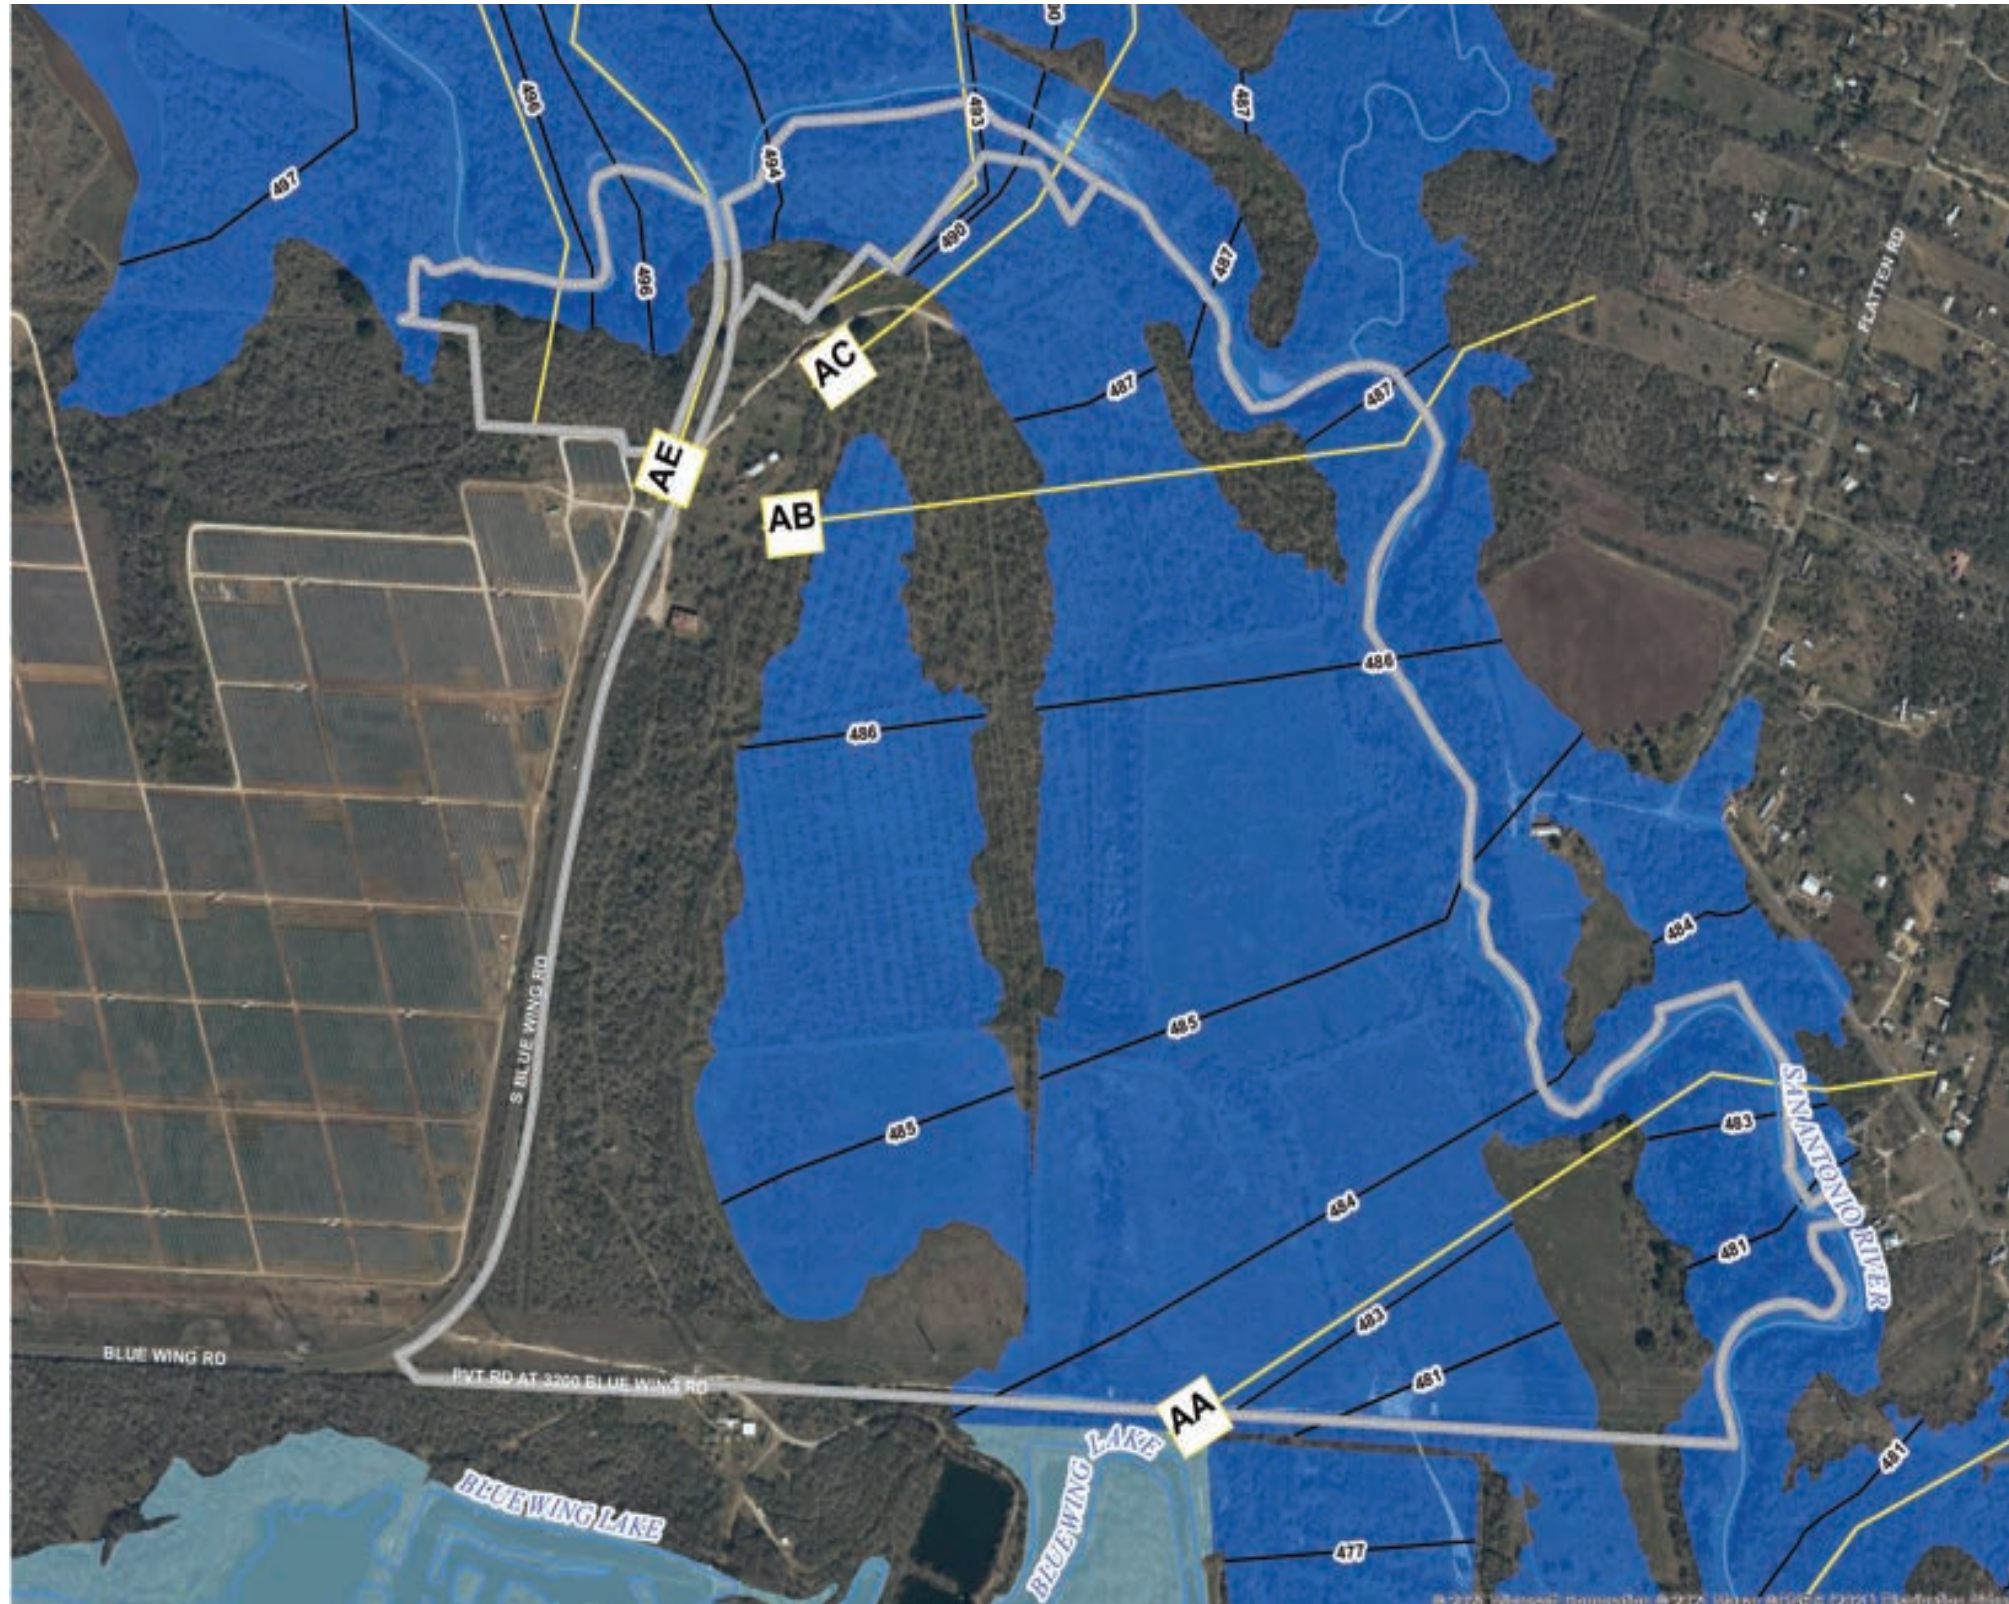
Contour Map

- 5' Contours
- 1' Contours

75% of the site is located within the 100 year flood plain. Locations for buildings and structures need to carefully consider the seasonal storm events and avoid sensitive habitat areas that are aligned with hydrologic patterns on the site.
