MASTER PLAN :: TRUEHEART RANCH NATURE PARK

August 9, 2022

Terra Design Group, Inc.
2015 N.E. Loop 410
San Antonio, Texas 78217
210.220.1400

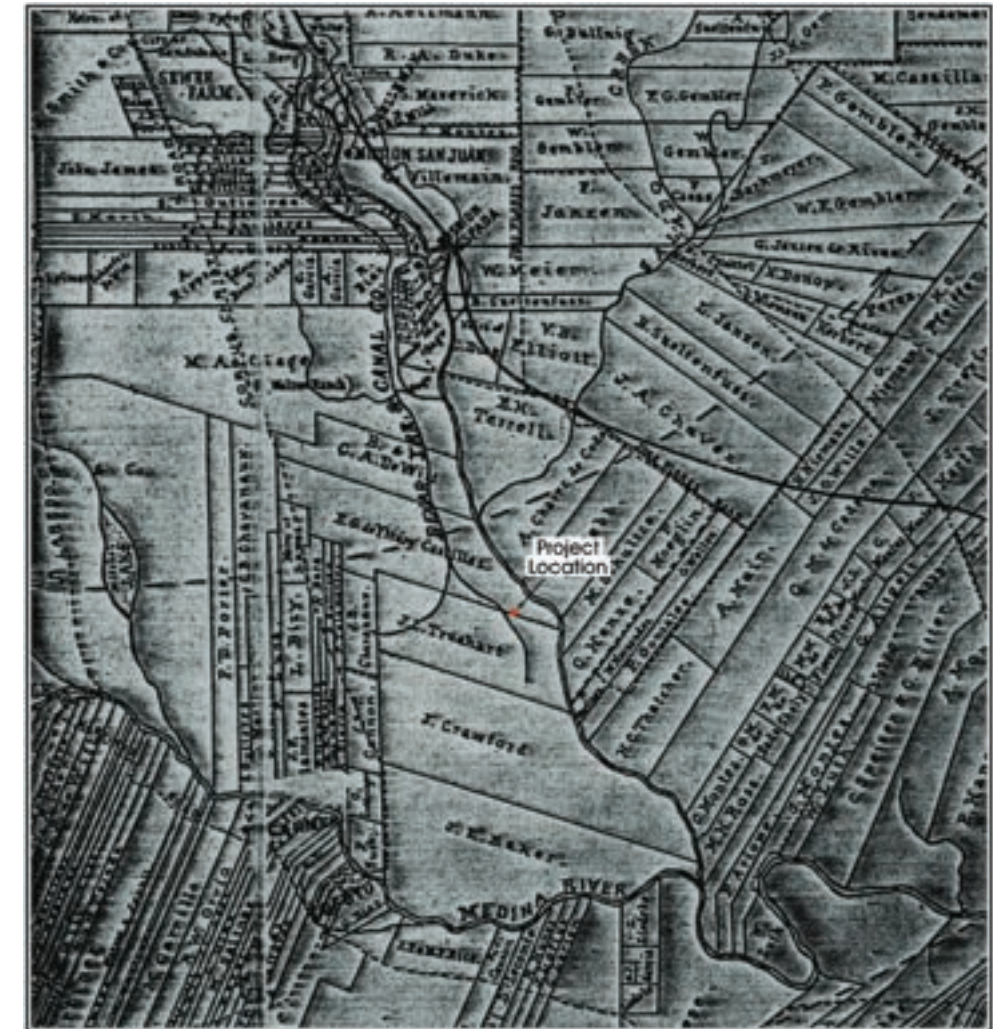
Figure 2. John D. Rullman's 1897 map showing the project location in relationship to the Trueheart property and the San Antonio River.

district clerk. In 1848, he became the county clerk. After marrying Petra de la Garza in 1848, Trueheart worked on the property he obtained in the marriage (Figure 2). He improved the land, constructed an irrigation system to water the croplands, and allowed a number of families to settle on portions of the property on small farm plots. The 1897 Rullman map depicted in Figure 2 shows a drainage labeled as "Bexar Irrigation and Canal Company".

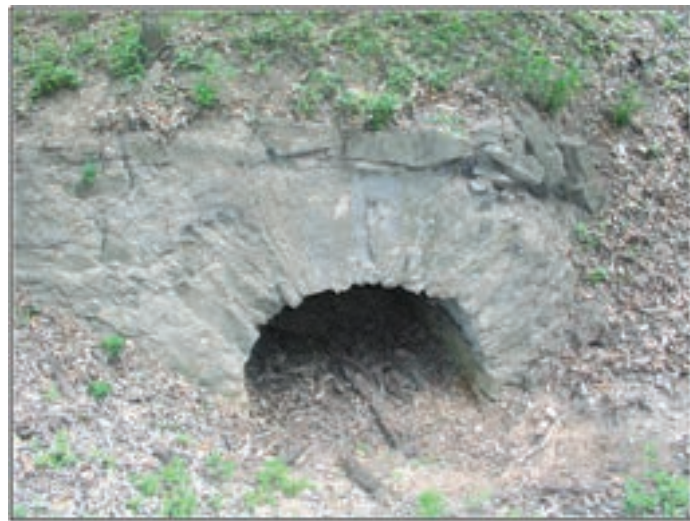
Figure 3. East face of archway.

The stone archway appears to have also been constructed of native limestone (Figure 3 and 4). HABS documentation completed in the 1935 by Charles Bertrand reports that the archway is contemporaneous with the construction of the house and was used by the builders of the house to transport lime during the construction of the house (HABS 2009). Photographs of the arch were taken in 1936 by Arthur W. Stewart to be included in the HABS documentation.

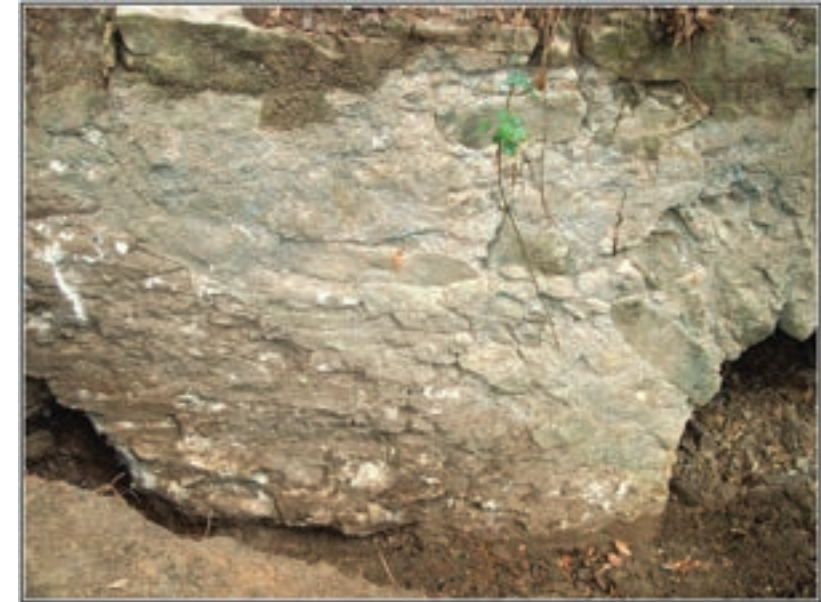
Figure 13. Base of the retaining wall along the north face of the arch.

To expose the extent of the retaining wall, archaeologists used shovels and a pick to remove the soil and find the edge of the feature (Figure 13). This trench was identified as Trench 4. The retaining wall may have acted as protection during flooding episodes. The wall is one course thick, and extended to a maximum depth of approximately 130 cmbs. The base of the retaining wall was sitting on soil rather than large footing stones such as those under the arch (Figure 13). The end of the wall protruded to the south approximately 2 meters from the arch. It appeared that there was possibly a second arch, but further excavation revealed that the depth of the wall decreased as it moved to the south.

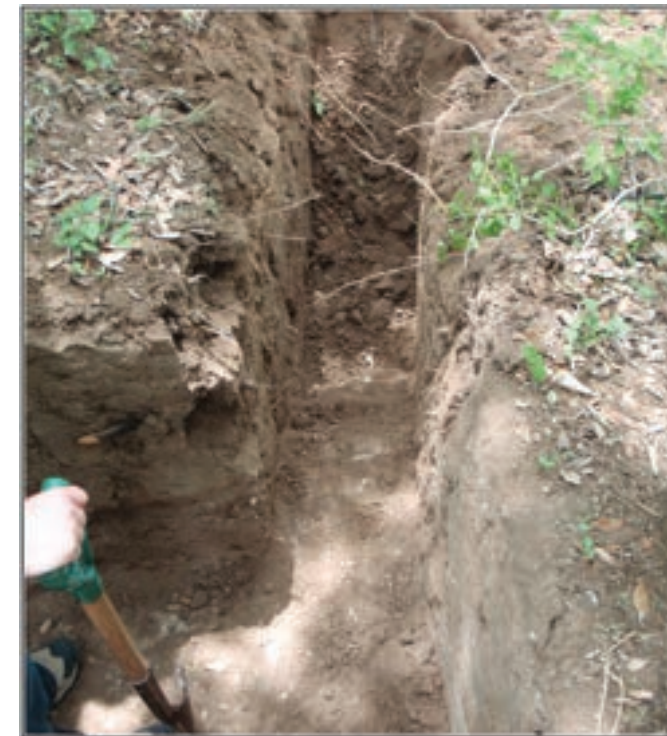
Figure 14. NPS BHT 1, looking southwest.

In addition to the areas excavated by CAR staff, NPS brought out a mini-excavator to trench in areas of interest. NPS-BHT 1 began at the south wall of Excavation Unit 1 and ran to the south (Figure 5). The trench was approximately one bucket wide (50 cm) and extended approximately two meters to the southwest (Figure 14). The trench removed a portion of EU 1's south wall. It was excavated to see if a second arch was located in the vicinity. The trench revealed that there was no second arch and that the arch was a lone standing feature. The exterior edge of the arch was uncovered and followed the curve of the arch to the base of the feature (Figure 14). There was no evidence suggesting that the feature was built to serve as an aqueduct.

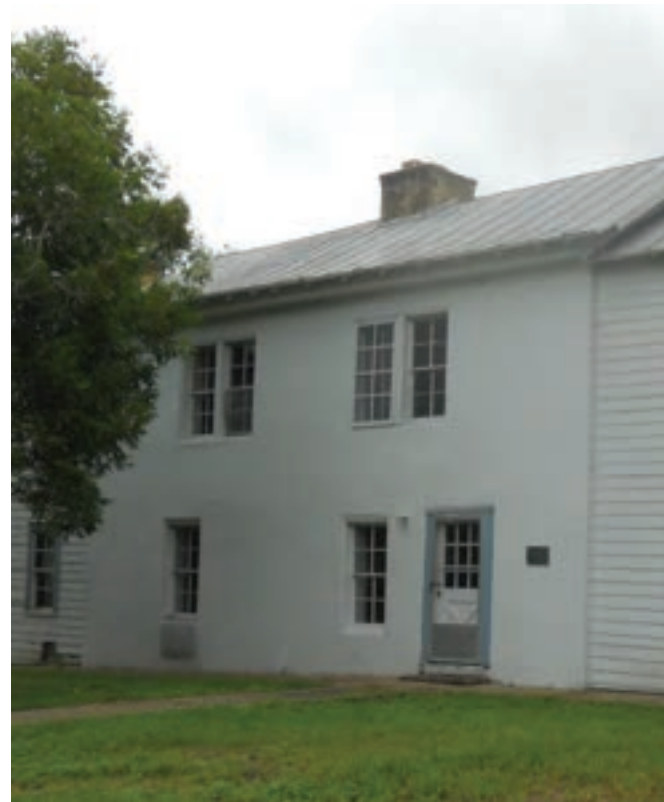
The central portion of the original two story Trueheart house was built in 1848. Constructed of limestone, the original house now has a cementitious stucco coat on the exterior. It is assumed that the stucco is made of Portland cement based on visual examination. Portland cement applied to a much more porous limestone creates many problems, including trapping moisture in the limestone walls which causes deterioration of the much softer limestone. Over time this undermines the integrity of the walls. Cracks in the plaster are visible around the original front windows on the ground floor. Water has entered the building from these cracks and evidence of water can be seen on the lower eastern room of the original house. Tapping on the plaster creates a hollow sound. This usually means that there is not a good bond between the stone and the plaster. On the north elevation the plaster is de-laminating from the stone structure - evidenced by the sagging/bulging plaster - confirming the poor bond.

Immediate – Seal the cracks to stop water penetration

Short term – in the next 1-3 years the cement stucco should be removed to expose the historic appearance of limestone walls. The walls will need to be re-pointed with a lime based mortar.

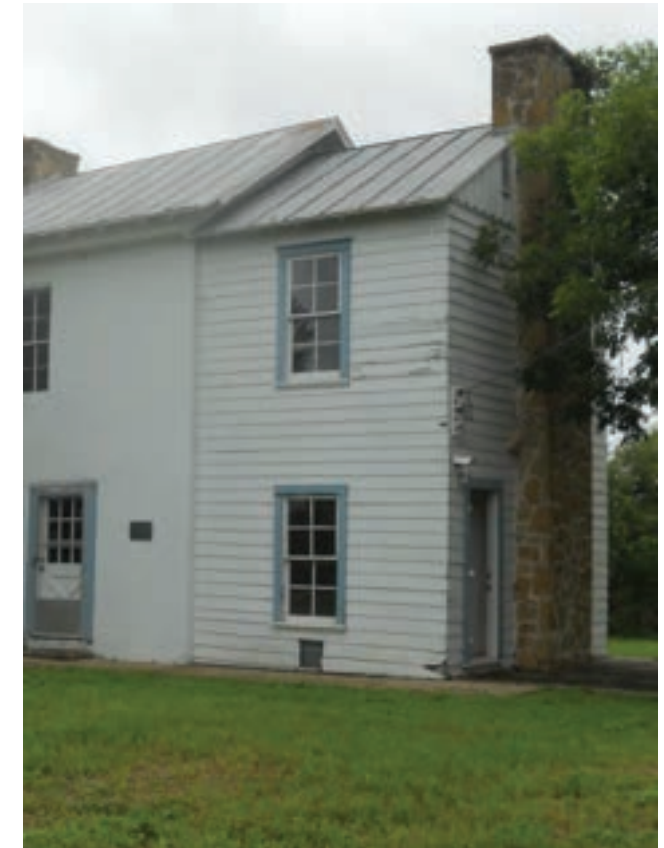
Two symmetrical wood frame wings were added to the original house on the east and west ends in 1939. The structural framing seems to be relatively solid in both wings. However there is some deflection (sinking) of the northeast corner. It is surmised from visual inspection that the deterioration of the framing may be caused by water penetrating the structure through the jamb and sill of the northern most windows of the east elevation. There is deterioration of the wood siding primarily at corners and at plate lines. The corner deterioration is most likely caused by the lack of trim boards at the corners. The mitered edges are susceptible to water penetration and the corners begin to take on moisture. This moisture eventually wicks further into the wood accelerating the deterioration. Rotten wood and flaking paint are evidence of the deterioration.

Immediate – Replace rotten wood and repaint. Examine exposed framing when replacing rotten wood to assure the framing has not been compromised. Repair framing as required.

Repair or replace rotten or missing window trim pieces.

Treat for termites. Although there was not evidence of current termite infestation, past activity was noted. it is good to assume the threat of termites and have the property treated.

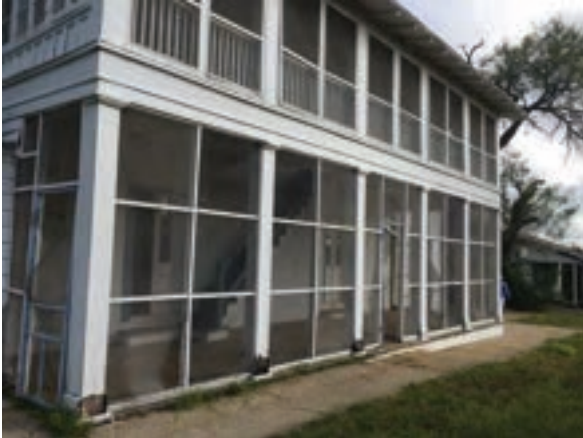
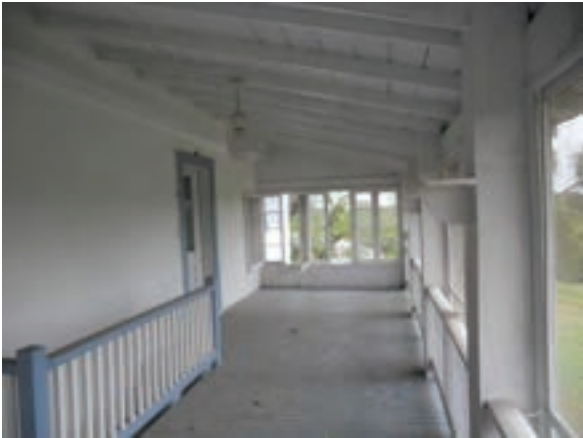
The two story screened porch was originally added sometime between the early 1900's and the 1920's. It has been altered, and differs from the HABS photos taken in 1936. The porch floor is now a foot above ground level on the east and in the photos the floor was raised four steps above grade, probably aligning with the first floor. On the west end, the porch floor is at ground level. The six columns appear to be in their original location, but in 1936 there was a solid wood band between the first and second floor that was at least three feet tall. Today the horizontal wood band only hides the floor joist of the second floor. Wood trim at the base of the columns has deteriorated. At this time there is no evidence that the structure is failing. Some screen has been detached from the frames and the rear screened door has fallen apart and for all practical purposes, is missing. The two side screen doors need to be repaired. On the second floor of the porch, the screen has become detached from the frame in a few places. On the east side, what appear to be casement windows are open and pieces are missing some glass.

The stairs located inside the screened porch appear to be in stable condition.

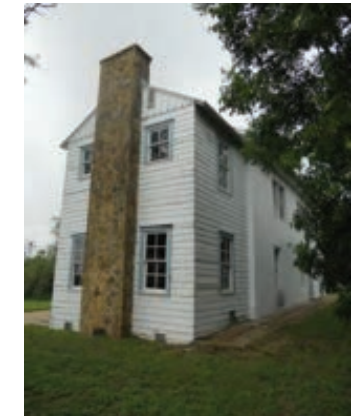
The stone chimneys located on either end are in relatively good condition. There is slight cracking near the southeast corner on the eastern fireplace. This may be due to water in the chimney wall corroding the reinforcing.

ACTION NEEDED: No action is necessary at this time.

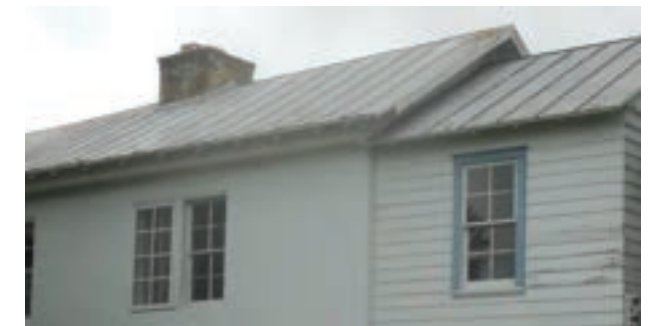
The abbreviated assessment did not examine the roof in detail. From the ground, the standing seam metal roof appears to be in relatively good shape. There is no evidence of leaks on the inside.

Immediate - No action is necessary at this time.

Short Term - Examine roof for holes and defects. Repair as required.

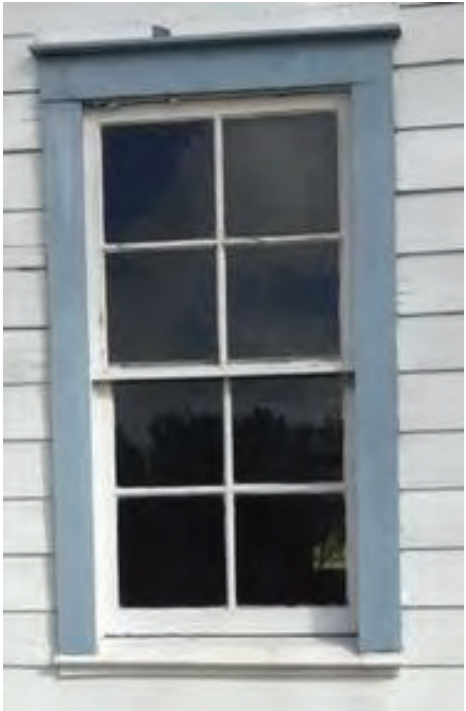
The four over four double hung wood windows are in relatively good condition. There are rotten sills and jambs on a few of the windows. Glass is missing from some of the panes. Screens are missing from most of the windows.

Doors should be secured with a minimum of 1/2 inch plywood to cover the entire door frame on the exterior. The plywood should be screwed into the existing frame. The screws can be removed for access to the property.

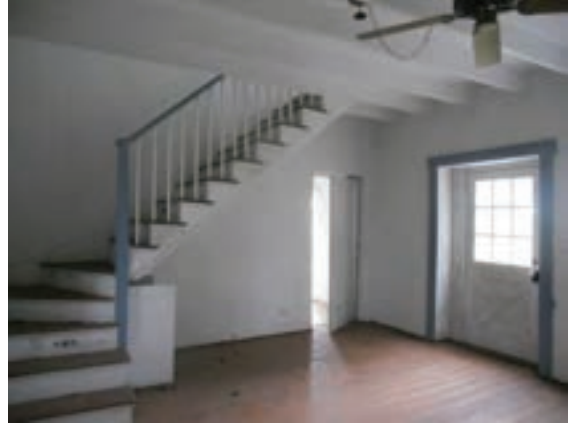
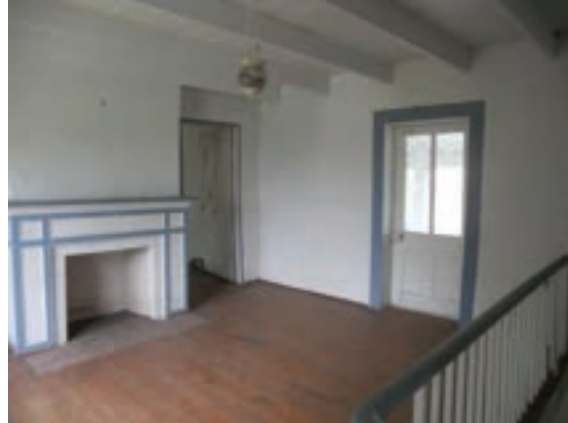
The interior is relatively clean and in good condition. Although there is some deflection of the framing around the central fireplace, the framing appears to be stable. A few cracks can be seen in the stone fireplace surround probably caused by the settling. The floors appear to be solid on both the ground and second floor, with the exception of the kitchen which may have some damage to the floor structure, perhaps from an earlier leak. There has been recent water penetration through the limestone wall on the eastern ground floor room. Water stains mixed with lime can be seen on the floor near the front windows. This has probably been caused by cracks in the exterior stucco.

There were a number of wasp hives, and evidence of a snake (a snake skin is the ground floor fire place). Some wasp removal has been started and many dead wasps are on the floors. Paw prints of an animal can be seen on the wall below a front window.

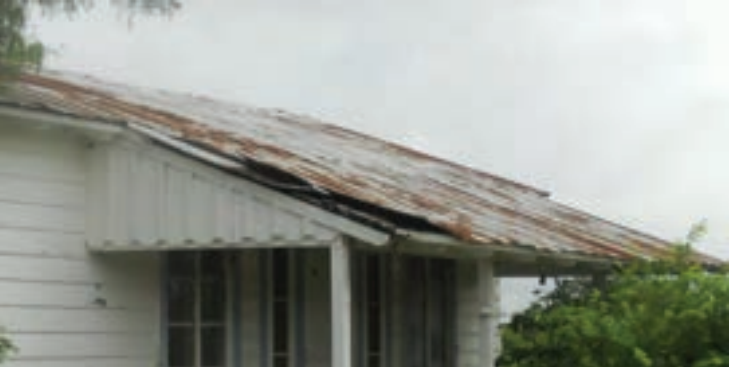
Roof
The roof is a metal roof that appears to be a Tennessee V Groove from observations from the ground. A thorough investigation of the roof was not performed. Although the roof is quite dilapidated, there was no evidence of water damage on the interior. The metal roof is detached from the framing on the eastern end of the porch and has curled away from the framing.

- Immediate - Repair the corner of the porch roof by reattaching the metal to the frame.
Short Term - Examine roof for holes and defects. Repair as required.

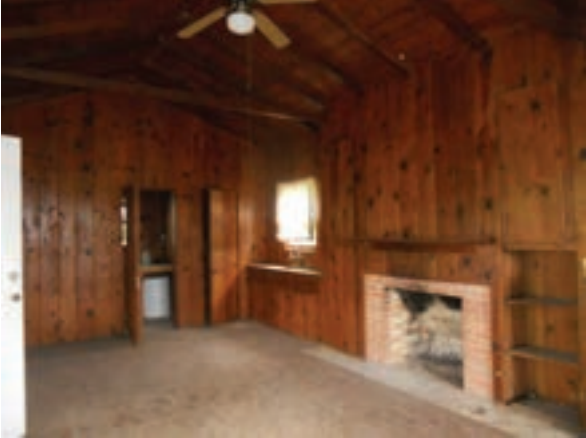
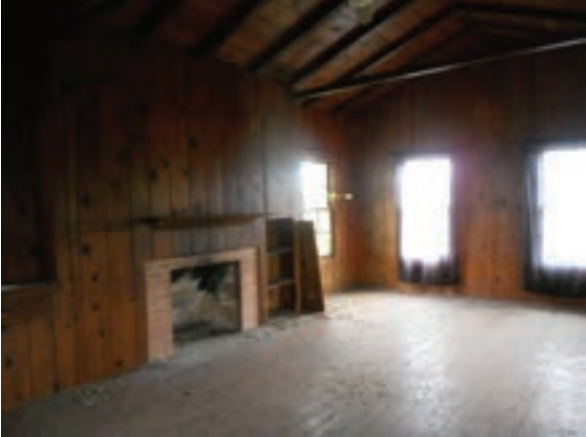
DOORS AND WINDOWS
The doors and windows are in relatively good condition. The screen door needs repair.

INTERIOR
The interior of the caretakers cottage is in relatively good condition. Old wasp nest can be seen, and dead wasp cover the floor. One new hive was spotted.

A complete pest control application should be completed to remove and deter all insects (wasps, spiders, cockroaches, etc) rodents, and snakes.
Because we don't know the condition of the electrical system in the cottage, a temporary service with temporary lights should be installed, so that the cottage can be inspected when the windows and doors are boarded.

Install alarm system to deter intruders

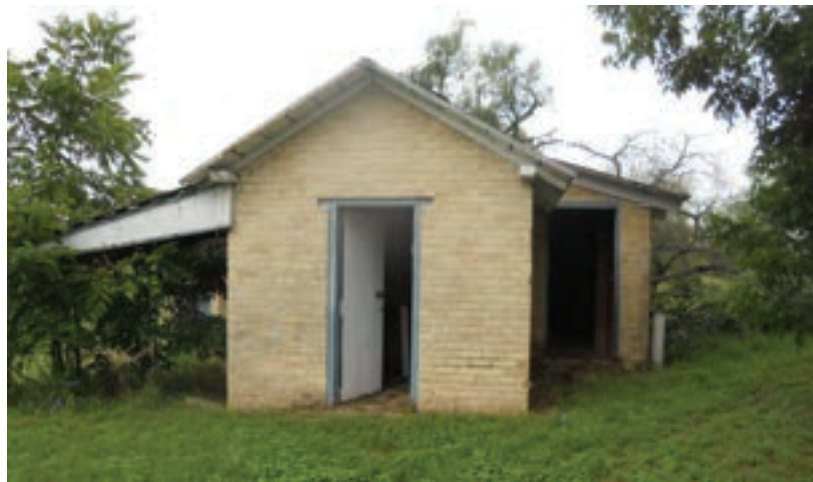
The one story brick building east of the main house is described in some reports as a kitchen, a carport or an outbuilding. There is a small structure (perhaps a smokehouse) with a larger addition to the east. They do not interconnect. The foundation perimeter beam on the back corner is not bearing on any soil, but suspended above the ground. This lack of structural support has caused large cracks to develop in the brick walls. Existing tie rods are evidence of the buildings need to be reinforced in the past. The yellow brick has been sandblasted, which will have long term detrimental effect on the building.

Immediate:- Place loose concrete blocks underneath the perimeter beam spaced no more than 4 feet apart to immediately help stabilize the structure.

Short Term- Replace perimeter beam . Re-grade for positive slope away from the building.

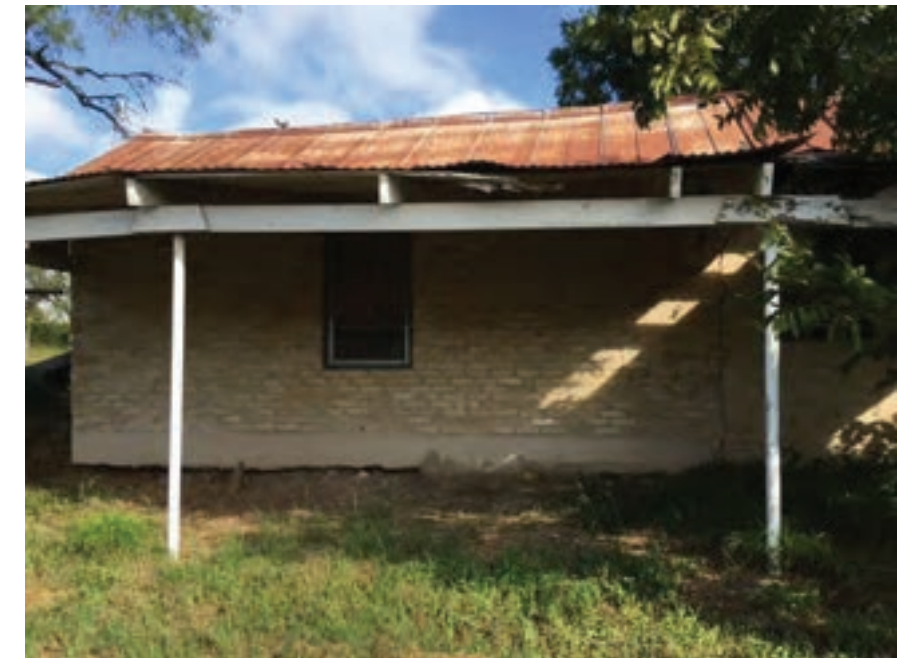
The carport on the south side of the building is severely dilapidated. The framing has collapsed or deteriorated.

The roof framing appears to be constructed of "found lumber." The roof is a metal Tennessee V-groove. The roof was only observed from the ground.

Immediate - Photo document the carport structure for later reference. Remove the carport by hand. Repair any damage to fascia.

Immediate – Make sure roof material is securely attached at eaves, no further action required.

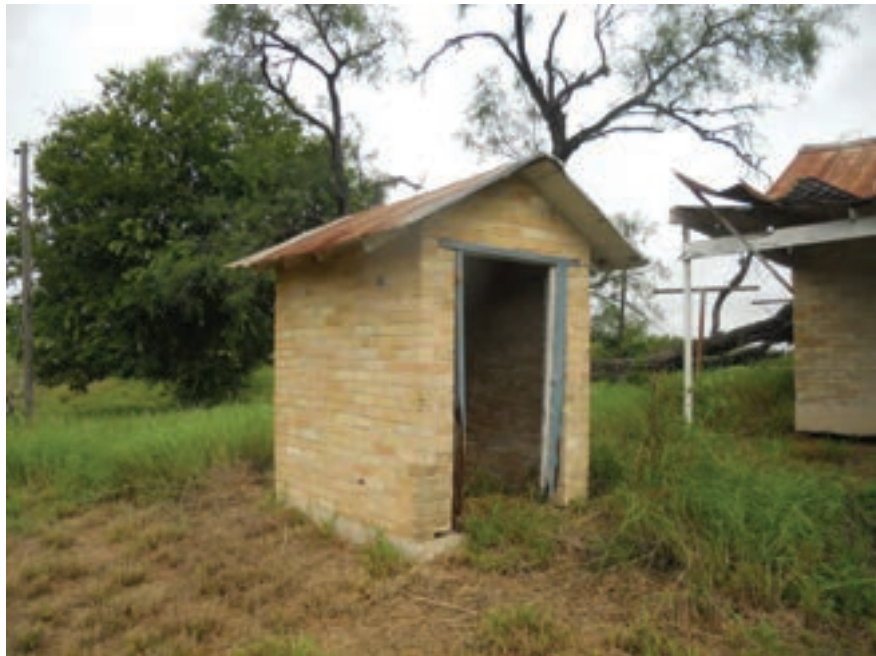
THE BRICK WELL HOUSE

EXTERIOR
The small brick well house is in stable condition. It is missing the door and some of the door jamb. It is constructed of yellow brick that has been sand blasted.

ACTION NEEDED:
No immediate action required.

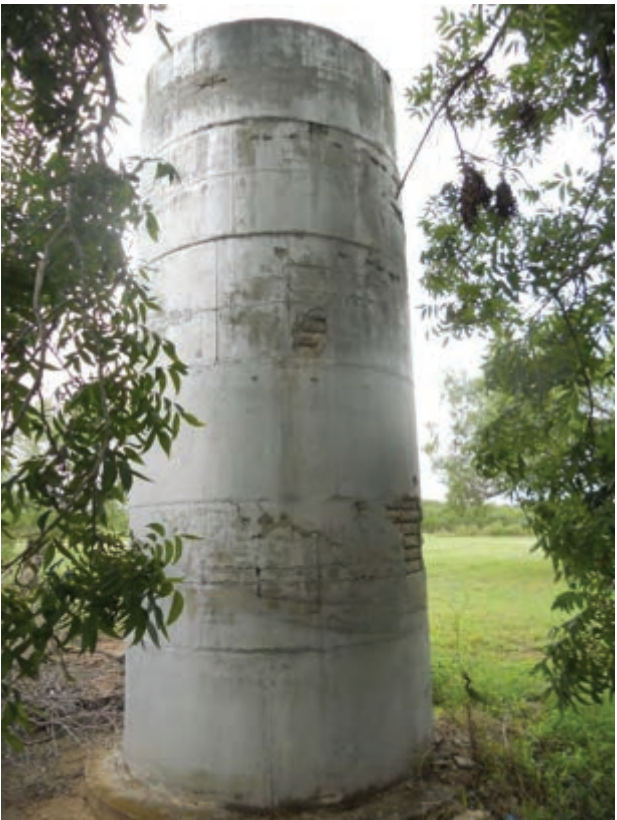
THE WATER TANK

EXTERIOR
The concrete water tank is showing severe signs of deterioration caused by the rusting of the exposed steel reinforcing. At this time the water tank is stable, but will continue to deteriorate. A stabilization plan should be developed for this feature.

ACTION NEEDED:
No immediate action required.

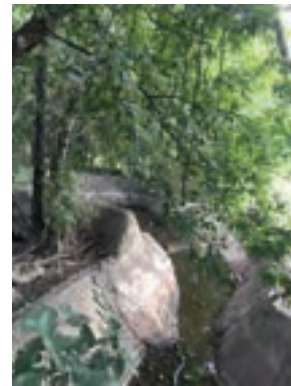
Concrete lined irrigation ditch

THREAT: deterioration and collapse

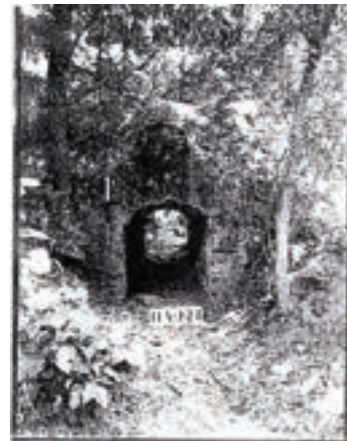
Stone bridge in 1936

THREAT: deposits create a dam like condition that will force eventual collapse, or bury the structure.

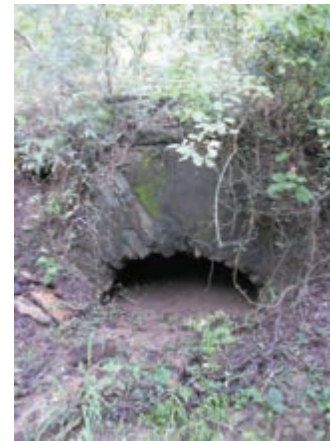
Stone bridge in 2016

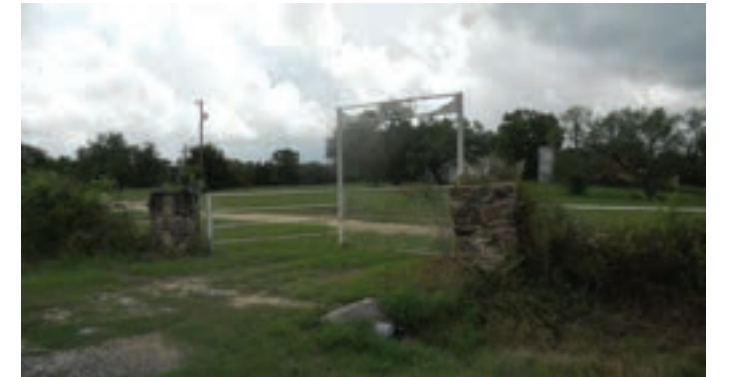
The existing front entrance gate off of Blue Wing Road consists of four stone pillars. The feature had a non- historic welded metal sign with a previous owners name added between the central pillars. The welded metal entrance is narrow not allowing large trucks to enter , as well as not allowing adequate distance between the road and gate for safe access. The entrance gate needs to be redesigned to be both historically appropriate and adequate.

THREAT: damage to historic stone pillars

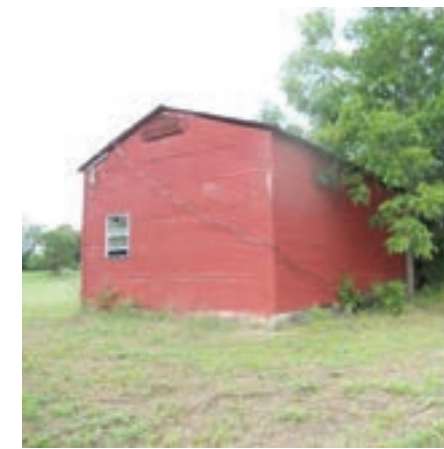
OUTBUILDINGS

Other outbuildings exist on the site. Some are in fine condition and others are in a state of collapse. Some might be historic and contribute of the history of the Ranch. Others are simply utilitarian. An assessment should be made as to the historical significance and/or the usefulness of the structures for other uses.

THREAT: demolition by neglect
