<b>EVALUATIO</b>	N OF POTENTIAL REHABILITATION	N PR	OJECTS			
STATE	TX	DAM	Escondido Cr	eek FRS No. 12	BY	SS	DATE	12/10/20	)24
	YEAF	R BUILT	1974	DESIGN HAZARD CLASS	L	DRAINA	GE AREA	11.64	mi <sup>2</sup>
WC	ORK PLAI	N DATE	1/1/1964	CURRENT HAZARD CLASS	Н	DAN	/ HEIGHT	34	ft
sht 1 of 5		CC	ONSEQUENC	ES OF DAM FAILURE (ver. 2021-01	l)		NID ID	TX043	15
POTENTIA	L DAM F	AILURE	:				-		_
Total Fail	ure Index							151	Α
POTENTIA	L LOSS (	OF LIFE	:						_
Maximum	n Populati	on-at-Ris	sk [PAR]				(number)	144	В
Total Risl	k Index							4	С
POTENTIA									
_	-			ach and rate impact as High (H), Med	dium	(M), Low (L)		•	٦
Commu	•	Kenedy,					(H,M,L,-)	M	D
			esses, major b	puildings			(number)	88	E
POTENTIA

EVALUATION OF POTENTIAL REHABILITATION PROJECTS								
STATE	TX	TX DAM Escondido Creek FRS No. 12 BY SS DATE 1							
sht 2 of 5

Escondido FRS No. 12 SWP-EA 60707508 **Geotechnical Laboratory Testing Summary Plots AE**COM Attachment No. April 2024

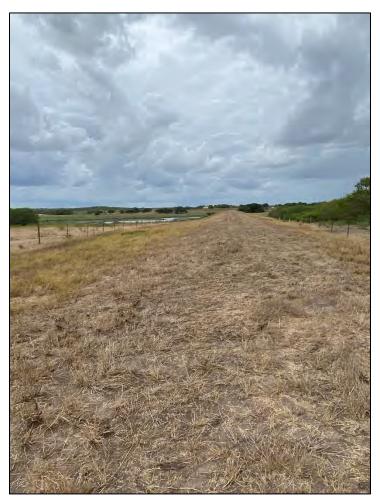
Figure 22. View of the top of Resource 001a, looking northwest

Resource 001a consists of an earthen-filled embankment dam designed for flood control (**Figure 22**). The resource is grass-covered and measures 2,667 ft in length with an embankment height of 343.3 ft. Resource 001a appears to retain all aspects of integrity. However, the resource is a common example of its type and does not exhibit exceptional architectural or engineering merit, or historical significance and is recommended Not Eligible for NRHP or SAL listing.

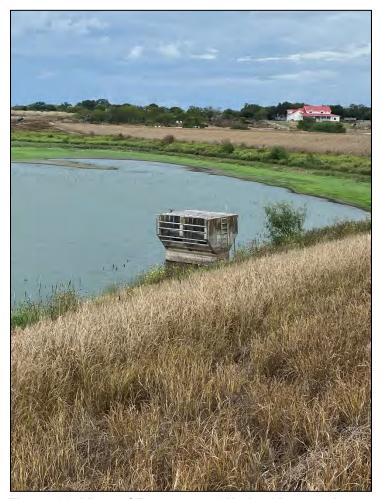
Figure 23. View of Resource 001b, looking northwest

Resource 001b is a Principal Spillway Inlet Riser and functions to convey water so that outflow from the reservoir can be regulated (**Figure 23**). Resource 001b is constructed of concrete and rises from the base of the reservoir on the northeast side. A Principal Spillway Outlet pipe (Resource 001c) extends from the base of the Spillway Inlet structure, beneath the dam and protrudes from the opposite of the dam to serve the Principal Spillway. The structure is open on the top and on the southeast and northwest sides to allow water to enter. Metal bars extend across these openings to limit the entry of debris into the structure. The northeast and southwest sides of the structure are solid concrete. A manual metal gate valve with a turn wheel is present on the west side of the structure to regulate the flow of water into the structure.

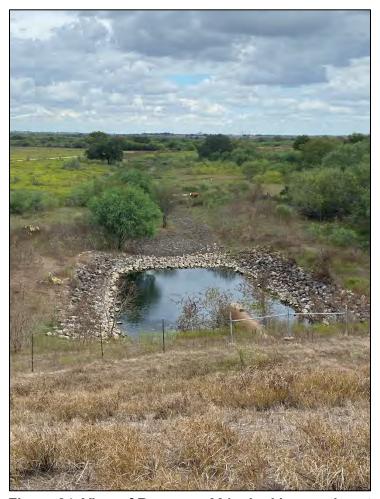
Figure 24. View of Resource 001c, looking northeast

Resource 001c is a concrete-lined steel cylinder pipe that rests in a concrete cradle support (**Figure 24**). The pipe functions as a Principal Spillway Outlet drainage structure. The outlet structure is used to regulate overflow from the reservoir when water from the reservoir passes through the Principal Inlet Structure (Resource 001b), into the outlet pipe under the dam to empty into the earthen Principal Spillway.

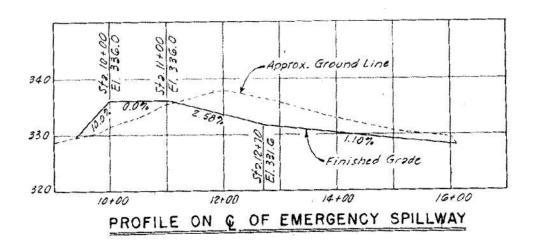
According to the as-built drawings, the dam is approximately 34 feet tall at the maximum section and is approximately 2,667 feet long. The crest was built to maximum elevation (EI). 343.4\* feet in the central portion of the creek valley (including over-build to compensate for post-construction settlement) and tapered to EI. 342.2\* feet and EI. 342.4\* feet at the left and right abutments, respectively. The upstream and downstream slopes of the embankment were constructed at an inclination of 2.5H:1V (horizontal:vertical). A 12-foot-wide wave protection berm was constructed on the upstream slope at approximately EI. 320.6\* feet. A 14-foot-wide berm was constructed on the downstream slope at EI. 318.13\*. The width of the embankment crest is approximately 14 feet. The dam features a vegetated ASW at the right abutment and a principal spillway (PSW) near the near the original creek alignment. The PSW consists of a drop inlet, four low-level ports with invert EI. 322.6\* feet, a conduit under the dam, and a rock riprap lined downstream plunge basin. Five (5) anti-seep collars spaced at 24 feet on center are also present.

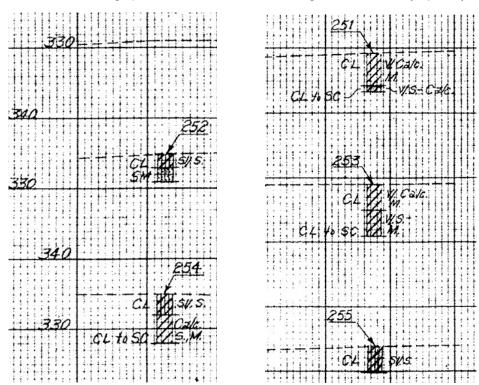
The ASW exit channel is oriented through the edge of a topographic knoll, where pre-construction ground surface was higher near the middle of the channel and lower at the upstream and downstream ends. The first 170 feet of the exit channel (ASW Sta. 11+00 and Sta. 12+70) was constructed at a 2.58% grade by placing up to 5 feet of earthfill on the interior (dam) side of the channel and excavating up to 5 feet into native clay and sand on the exterior (abutment) side of the channel. at the last 330± feet of the channel was constructed at 1.1% grade to the channel's termination where it ties into original ground surface by excavating to depths ranging from 1 to 4.5 feet which generally decreased going downstream. For reference, the as-built ASW spillway profile is shown in the image below as well as the stick logs provided in the as-built drawings for the auxiliary spillway.

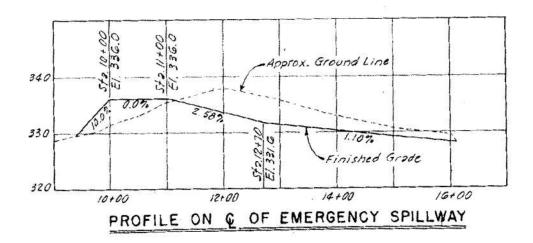
According to the as-built drawings, the dam is approximately 34 feet tall at the maximum section and is approximately 2,667 feet long. The crest was built to maximum elevation (EI). 343.4\* feet in the central portion of the creek valley (including over-build to compensate for post-construction settlement) and tapered to EI. 342.2\* feet and EI. 342.4\* feet at the left and right abutments, respectively. The upstream and downstream slopes of the embankment were constructed at an inclination of 2.5H:1V (horizontal:vertical). A 12-foot-wide wave protection berm was constructed on the upstream slope at approximately EI. 320.6\* feet. A 14-foot-wide berm was constructed on the downstream slope at EI. 318.13\*. The width of the embankment crest is approximately 14 feet. The dam features a vegetated ASW at the right abutment and a principal spillway (PSW) near the near the original creek alignment. The PSW consists of a drop inlet, four low-level ports with invert EI. 322.6\* feet, a conduit under the dam, and a rock riprap lined downstream plunge basin. Five (5) anti-seep collars spaced at 24 feet on center are also present.

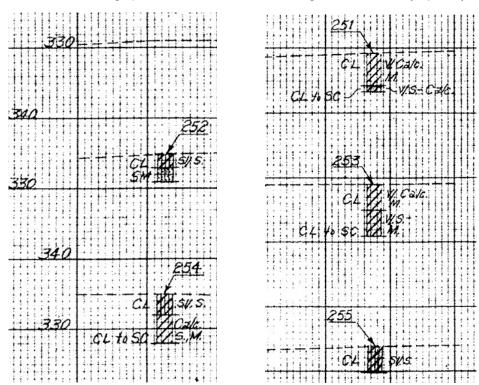
The ASW exit channel is oriented through the edge of a topographic knoll, where pre-construction ground surface was higher near the middle of the channel and lower at the upstream and downstream ends. The first 170 feet of the exit channel (ASW Sta. 11+00 and Sta. 12+70) was constructed at a 2.58% grade by placing up to 5 feet of earthfill on the interior (dam) side of the channel and excavating up to 5 feet into native clay and sand on the exterior (abutment) side of the channel. at the last 330± feet of the channel was constructed at 1.1% grade to the channel's termination where it ties into original ground surface by excavating to depths ranging from 1 to 4.5 feet which generally decreased going downstream. For reference, the as-built ASW spillway profile is shown in the image below as well as the stick logs provided in the as-built drawings for the auxiliary spillway.

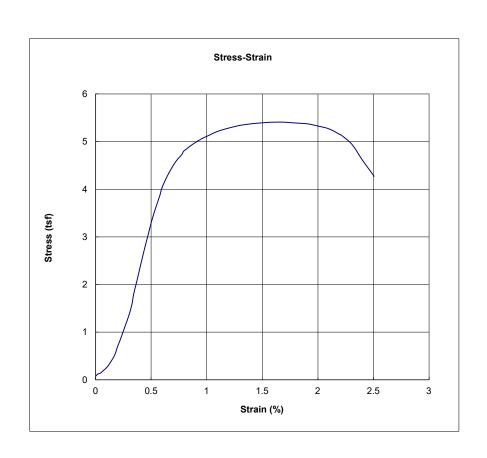
Specimen and resumg betails		
Borehole		201-23
Depth (ft)		2 - 3
Sample Date		7/20/2023
Soil Type		SANDY FAT CLAY (CH)
Specimen Height	inch	5.54
Specimen Diameter	inch	2.77
Moisture Content	%	35.6
Dry Density	pcf	91.7
Confining Pressure	psi	0
Membrane Correction Used?	Y/N	N
Axial Strain	%	1.60
Failure Stress	tsf	5.41

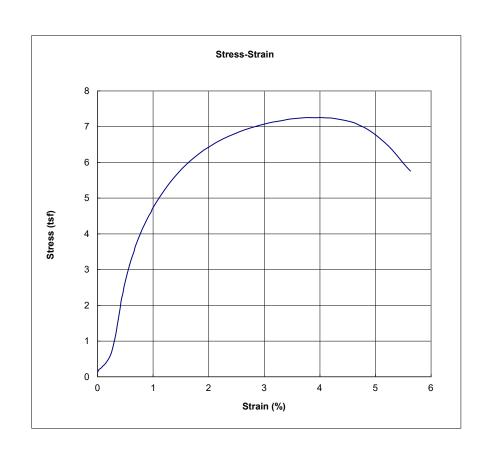
Specimen and resulting Details		
Borehole		201-23
Depth (ft)		12 - 14
Sample Date		7/20/2023
Soil Type		FAT CLAY (CH)
Specimen Height	inch	5.56
Specimen Diameter	inch	2.77
Moisture Content	%	15
Dry Density	pcf	116.31
Confining Pressure	psi	0
Membrane Correction Used?	Y/N	N
Axial Strain	%	7.26
Failure Stress	tsf	4.01

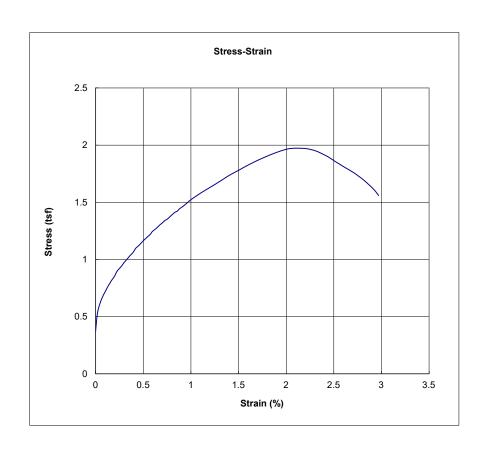
Specimen and resumg betails		
Borehole		202-23
Depth (ft)		14 - 16
Sample Date		7/20/2023
Soil Type		LEAN CLAY (CL)
Specimen Height	inch	5.51
Specimen Diameter	inch	2.74
Moisture Content	%	39.6
Dry Density	pcf	82.43
Confining Pressure	psi	0
Membrane Correction Used?	Y/N	N
Axial Strain	%	2.11
Failure Stress	tsf	1.97

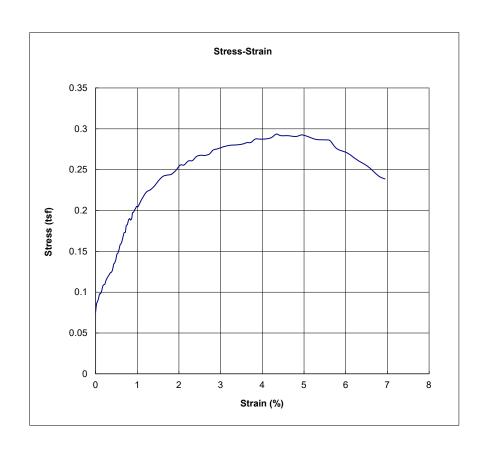
opecimen and resting betails		
Borehole		202-23
Depth (ft)		40 - 42
Sample Date		7/20/2023
Soil Type		FAT CLAY (CH)
Specimen Height	inch	5.51
Specimen Diameter	inch	2.78
Moisture Content	%	28.6
Dry Density	pcf	86.13
Confining Pressure	psi	0
Membrane Correction Used?	Y/N	N
Axial Strain	%	4.33
Failure Stress	tsf	0.29

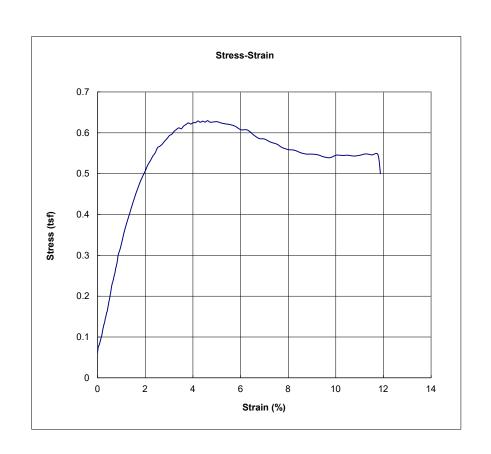
Specimen and resumg betails		
Borehole		203-23
Depth (ft)		10 - 11
Sample Date		7/20/2023
Soil Type		FAT CLAY (CH)
Specimen Height	inch	4.69
Specimen Diameter	inch	2.86
Moisture Content	%	27.8
Dry Density	pcf	88.74
Confining Pressure	psi	0
Membrane Correction Used?	Y/N	N
Axial Strain	%	4.62
Failure Stress	tsf	0.63

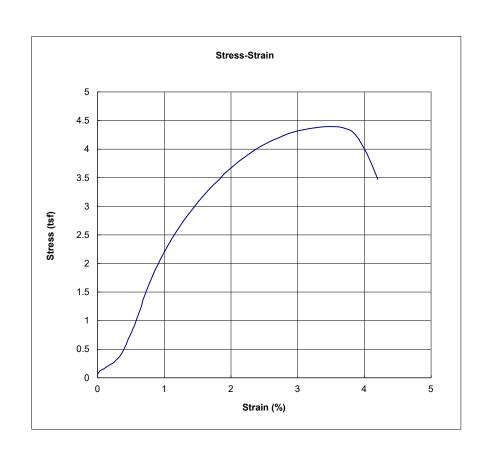
opecimen and resting betails		
Borehole		204-23
Depth (ft)		0 - 2
Sample Date		7/20/2023
Soil Type		FAT CLAY with SAND (CH)
Specimen Height	inch	5.59
Specimen Diameter	inch	2.85
Moisture Content	%	22.1
Dry Density	pcf	98.89
Confining Pressure	psi	0
Membrane Correction Used?	Y/N	N
Axial Strain	%	3.51
Failure Stress	tsf	4.39

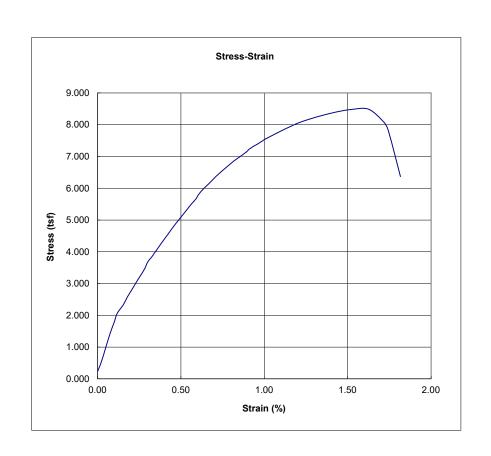
operation and recalling peration		
Borehole		204-23
Depth (ft)		8 - 10
Sample Date		7/20/2023
Soil Type		FAT CLAY (CH)
Specimen Height	inch	5.59
Specimen Diameter	inch	2.87
Moisture Content	%	15.7
Dry Density	pcf	109.89
Confining Pressure	psi	0
Membrane Correction Used?	Y/N	N
Axial Strain	%	1.63
Failure Stress	tsf	8.49

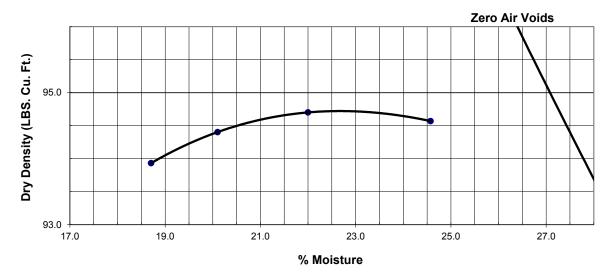
Test results for sample I.D.: 23-0841
Maximum Dry Density(lb/ft3): 94.7
Optimum Moisture Content (%): 22.6
Liquid Limit: 60
Plasticity Index: 40
(Estimated) Specific Gravity: 2.6
