# Dam Existing Condition and Concept Design Hydrology and Hydraulics Investigation and Analysis Report

Escondido Creek Floodwater Retarding Structure No. 1 Rehabilitation Project  
Karnes County, Texas

U.S. Department of Agriculture - Natural Resources Conservation Service

Project number: 60700486

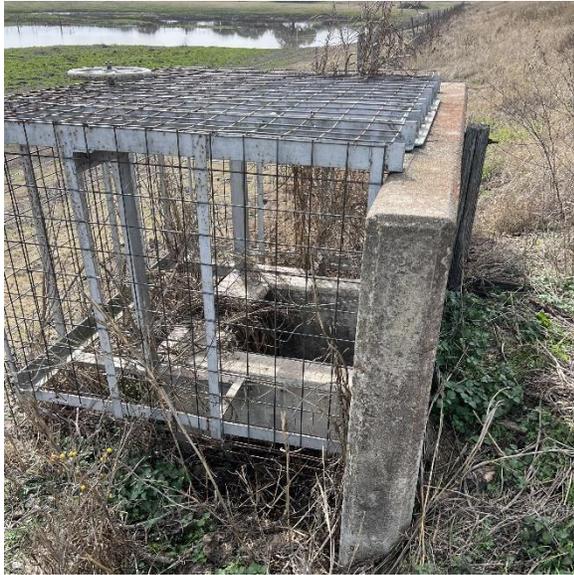
Inlet structure looking southwest

**Figure 2.1 FRS No. 1 Principal Spillway Inlet and Outlet**

The latest NRCS dam safety inspection report (2023) indicated that the visible section of the concrete principal spillway inlet and outlet was in good condition. The principal spillway conduit had good alignment near the outlet. An area of possible leakage through the joint near the top of the riser was noted. The inlet filter housing was functional with some rusting, also slight rust was noted on the slide gate. Johnsongrass around the inlet and small trees (1 inch diameter) on the right side of the outlet pipe were observed. A shallow hole upstream and to the left of the inlet was also located during inspection. The rock riprap around the outlet pipe was found to be in good condition with some burrows around the rock. Mesquites are growing downstream of the plunge basin, but the trees are not restricting flow at this time.

Photographs of the existing principal spillway system, taken during a site visit on January 30<sup>th</sup>, 2024, are provided in **Figure 2.1**. A low-level drain with a 16-inch by 24-inch opening resides on the upstream side of the riser. At the top of the riser, there is a debris guard and baffle wall cover. On the opposite side of the baffle wall, a valve stem extension is situated, which is linked to the gate valve at the bottom of the inlet riser.

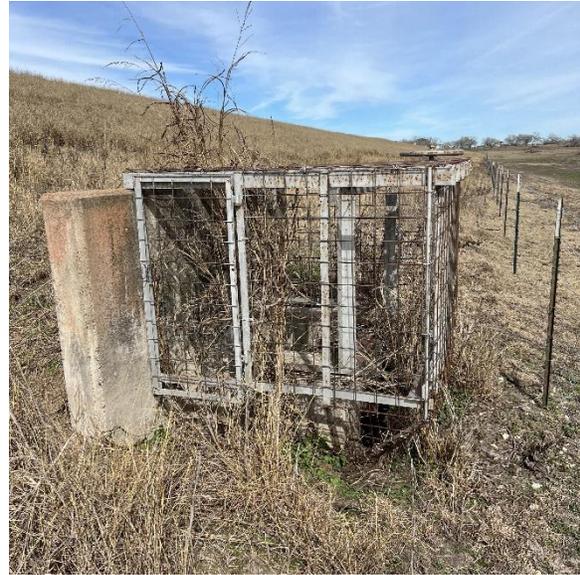
Inlet structure looking northeast

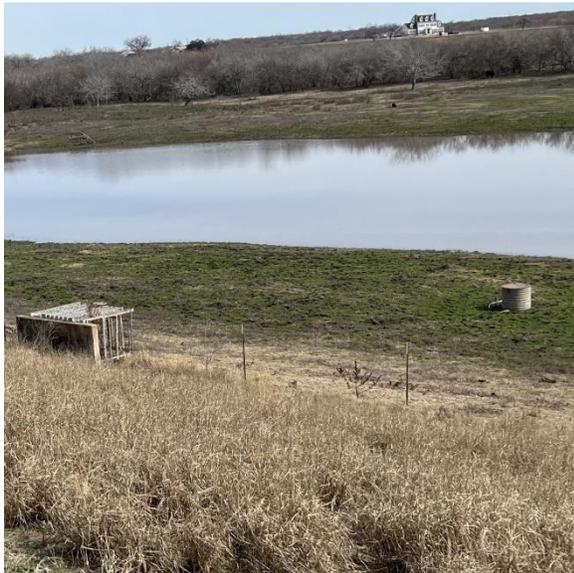
Inlet structure and inlet filter housing

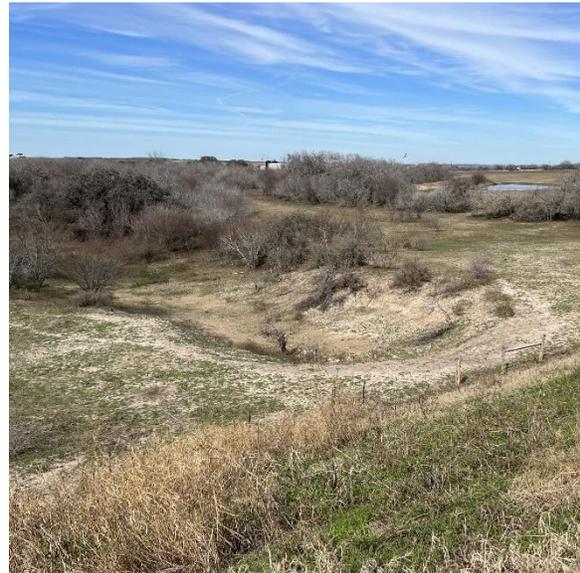
Plunge pool, currently dry

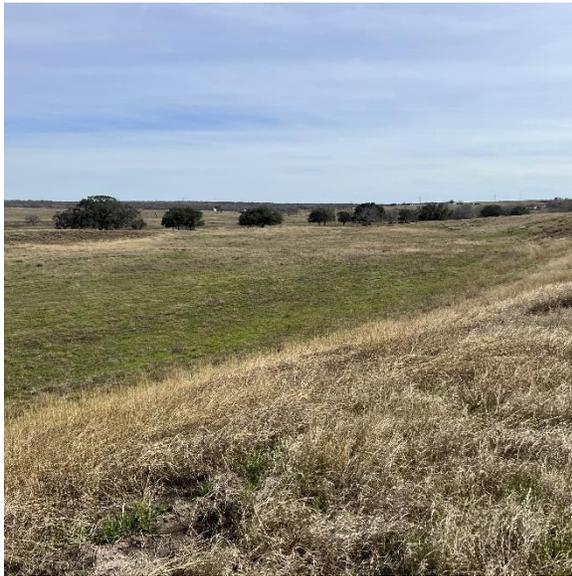
Auxiliary spillway control section

**Figure 2.2 FRS No. 1 Auxiliary Spillway Condition**

The auxiliary spillway is a 250-foot-wide, grass-lined channel with 3H:1V side slopes. The as-built drawings show the auxiliary spillway as having a flat grassed inlet section with 0% slope up to the control section, a 50-foot-long control section at elevation 377.87 feet (per as built) or 378.02 feet (per LiDAR), and an exit section with slopes ranging from 1.75% to 9.61% extending for approximately 1078 feet before transitioning back to the original ground. A channel was excavated at the end of spillway for relief wall drainage. Per correspondence with the San Antonio River Authority, there is no record of the auxiliary spillway flowing since dam construction.

According to NRCS dam safety inspection report (2023), all three sections of the auxiliary spillway were found to be in good dimensional condition with good vegetative cover. Some sparse areas were observed in the control section where the grass was slightly thin. An ATV trail was also noted across the control section. A harvester ant bed was found on the inside berm at the left end of the dam. The fence around the spillway was recorded as in good condition. Auxiliary spillway photos are provided in **Figure 2.2**.

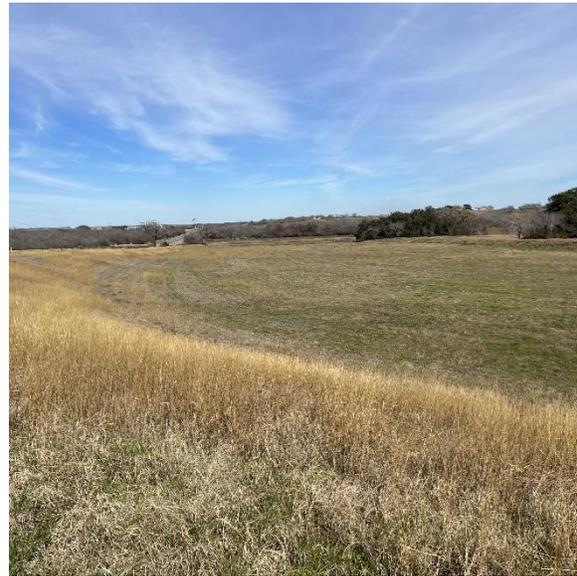
Auxiliary spillway channel downstream of control section

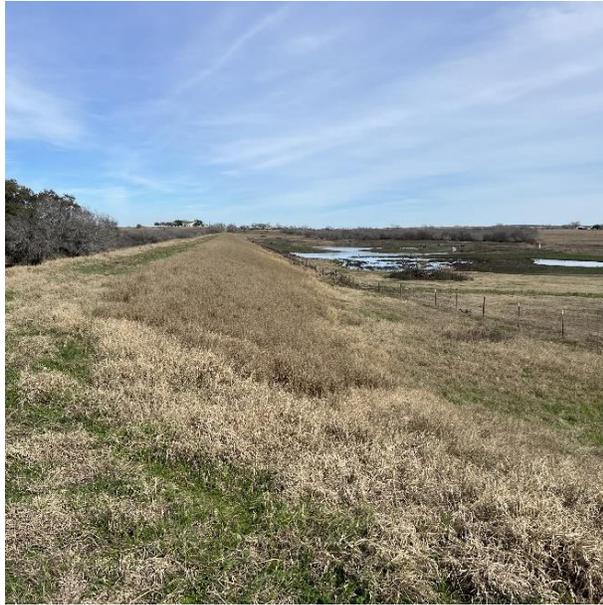
Upstream embankment

**Figure 2.3 FRS No. 1 Embankment Condition**

Per the NRCS dam safety inspection report (2023), the upstream and downstream embankments were observed to be in good condition with good vegetation covering most of the dam but with some slightly bare grass on the right end of the dam (looking downstream). Several deep burrows were noted on the dam up to 4.5 feet deep, along with a harvester ant bed measuring 2.5 feet diameter on the crown, 500 feet right of the principal spillway and 2.0 feet diameter at the upstream edge of crown, 150 feet left of relief well. Subterranean termites were also noted on the crown at the left end. A 3-feet by 3.5-feet hole was found ten feet down on the downstream slope, approximately 150 feet from the left end of the dam, with a smaller hole 5 feet to the right. Evidence of armadillo and old hog rooting were noted on the dam.

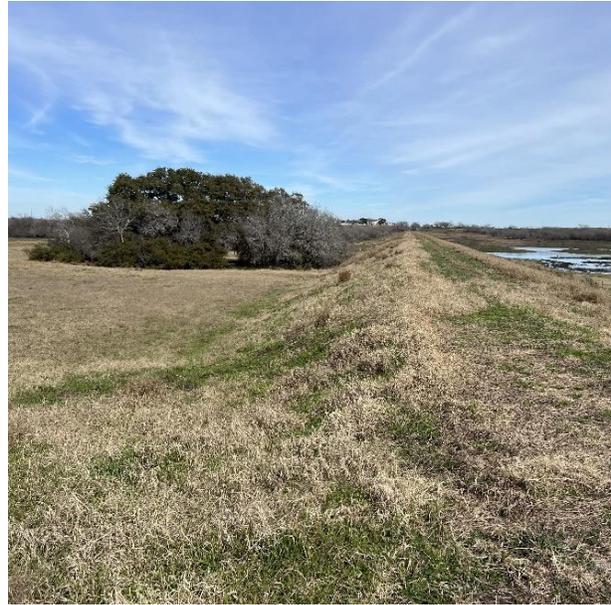
Downstream embankment

The crown is rounded at the downstream edge at the principal spillway alignment. An early-stage slope slide was visible over the principal spillway alignment on the downstream slope. A 6-foot-tall retama tree has sprouted mid-slope on the downstream embankment, roughly 200 feet to the right of the principal spillway alignment. An all-terrain vehicle (ATV) trail was located over the dam right of the monitoring station near the principal spillway. During the time of inspection, no livestock were present on the site and there was no water in the reservoir or the plunge pool. The downstream slope drain was clear with some minor sediment on the grate. Embankment photos are provided in **Figure 2.3**.

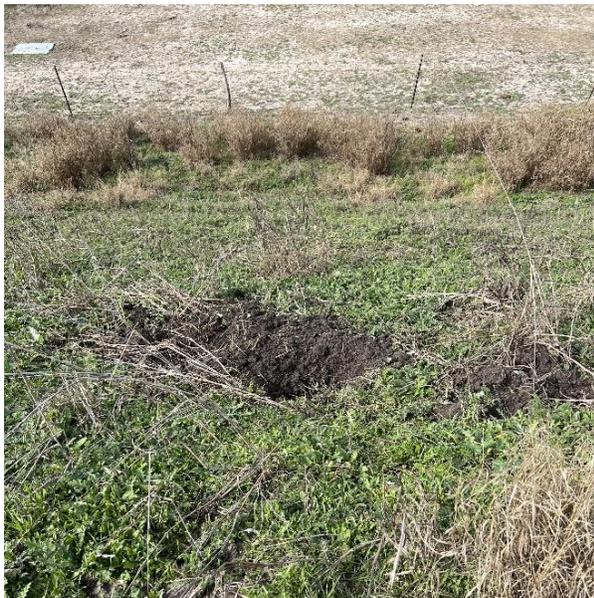
Downstream embankment showing burrows

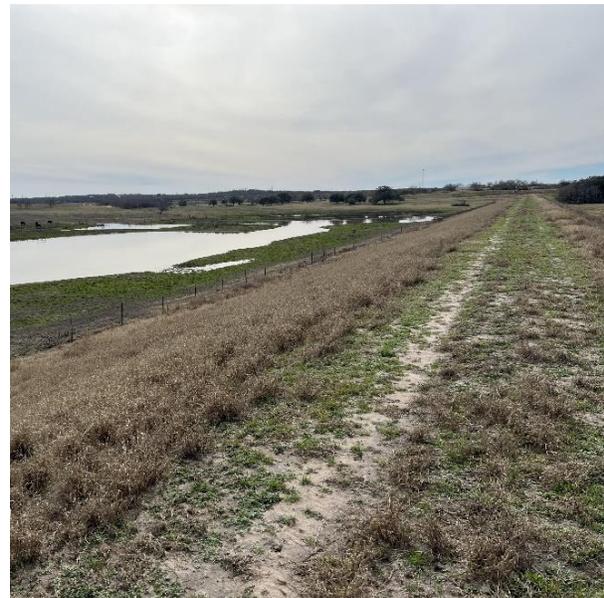
Top of embankment

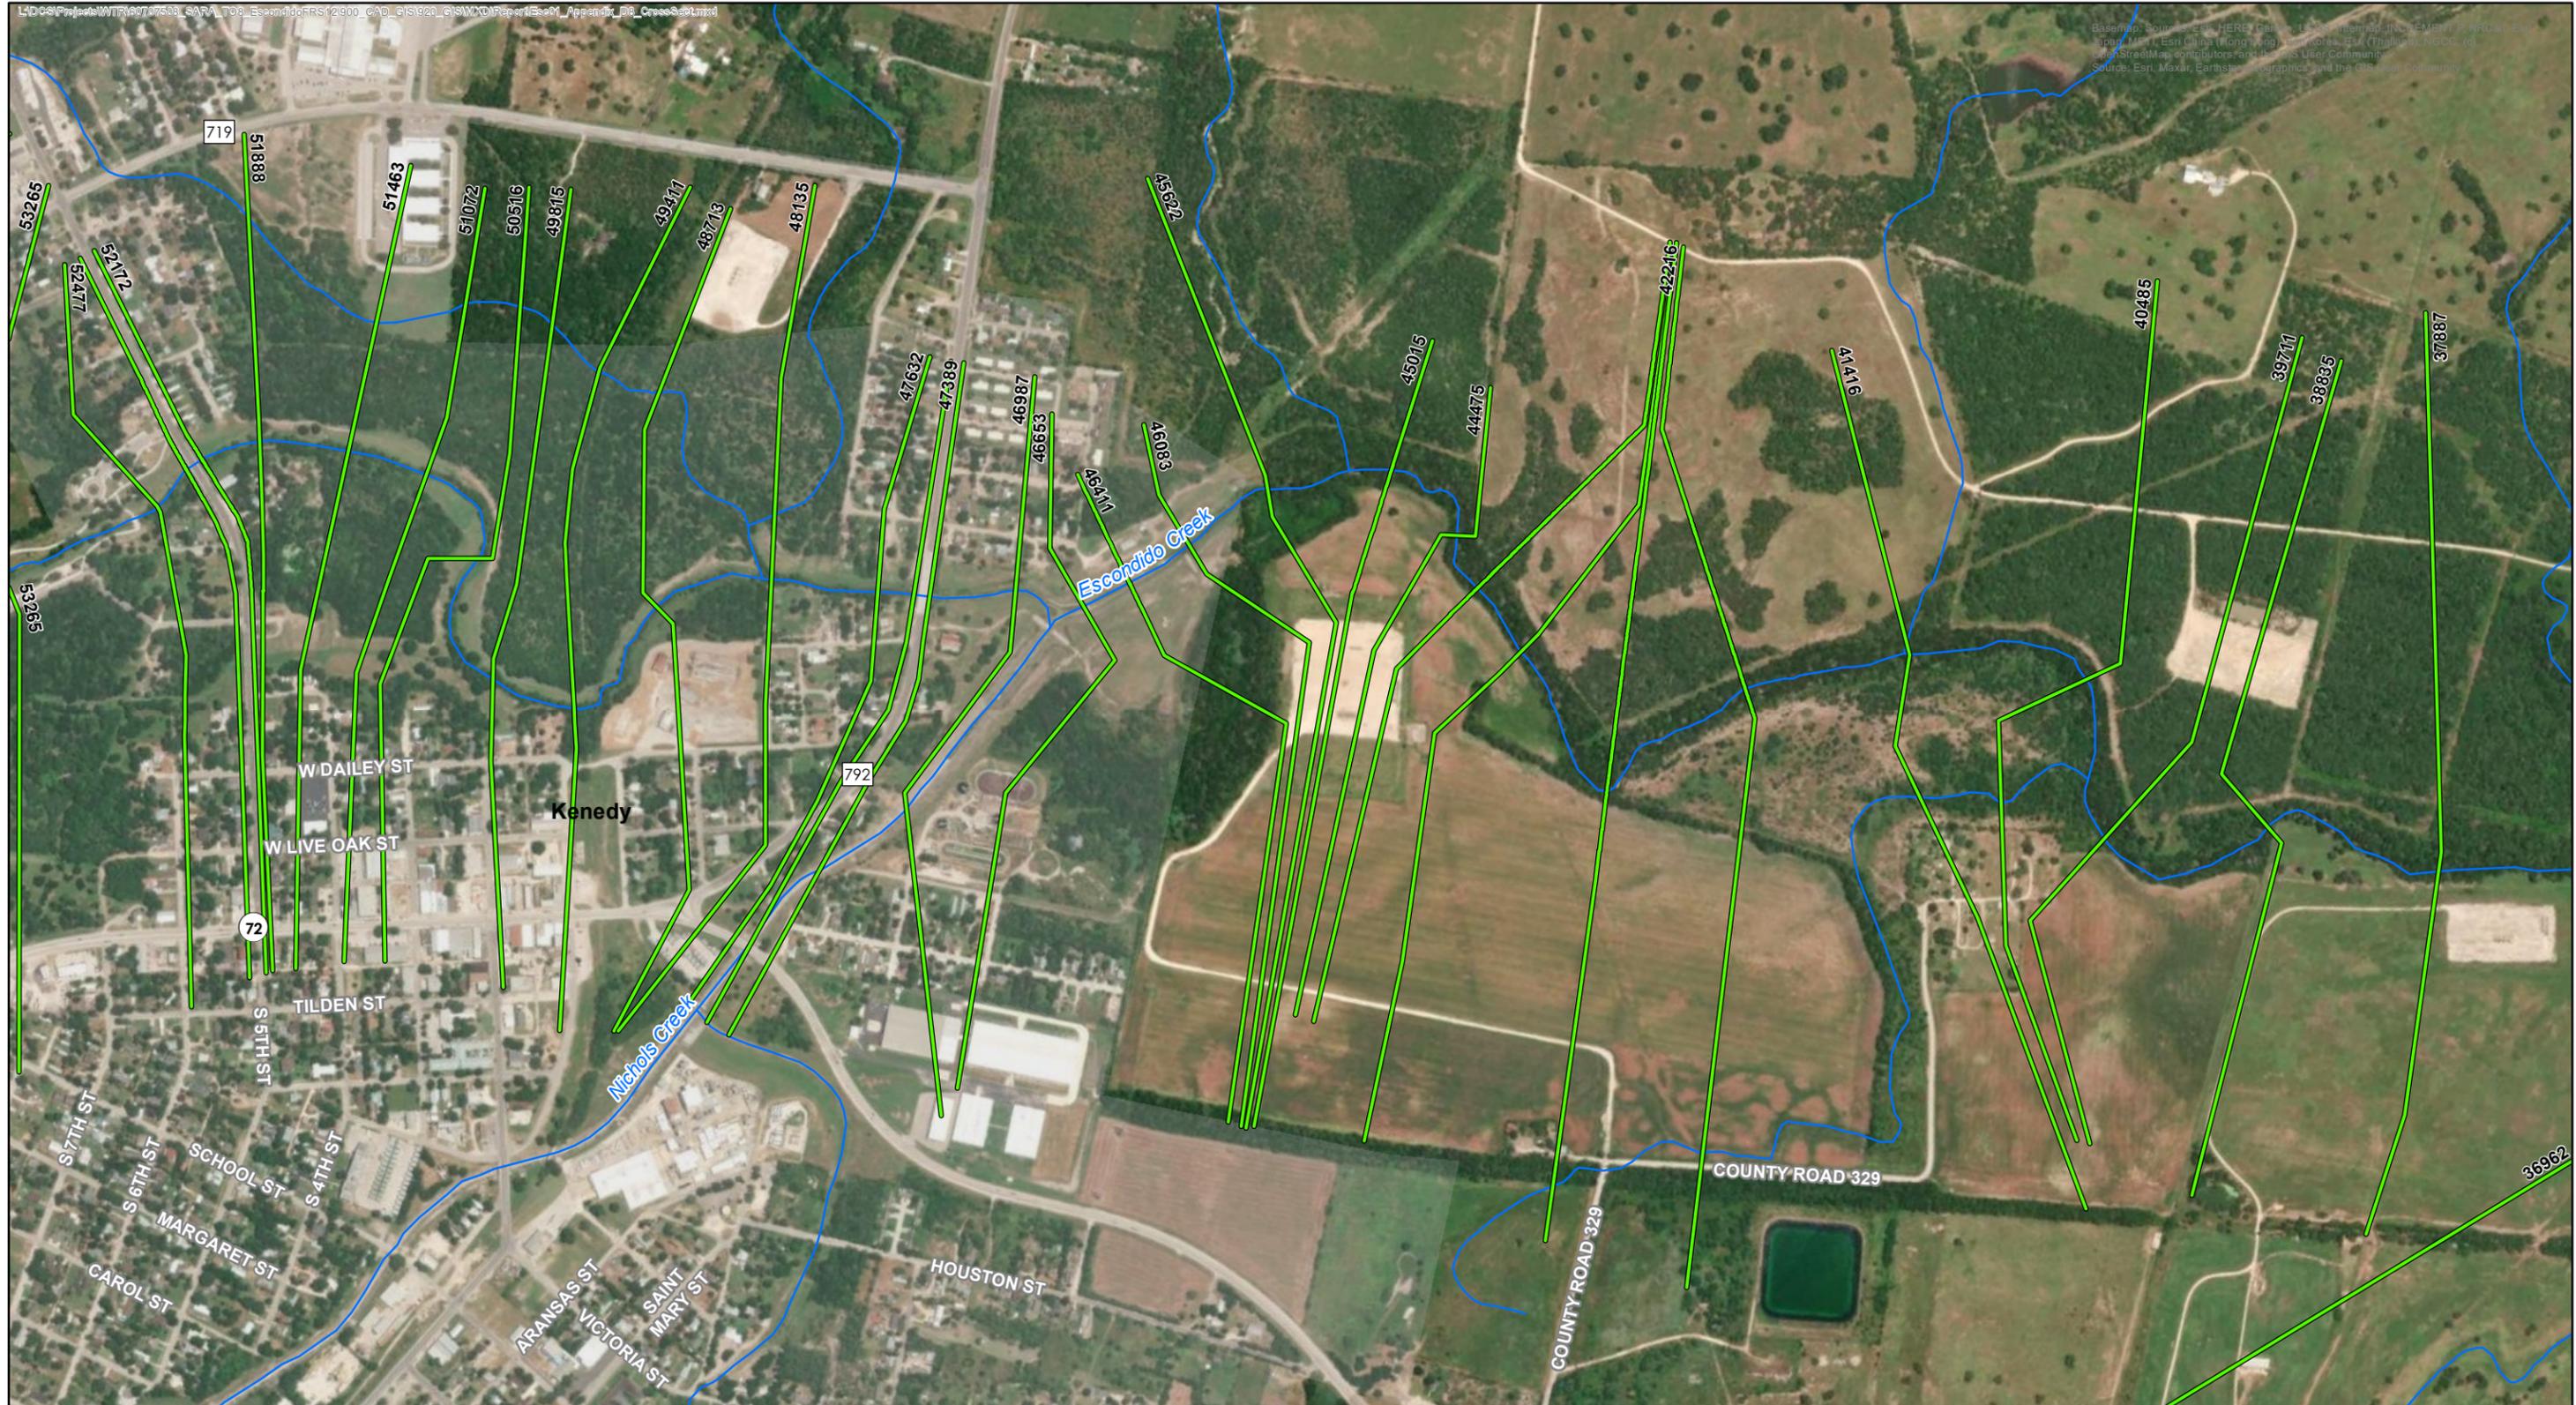
Figure D-8  
FRS No. 1 HEC-RAS Cross-Section Map  
1 of 6

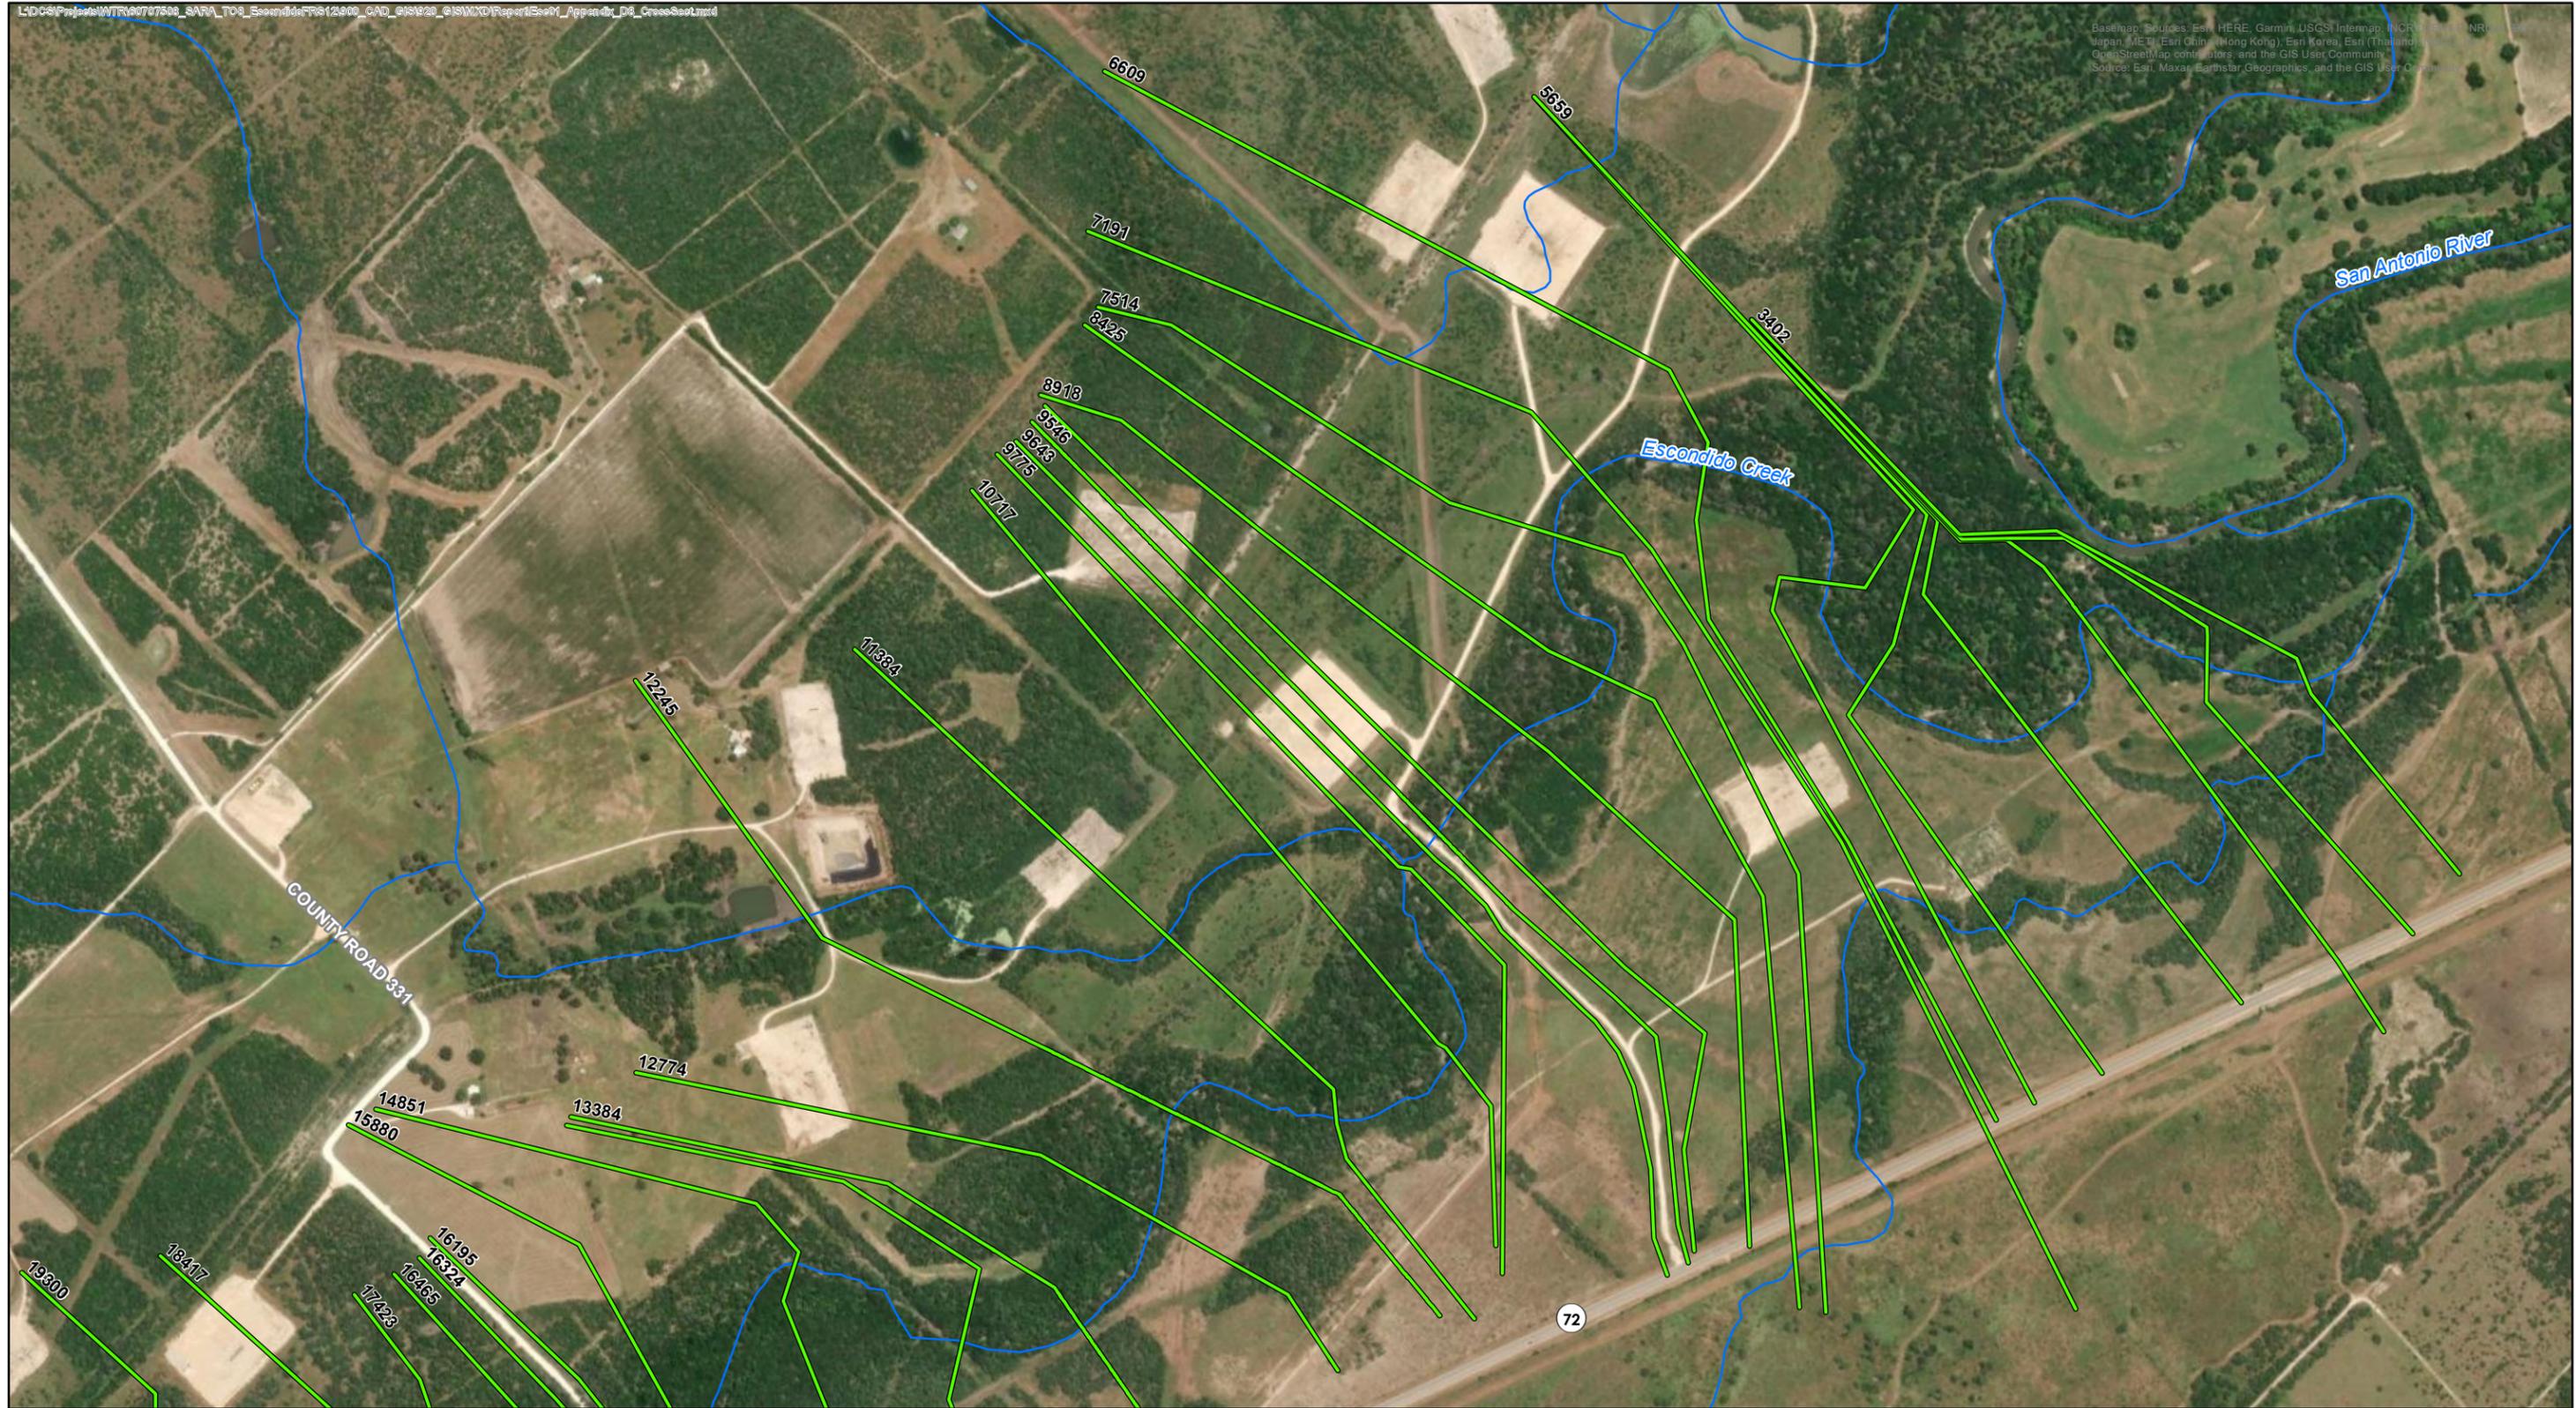
**Figure D-8**  
**FRS No. 1 HEC-RAS**  
**Cross-Section Map**  
4 of 6
