Appendix E Other Supporting Information

EVALUATIO	N OF POTENTIAL REHABILITATIO	N PR	OJECTS			
STATE	ТΧ	DAM	Es	condido Creek FRS No. 1	BY	SS	DATE	4/22/20)24
	YEAF	R BUILT	1954	DESIGN HAZARD CLASS	L	DRAINA	GE AREA	3.22	mi ²
WO	RK PLA	N DATE	6/1/1954	CURRENT HAZARD CLASS	Н	DAI	M HEIGHT	38	ft
sht 1 of 5		CC	DNSEQUENC	ES OF DAM FAILURE (ver. 2021-01	l)		NID ID	TX020	32
POTENTIA	L DAM F	AILURE	:						
Total Fail	ure Index	Σ.						156	А
POTENTIA	LLOSS	OF LIFE	:						_
Maximum	Populati	on-at-Ris	sk [PAR]				(number)	6	В
Total Risk	Index							7	С
POTENTIA	LLOSS	OF PRO	PERTY:						
Identify m	ajor com	munity af	ffected by brea	ach and rate impact as High (H), Meo	dium	(M), Low (L)	or None(b	ank)	_
Commu	inity						(H,M,L,-)	-	D
Number	r of home	es, busine	esses, major b	uildings			(number)	0	E
POTENTIA									
Water sup	oply, iden	tify comr	nunity disrupte	ed by dam failure, and estimate num	oer/a	mount	i		_
	al sole so					Users	(number)	0	F
	nental so	ource				Users	(number)	0	G

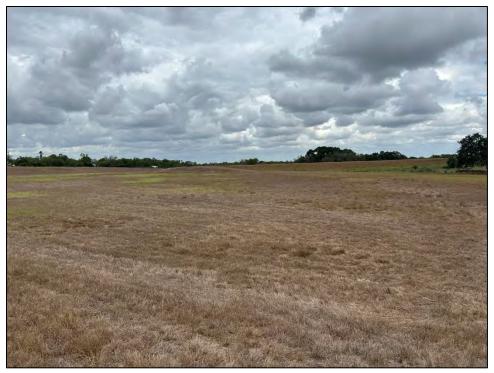
Figure 4. Overview of APE, facing northwest

The APE encompasses a mixture of open pasture, rangeland, natural short and tall grasses, and wooded areas (**Figure 4**). Prior disturbances include construction of the current earthen dam, reservoir, auxiliary spillway, drainage outlet, impact basin, channel modifications, and berms (**Figures 5-9**).

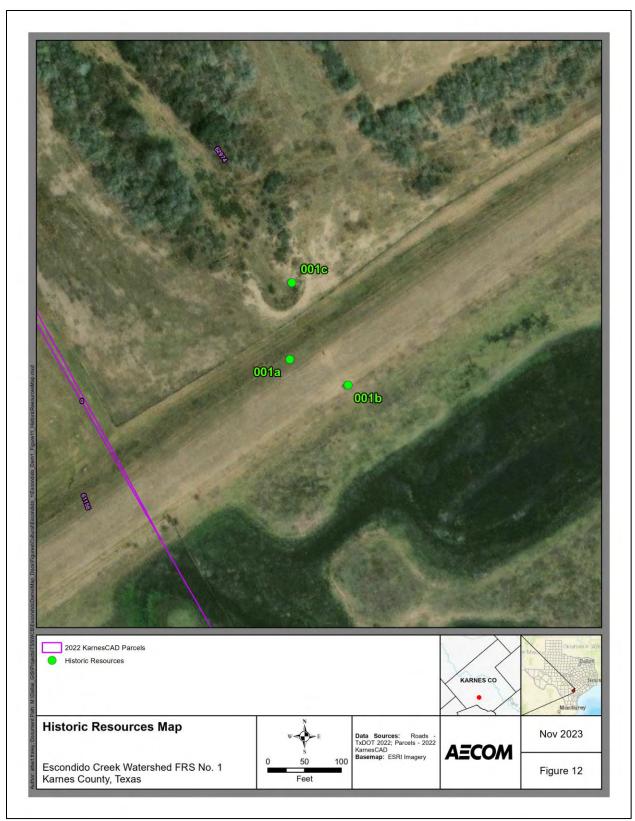
Figure 12. Historic Resources Site 001 location map

Site 001 consists of the Escondido Creek Watershed FRS 1, located on a tributary to Panther Creek. The site contains three historic-age resources: Resource 001a - earthen dam structure; Resource 001b - principal spillway inlet structure; and Resource 001c - principal spillway outlet drainage pipe and basin (see **Figures 11-12**). The site was constructed as part of the Escondido Creek Watershed Work Plan under the authority of the Soil Conservation Act of 1935 as implemented by the Watershed Protection item in the Department of Agriculture Appropriation Act of 1954. The National Inventory of Dams ID number for this dam is TX02032 and records a 1954 construction date for Resources 001a-c. Research indicates that Site 001 is situated on a large Spanish land grant originally consisting of 66,426 acres. The title was issued to Carlos Martinez on June 7, 1788, and the land was recorded in Texas GLO records as Patent #149, Volume 30, File 000130:2 on November 6, 1839.

One aboveground historic-age resource site (Site 001) was identified in the indirect APE (**Figures 11-12**) and evaluated by an architectural historian.

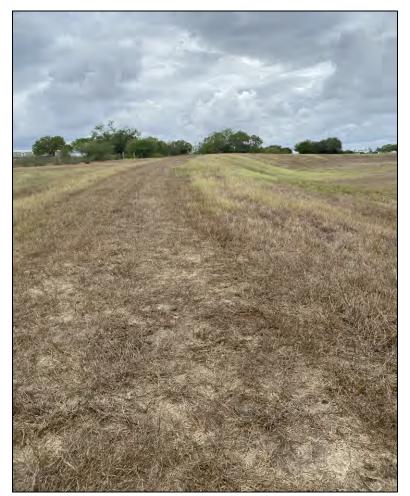
Figure 13. View of the top of Resource 001a, facing northeast

Resource 001a consists of an earthen-filled embankment dam designed for flood control (**Figure 13**). The resource is grass-covered and measures 2,606 feet in length with an embankment height of 36 ft. The dam structure is oriented southwest to northeast. Resource 001a appears to retain all aspects of integrity. However, the resource is a common example of its type and does not exhibit exceptional architectural or engineering merit, or historical significance and is recommended Not Eligible for NRHP listing.

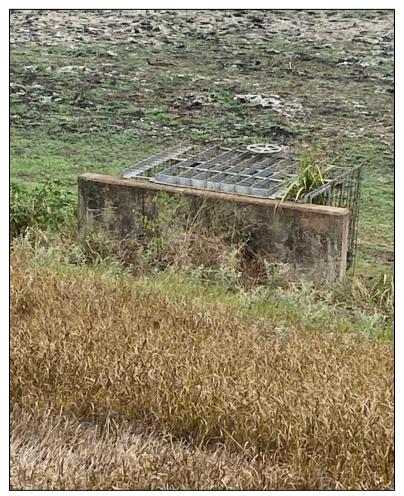
Figure 14. View of Resource 001b, facing east

Resource 001b appears to retain all aspects of integrity. However, the resource is a common example of its type and does not exhibit exceptional architectural or engineering merit, or historical significance and is recommended Not Eligible for NRHP listing.

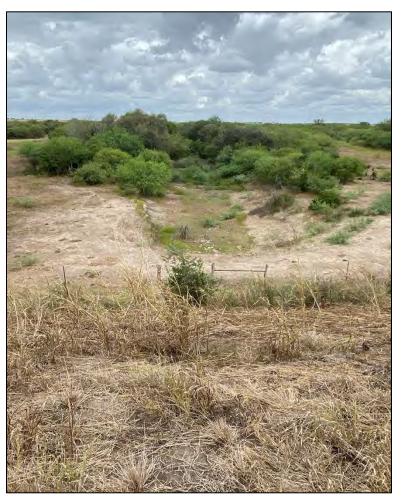
Figure 15. View of Resource 001c, facing northwest

Resource 001c appears to retain all aspects of integrity. However, the resource is a common example of its type and does not exhibit exceptional architectural or engineering merit, or historical significance and is recommended Not Eligible for NRHP listing.

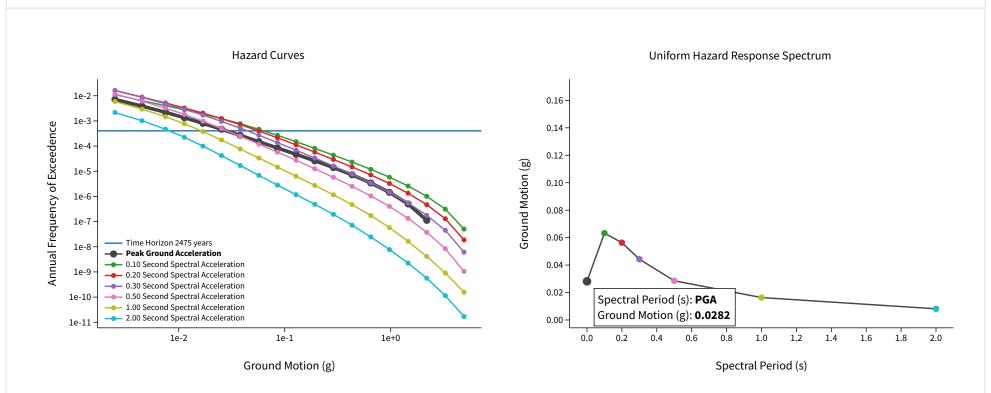
Hazard Curve

Component Curves for Peak Ground Acceleration

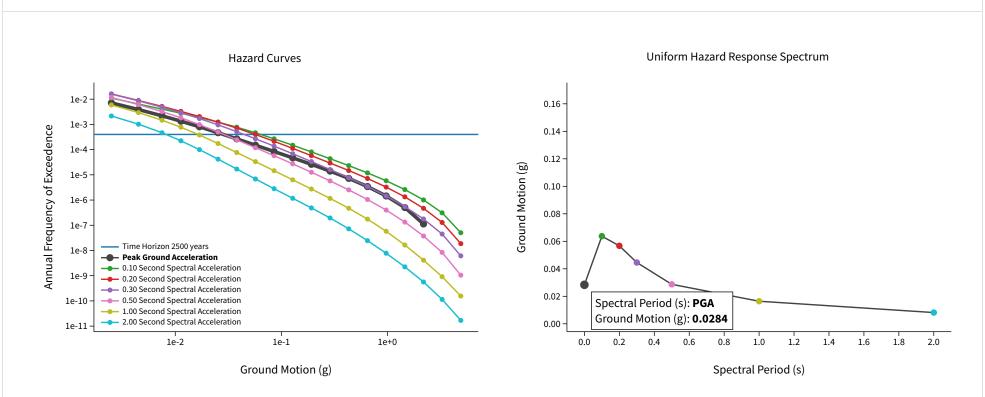
Hazard Curve

Component Curves for Peak Ground Acceleration

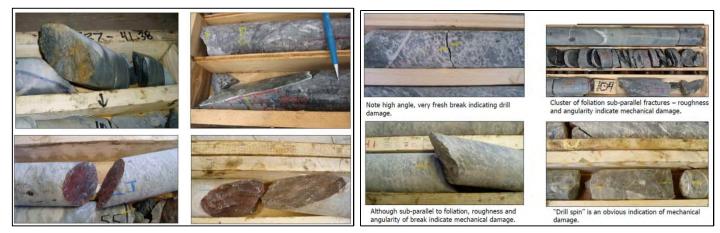
- Sections of core with mechanical breaks or a single sub-parallel fracture are counted as intact rock and included in the RQD calculation.
- Sections of core weaker than R2 strength are omitted from the RQD calculation, it doesn't meet the soundness criteria.

Example of natural joint surfaces, note surface staining.

Example of mechanical breaks, note fresh jagged surfaces.

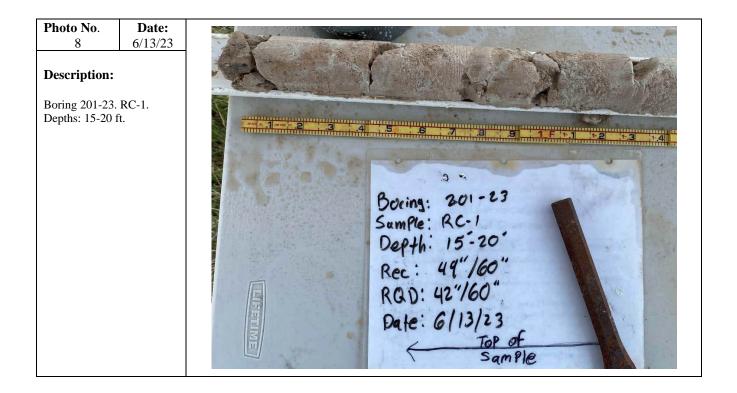
AEC	ЮM		PHOTOG	RAPHIC LOG
Client Name:			Site Location:	Project No.
San Antonio F	River Author	ity	Escondido FRS No. 1: Karnes County, TX	60707486
Photo No. 9	Date: 6/13/23			
Description:		Sale Para	ALL AN ROUTE	
Boring 201-23. Depths: 15-20 f			Boring: 201-23 Sumple: RC-1 Depth: 15-20 Rec: 49"/60" RQD: 42"/60" Date: 6/13/23 Top of Sample

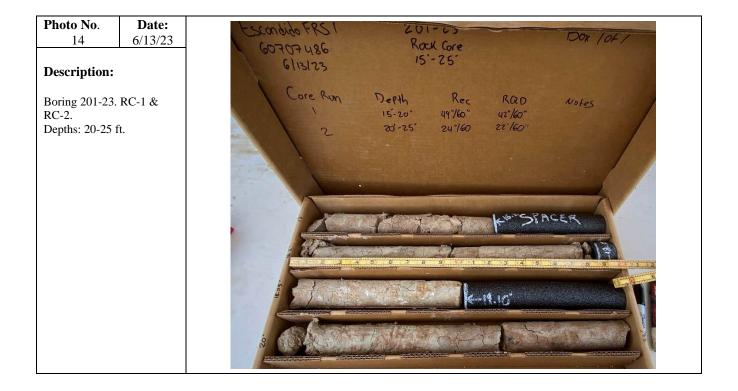
AECOM	PHOTOG	RAPHIC LOG
Client Name:	Site Location:	Project No.
San Antonio River Autho	Escondido FRS No. 1: Karnes County, TX	60707486
Photo No. Date: 13 6/13/23		
Description:		
Boring 201-23. RC-2. Depths: 20-25 ft.	1F 11 12 13 14 15 16 17 18 19	
	Barro Dala 23	
	Boeing: 201-23 Sumple: RC-2	
	Depth. 20-23 Rec: 24"/60"	
	RGD: 22/160"	3
	Date: 6/13/23 Top of	
	Sample

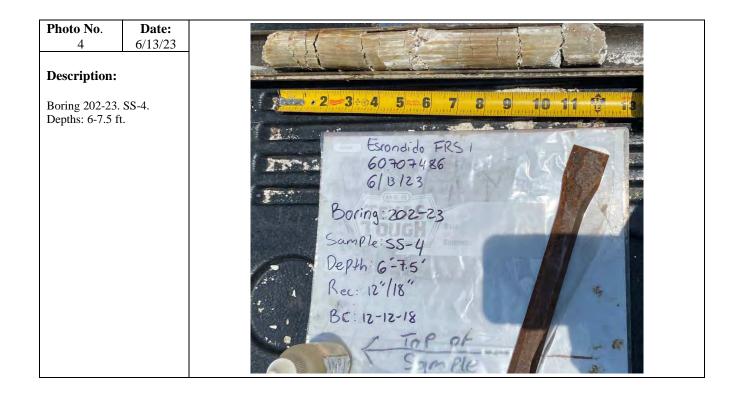
AEC	COM			PHO	TOGR	APHIC LOG
Client Name	:		Site Location:			Project No.
San Antonio River Authority		Escondido FRS I	Escondido FRS No. 1: Karnes County, TX		60707486	
Photo No. 5	Date: 6/13/23		l			
Description: Boring 202-23 Depths: 8-10 fr	. ST-5.			Кс: и	61	bide 1 07 4186 2-23 5/23 Depth:8'-10'

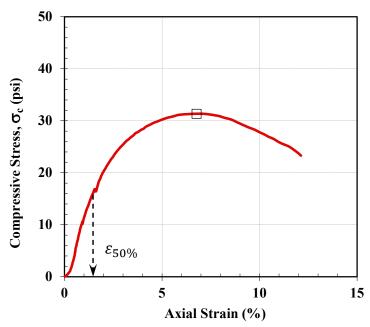
Client: Arias & Associates, Inc. Project Name: Escondido FRS No.1 (PN: 2023-134) Sample ID: 201-23, ST-2 (2-4 ft)

Initial Conditions	
Avg. Diameter (in)	2.84
Avg. Height, H_0 (in)	5.68
Avg. Water Content (%)	20.8
Total Unit Weight, γ_{total} (pcf)	124.5
Dry Unit Weight, γ_{dry} (pcf)	103.1
Void Ratio, <i>e</i> ₀	0.62
Specific Gravity (Assumed)	2.68

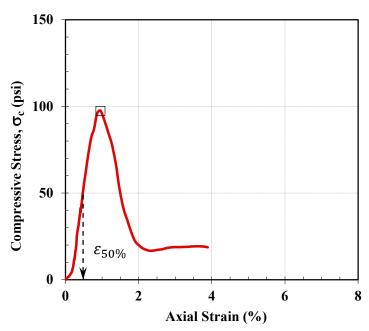
Client: Arias & Associates, Inc. Project Name: Escondido FRS No.1 (PN: 2023-134) Sample ID: 202-23, ST-5 (8-10 ft)

Initial Conditions	
Avg. Diameter (in)	2.85
Avg. Height, H_0 (in)	5.69
Avg. Water Content (%)	21.5
Total Unit Weight, γ_{total} (pcf)	131.5
Dry Unit Weight, γ_{dry} (pcf)	108.2
Void Ratio, <i>e</i> ₀	0.55
Specific Gravity (Assumed)	2.68

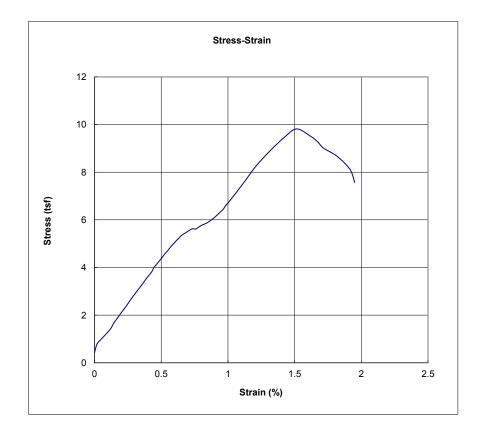
Unconfined Compressive Strength Test ASTM D2166

Specimen and Testing Details 203-23 Borehole Depth (ft) 6 - 6.5 Sample Date 6/14/2023 FAT CLAY (CH) with Sand Soil Type Specimen Height inch 4.623 Specimen Diameter inch 2.858 Moisture Content % 13.3 112.46 Dry Density pcf Confining Pressure 0 psi Membrane Correction Used? Y/N Ν Axial Strain % 1.51 9.82 Failure Stress tsf

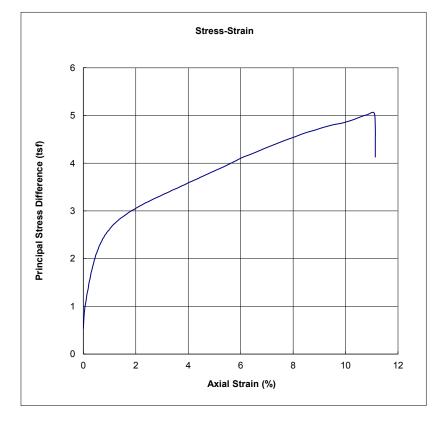
Unconsolidated Undrained Triaxial Compression Test ASTM D2850

Specimen and Testing Details		
Borehole		201-23
Depth (ft)		12 - 14
Sample Date		6/13/2023
Soil Type		Lean Clay with Sand (CL)
Specimen Height	inch	5.17
Specimen Diameter	inch	2.79
Moisture Content	%	15
Dry Density	pcf	115.71
Confining Pressure	psi	11.5
Membrane Correction Used?	Y/N	Ν
Axial Strain	%	11.09
Failure Stress	tsf	5.05
