# 2025 San Antonio River Basin Highlights Report

## Watershed Characterization for Cibolo Creek Watershed

***Prepared by the San Antonio River Authority***

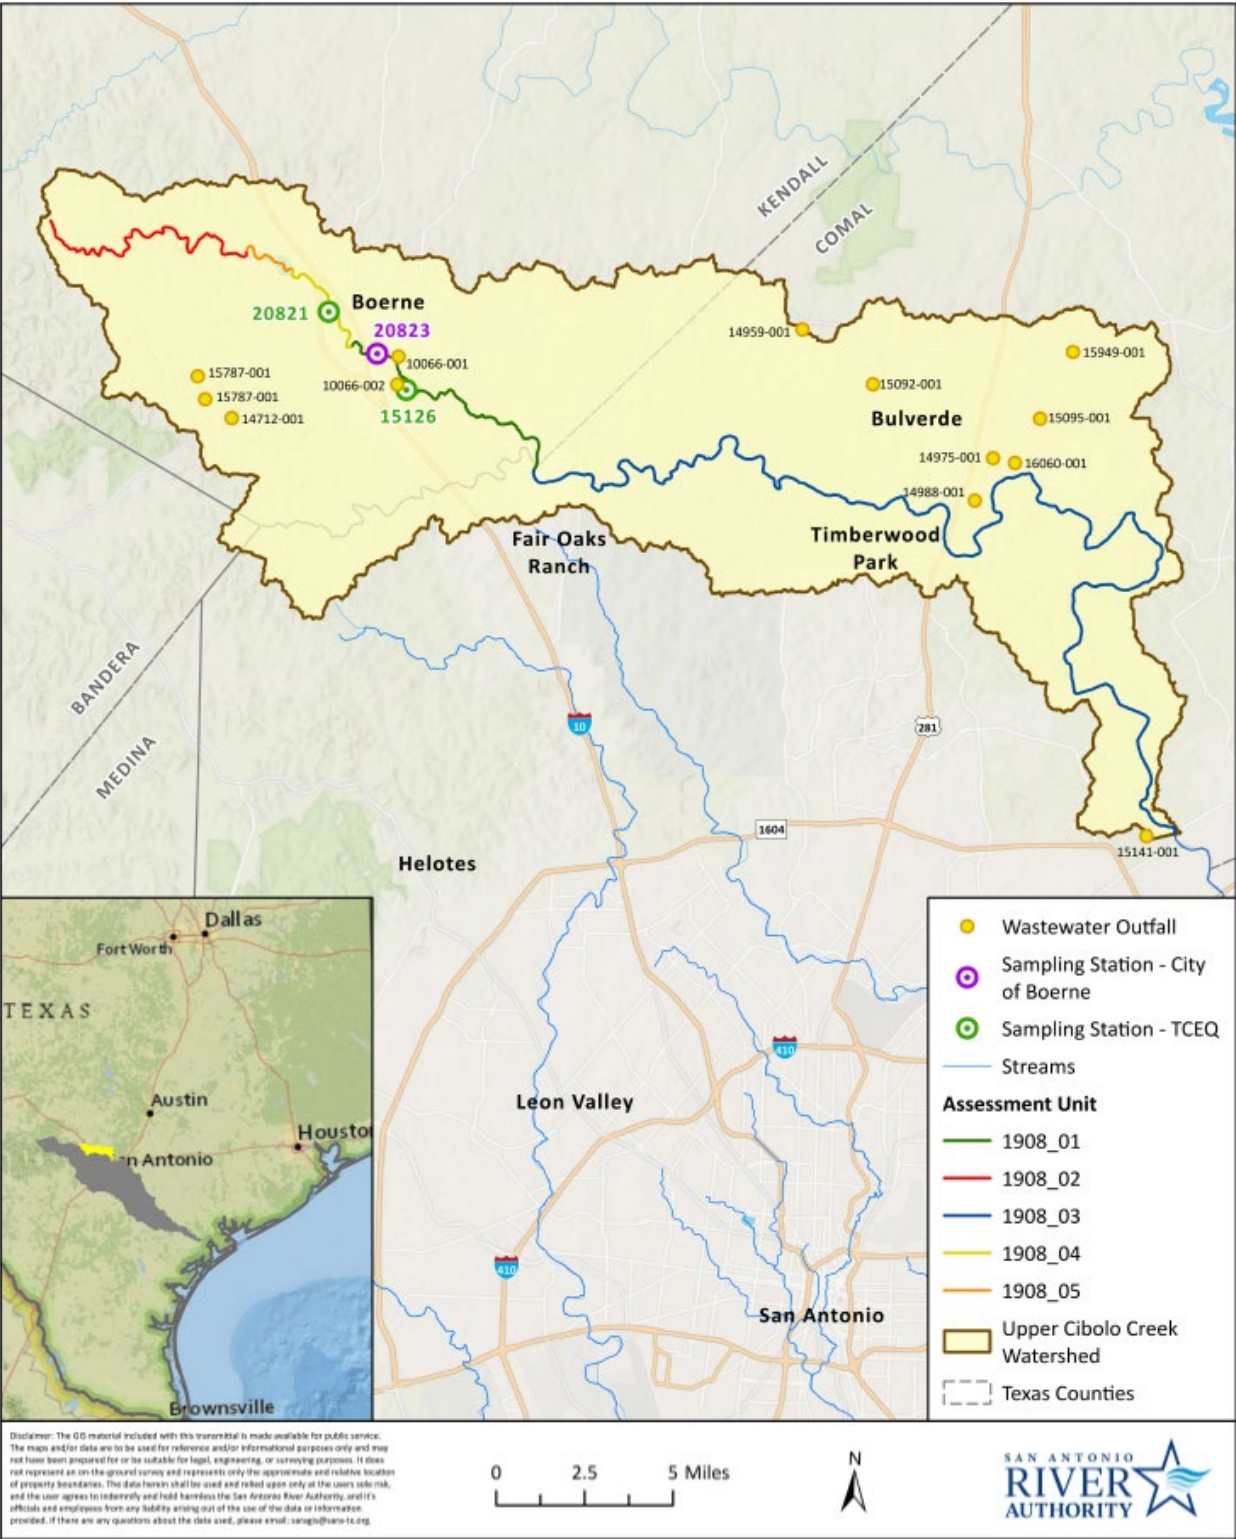
Figure 2-1: Map of Upper Cibolo Creek Watershed. Segment 1908 with current sampling stations and permitted wastewater treatment plants identified.

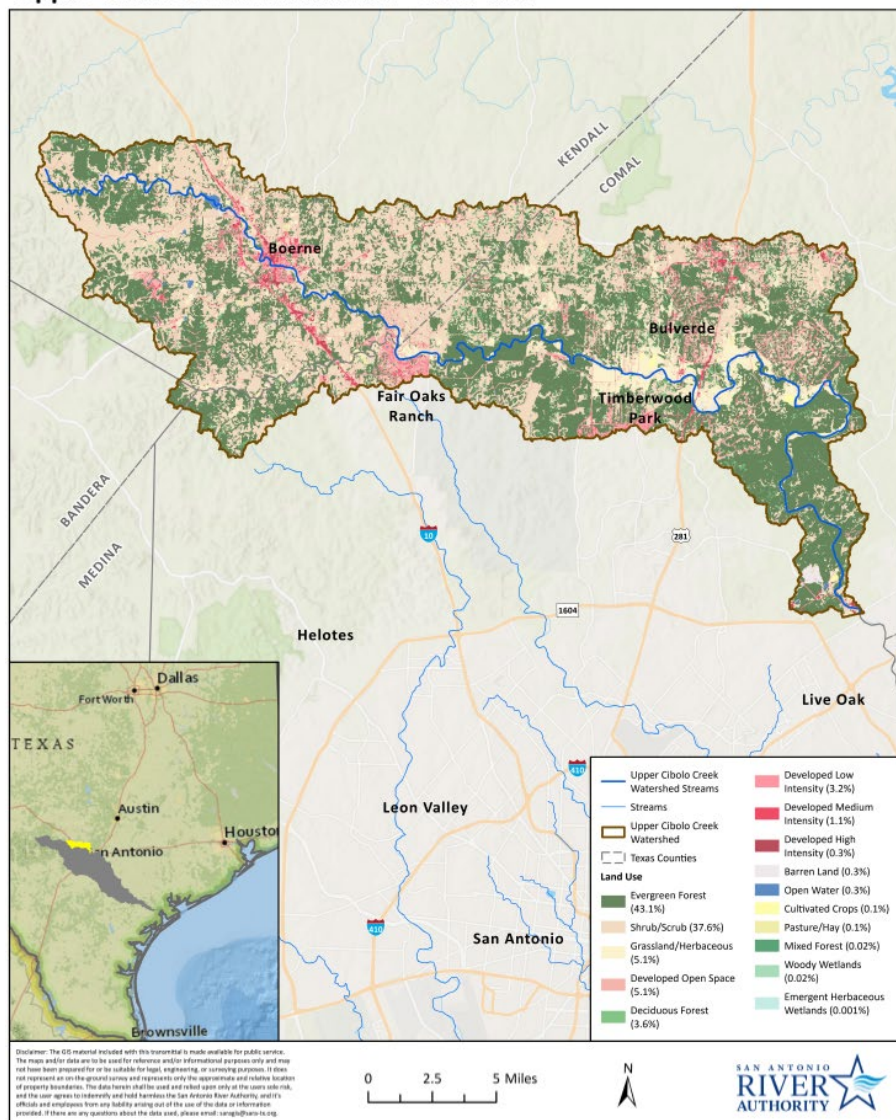
Figure 2-2: Upper Cibolo Creek Watershed land use.

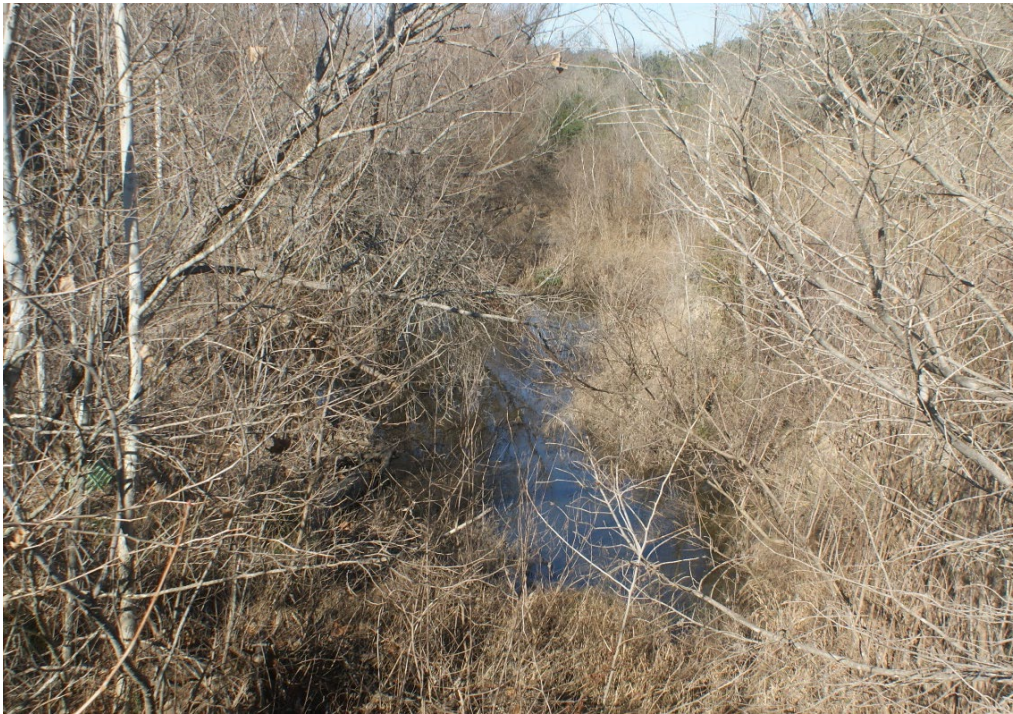
Figure 2-3: Upper Cibolo Creek downstream of Northrup Park (near station 20821) at Johns Rd. in the City of Boerne

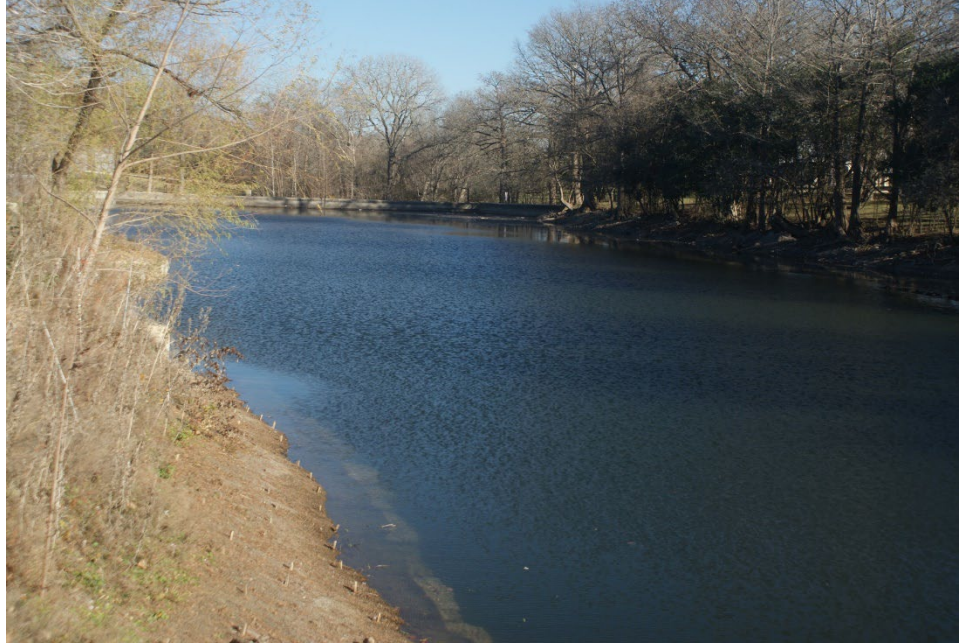
Figure 2-6: Upper Cibolo Creek at River Road Park in Boerne, looking downstream at Dietert Mill Dam (Station 20823).

Station 20823, Upper Cibolo Creek at River Road Park is located approximately 100 ft. upstream of Dietert Mill Dam. This is the Boerne River Road Park and an area that is heavily used by residents and wildlife.

Flow data is unavailable at Station 20823, since it is a small reservoir. However, an examination of *E. coli* data for station 15126, shows that elevated *E. coli* values are occurring under both low flow and high flow conditions indicating that both point source pollution (likely wildlife) and non-point source pollution due to urban storm water runoff are both influencing the elevated *E. coli* levels in AU 1908\_01.

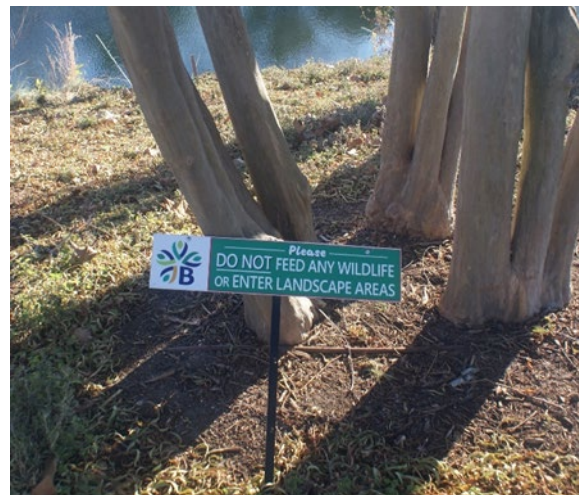
Figure 2-10: Photo of Do Not Feed any Wildlife sign at Boerne River Road Park.

- Installation of permanent “Do Not Feed Waterfowl” signage
  - Installation of permanent educational signage at River Road Park and the Patrick Heath Public Library dedicated to the topics of “What is a Watershed” and “What is Riparian”

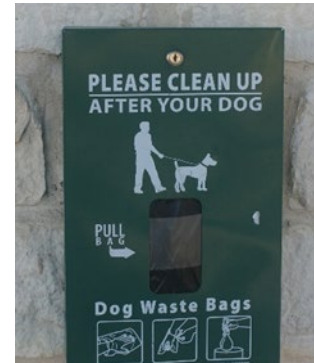
*Figure 2-11: Photo of pet waste station.*

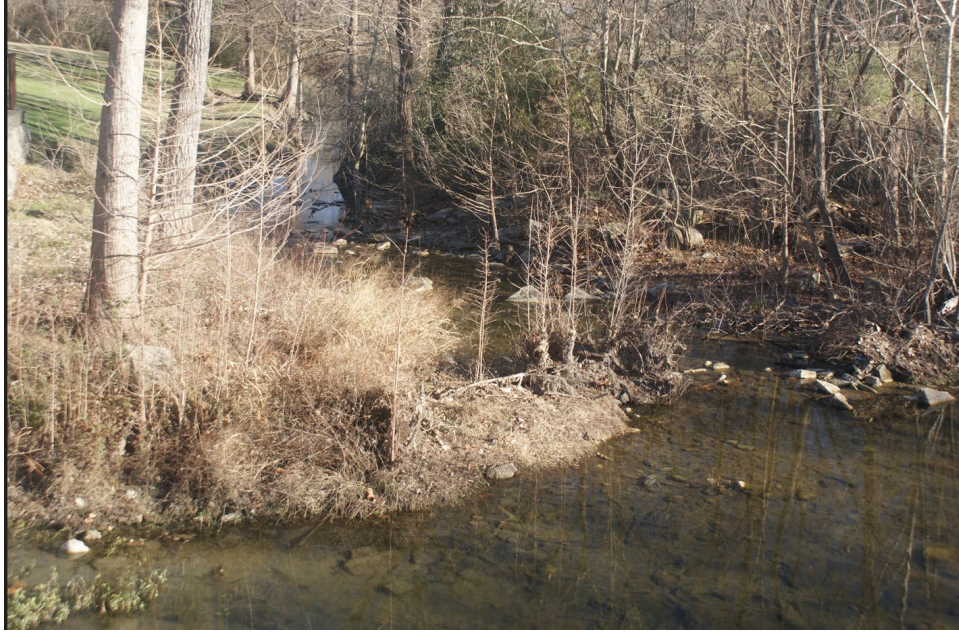
*Figure 2-12: Upper Cibolo Creek downstream of Dietert Mill Dam.*

Since 2022, most of the Upper Cibolo Watershed has been under drought conditions.

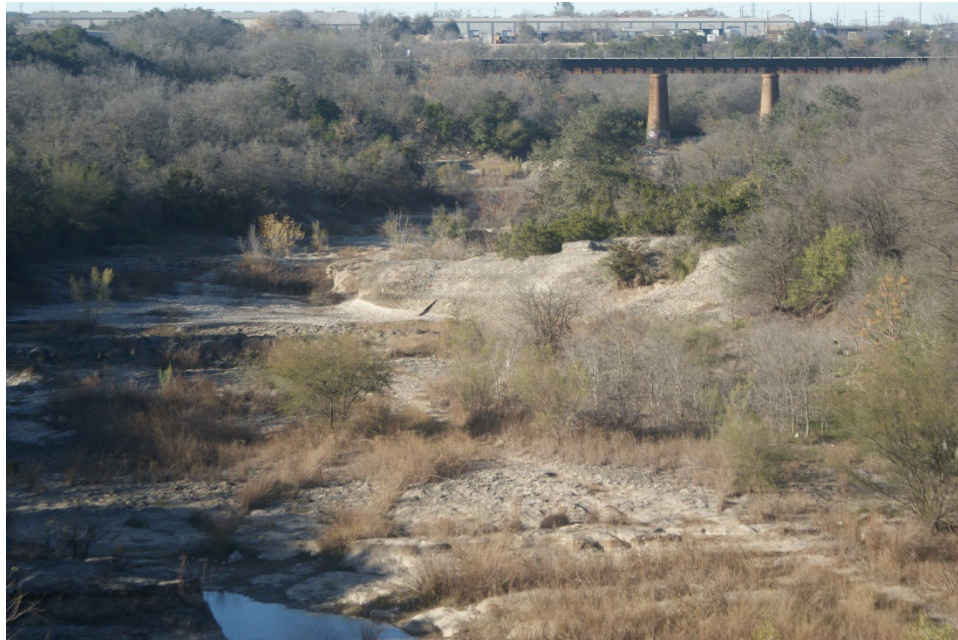
*Figure 3-2: Mid Cibolo Creek upstream of Nacogdoches Road West of Bracken. Pooled water can be seen at the bottom of the picture, upstream is dry. Note the railroad bridge in the distance is the segment divider between the Upper and Mid Cibolo Creek.*

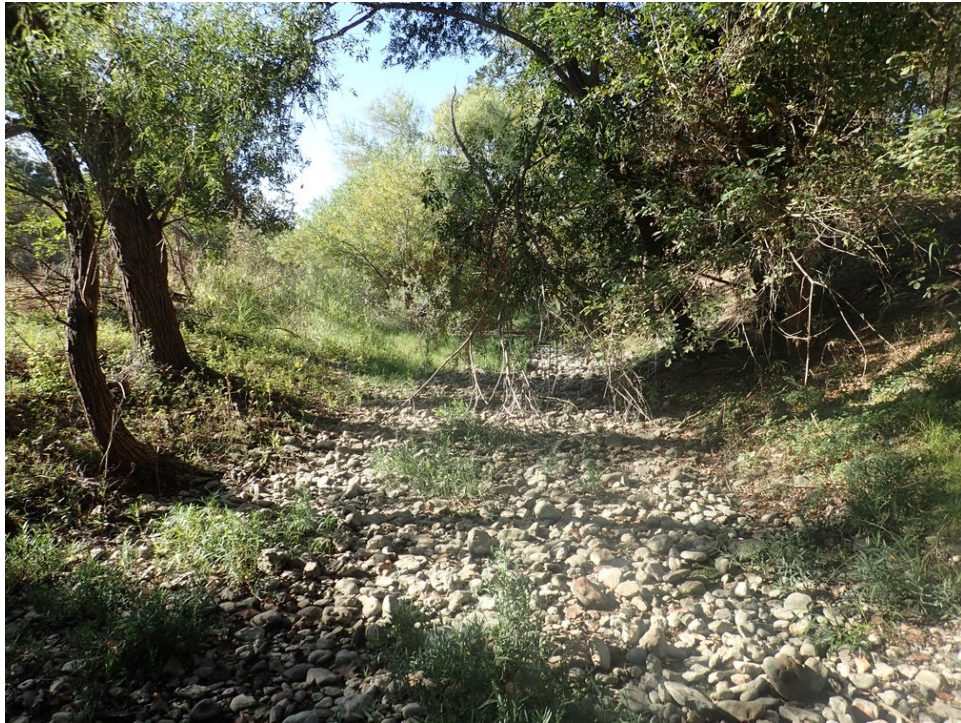
*Figure 3-4: Station 14212 Mid Cibolo Creek upstream of CCMA Wastewater Treatment Plant off River Road.*

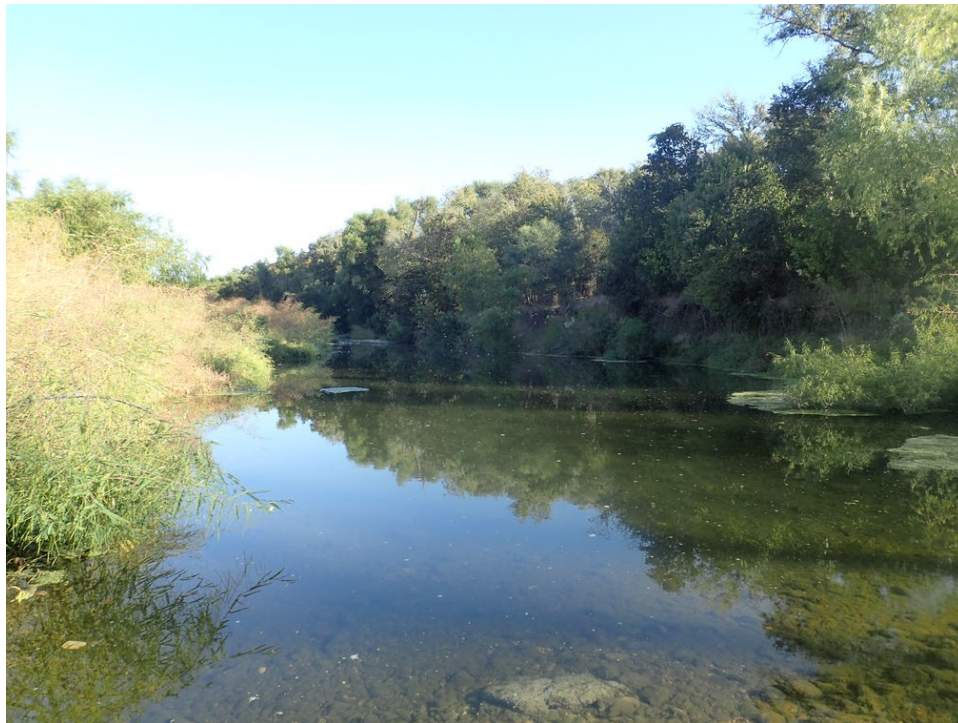
Figure 3-8: Station 12924 at Schaeffer Road downstream of CCMA Wastewater Treatment Plant Discharge.

The likely cause is the wastewater treatment plant discharge. However, a review of the data indicates that since 2021, sampling downstream of the WWTP is meeting the TCEQ screening level for total phosphorus. It is estimated that if this trend continues, the TCEQ 2028 integrated report will no longer have a concern for total phosphorus in AU 1913\_02. (see figure 3-7)

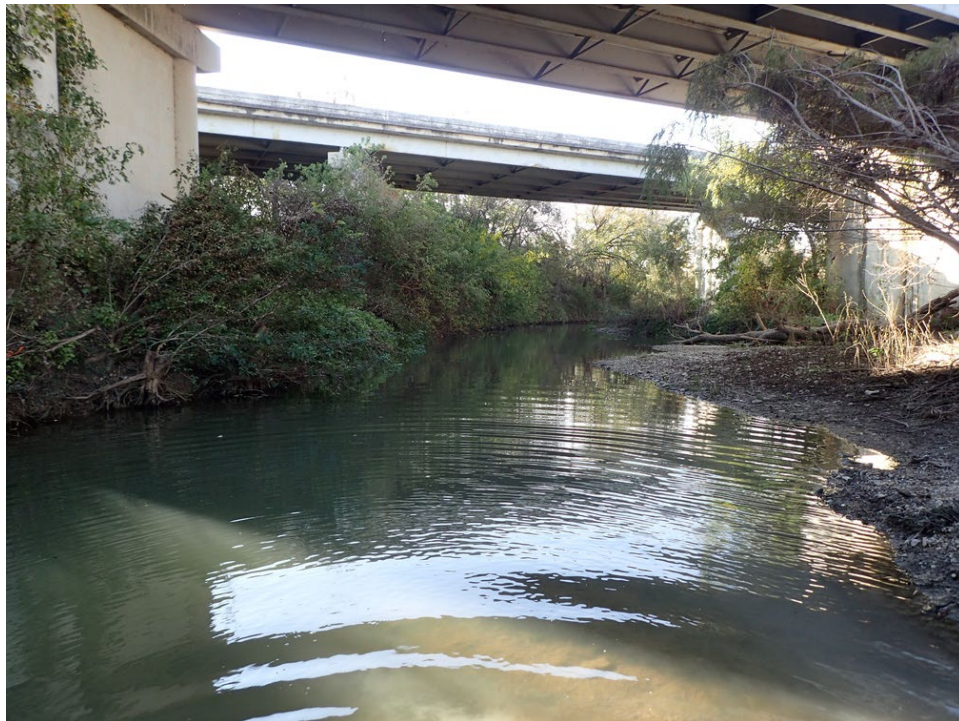
*Figure 3-11: Mid Cibolo Creek at IH 10 looking downstream.*

Like much of Texas, this area suffered from drought. Due mainly to wastewater discharge from CCMA, the creek was perennial downstream of the discharge outfall.

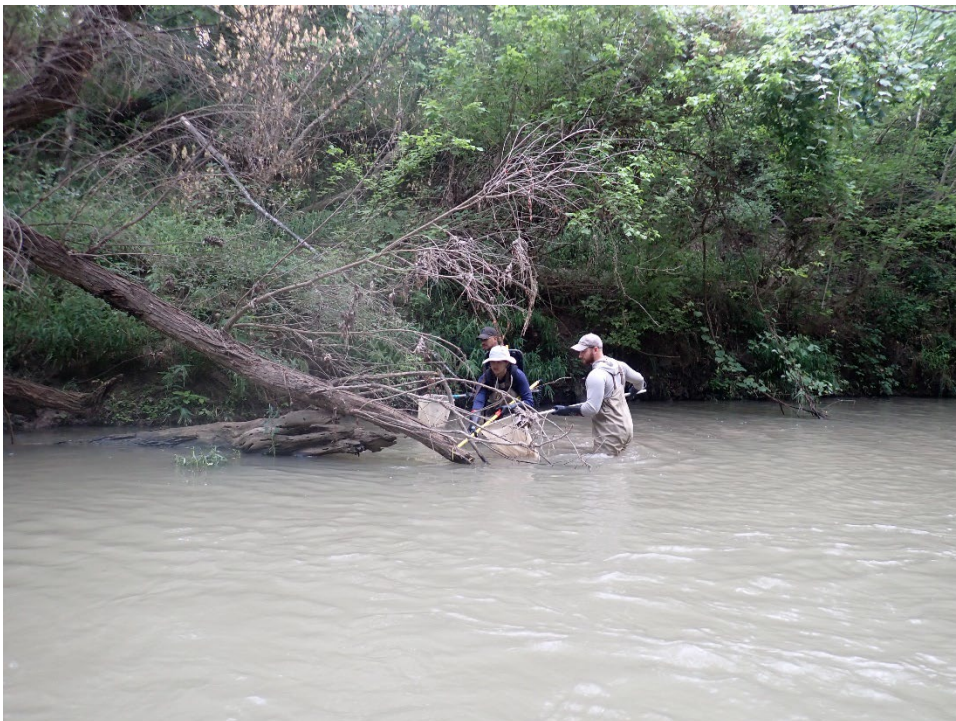
*Figure 4-2: Aquatic biologists and student intern electrofishing underneath fallen tree at station 14197, Cibolo Creek at Scull Crossing. (Electrofishing shocks the fish, they are stunned, caught, identified, measured and allowed to recover prior to release).*

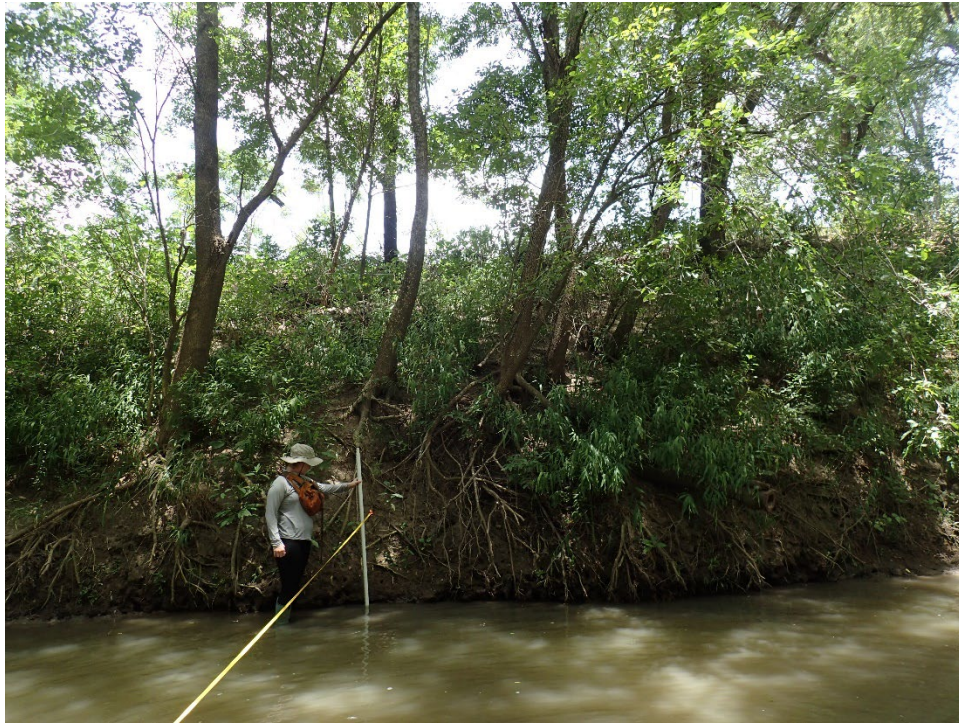
*Figure 4-13: SARA intern conducting habitat transect at station 12802. Note bank failure, exposed soil and tree roots.*

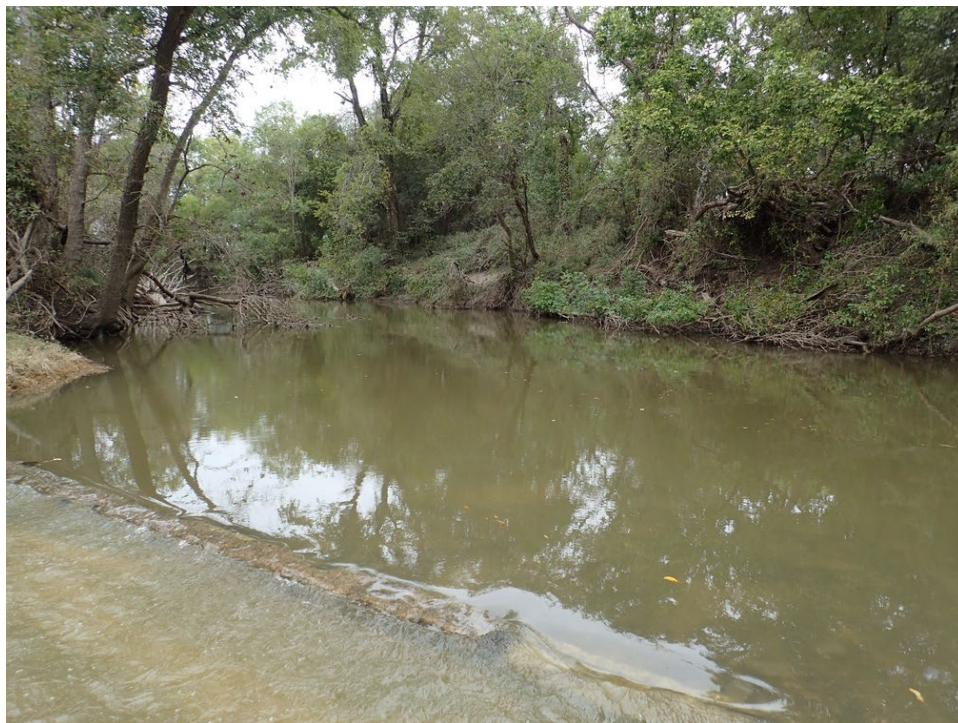
Figure 4-14: Station 14211 (AU 1902\_02) Cibolo Creek at CR 389 near Cestohowa, Texas.

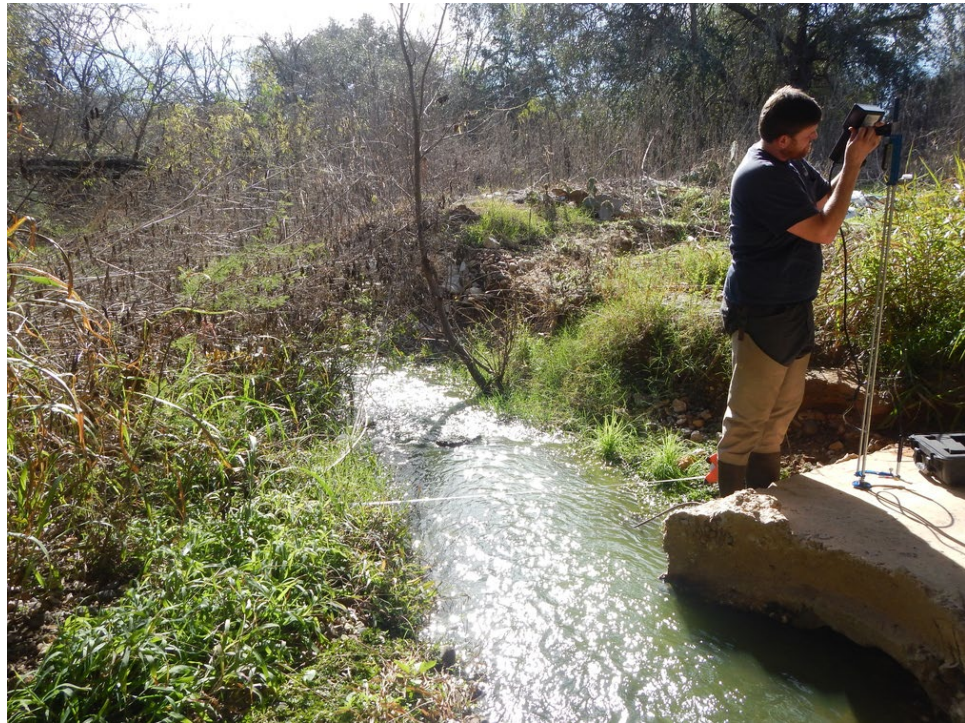
*Figure 4-15: Station 20776 Clifton Branch at Old Floresville Road. SARA aquatic biologist preparing to measure flow.*

It is believed that the DO impairment on Clifton Branch is due to a combination of very low flow along with elevated nutrient concerns (ammonia nitrogen and total phosphorus).
